Continuous debonding monitoring of a patch repaired helicopter stabilizer: Damage assessment and analysis

The present work focuses on the structural health monitoring of an aluminium vertical helicopter stabiliser with a pre-introduced crack which was repaired with an adhesively bonded composite patch. The structure was monitored under bending fatigue and its performance was evaluated with Lamb waves, lock-in thermography and ultrasonic testing. Outlier analysis of Lamb waves captured the onset and progress of the damage in the form of patch debonding, enabling the identification of five damage-severity regions. Principal component analysis showed distinctive clusters that corresponded to different damage levels while the application of principal curves on the selected features proved to be an additional damage detection index. Amplitude and phase lock-in images accurately captured the onset and evolution of the damage in the form of patch debonding and honeycomb/skin debonding in agreement with the damage indices obtained from Lamb waves. C-scan further validated the damage mechanisms that were captured by the other methods.

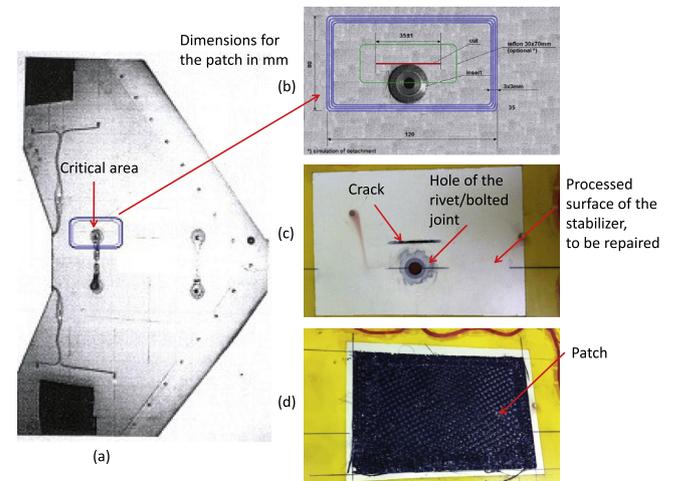
A vertical stabilizer of a helicopter located on the tail boom and manufactured by PZL-Swidnik/AgustaWestland (Poland) was selected as a representative aeronautical structure for repair and non-destructive testing. The panel was of a honeycomb construction, the core of which was made of HexWeb CRIII-5/32-5052-.001N-3.8 and the skin of AL-2024 T3 alloy sheet, of a thickness variation from 0.6 mm to 1.5 mm. Prior to the selection of the area to be repaired, bending fatigue was performed and the most critical region was identified to be around the rivets/bolted joints at the centre of the stabilizer as illustrated in Fig. 2(a). An artificially 35 mm crack that would be repaired by a bonded composite patch was introduced, located close to the hole as shown in Fig. 2(b) and (c).

Fig. 2. (a) Critical area and proposed location (blue line) for the attachment of the repair patch (b) schematic illustration of the repaired region (c) image of the processed surface of the stabilizer around the crack and the hole before the attachment of the patch (d) final implementation of the patch.¹ (For interpretation of the references to colour in this figure legend, the reader is referred to the web version of this article.)

The repair patch consisted of 4 plies AGP 280 (Hexcel 43280S) with a stacking ply sequence $[90/0]_2$ and total thickness equal to 1.16 mm. First the repaired surface was prepared using BR127 primer, Fig. 2(c), and each ply was impregnated with carbon nanotube (CNT) doped epocast. Each ply was cut to the final dimensions and laid up on the repaired region following a stepwise configuration as outlined in Table 1. Finally, a heating blanket was used for 2 h at 93 °C under vacuum conditions for the curing. The final cured patch is shown in Fig. 2(d). A C-scan was performed on the demonstrator prior to testing for evaluation of the bonding quality of the composite patch as shown in Fig. 19(a).

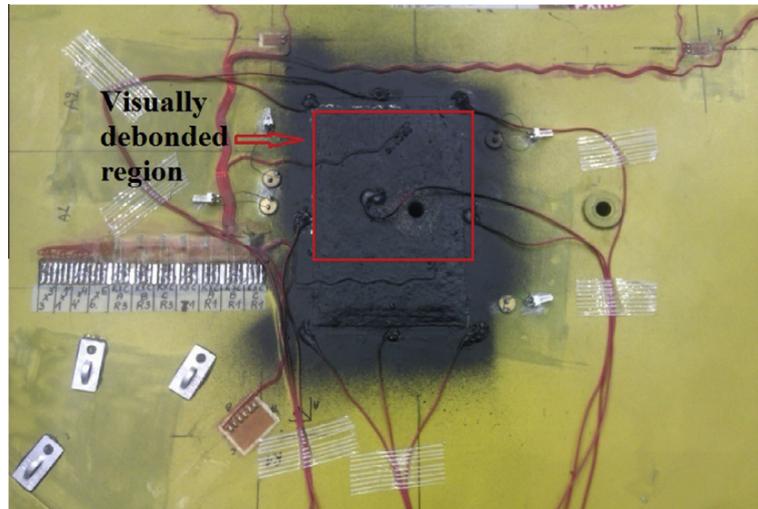
After 580 k fatigue cycles, at the end of the test, a clear debonding could be visually observed as illustrated in Fig. 8 which signified the end of the mechanical testing. Thermographic images were captured at different number of applied fatigue cycles and discussed in following sessions.

Fig. 8. Final debonding after 580,000 cycles of bending fatigue testing.

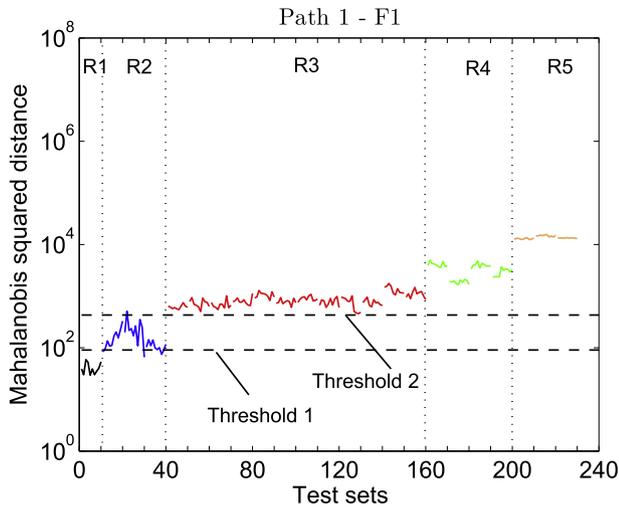
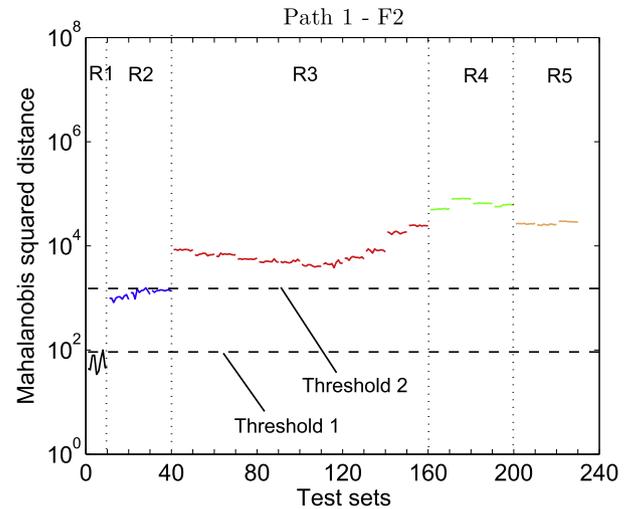
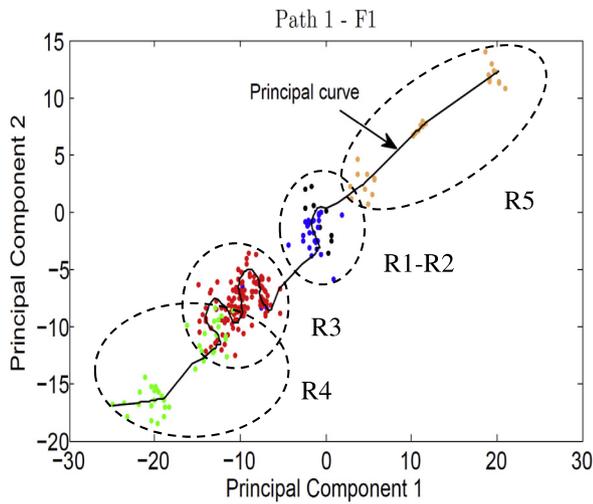
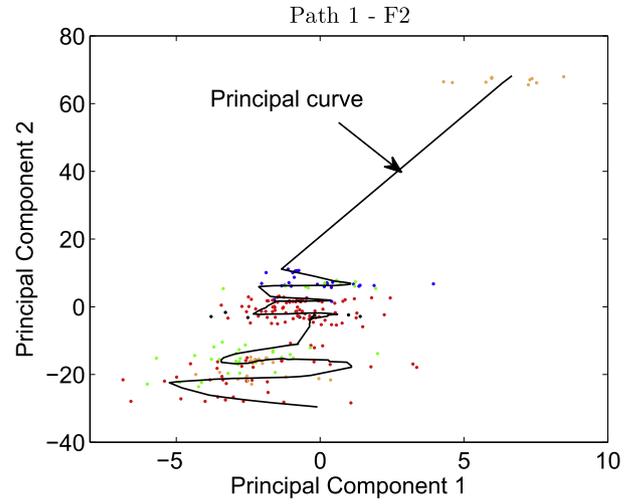
Figs. 9 and 10 illustrate the OA results and the PCA results for the selected features for propagation path 1. All the OA figures have the same scale in the y-axis for comparison purposes. Five areas can be distinguished in Figs. 9(a) and 10(a) based on the level of deviation from the assigned threshold (threshold 1), noted in the figure as R1–R5, each region corresponding to a different colour. The same colours have been assigned to the corresponding clusters in the PCA figures in Figs. 9(b) and 10(b). Regions R1 and R2 (from 0

to 15,000 cycles) are for both features very close to the threshold, while the deviation from the normal condition is not significant. However, region R2 is flagged as outlier (e.g. above the threshold). At this stage, the stabilizer was loaded for just 15,000 cycles at low loads (120 kN at loading point P2 and 150 kN at loading point P1). Given the testing conditions and the little deviation of the region from the threshold, it was assumed that no critical damage could have occurred at this stage. Nevertheless, something in the structure changed, leading to the change of the boundary conditions. An assumption of the possible reason for this behaviour is the increase in the temperature of the stabilizer after a few loading cycles, or micro-cracks at the adhesive of the transducers as soon as the testing started. These small changes could be sufficient for the observed behaviour, without necessarily notifying about a critical damage. Therefore a second threshold was defined (threshold 2) as shown in Fig. 9(a).

Fig. 9. (a) Outlier analysis (OA) and (b) principal component analysis (PCA) for path 1 – feature 1 (F1). Threshold 1 estimated through Monte Carlo technique and Threshold 2 assigned to reflect changes in boundary conditions, outliers above thresholds represent damage, regions R1–R5 show progressive damage increase in the form of increasing Mahalanobis distance OA values and as separate PCA clusters.

Region R3 (15,000– 405,000 cycles) in Fig. 9(a) is only slightly flagged above the thresholds but without any considerable deviation. However, there is a certain increasing tendency which suggests that damage has started accumulating in the monitored area (path 1). Region R4 (405,000–480,000 cycles) shows a higher deviation from the thresholds than region R3 while the region R5 (480,000–580,000 cycles) clearly corresponds to a stage where significant damage has developed. Feature 1 (F1), shown in Fig. 9(a), which corresponds to the part of the waveform that has been captured by the sensor without interacting with any other features/ boundaries, shows more distinctive differences than feature 2

(F2), shown in Fig. 10(a). However feature 2 (F2) exhibits higher values of deviation from the normal condition (higher Mahalanobis squared distance) (areas R3–R5).

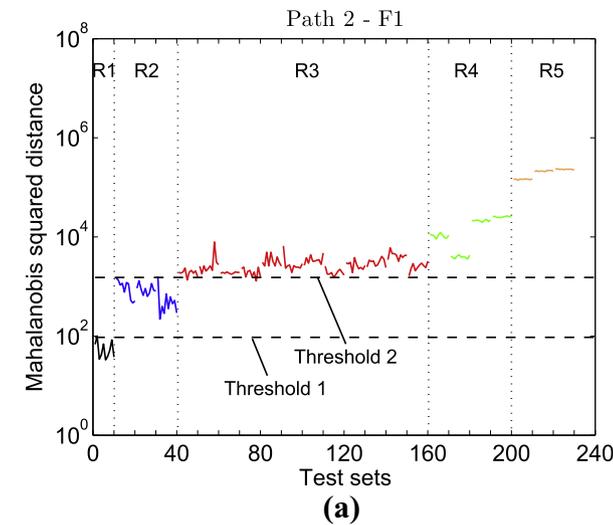
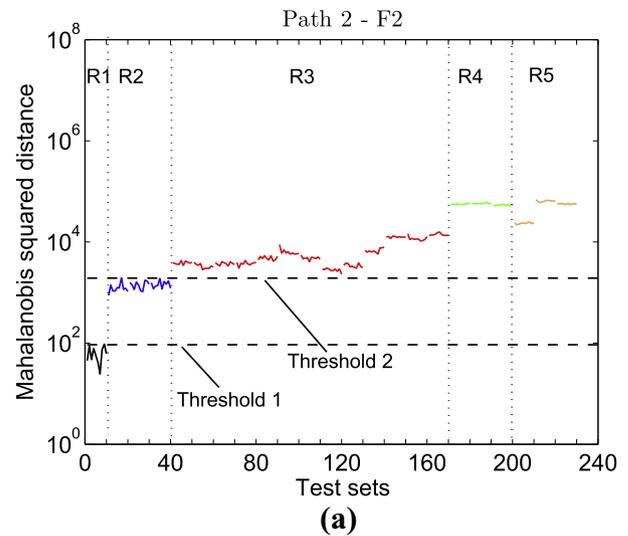
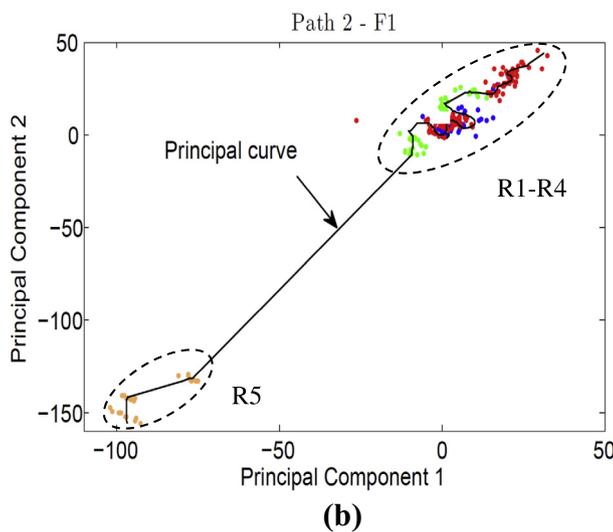
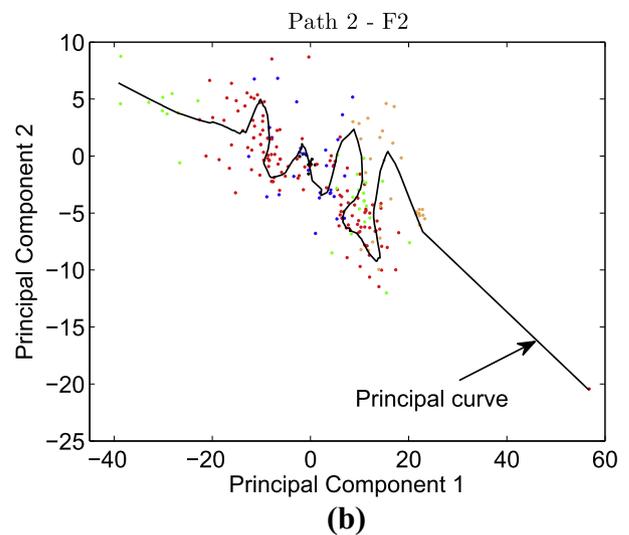
Figs. 11 and 12 illustrate the same results but for path 2. The y-axis is scaled in the same way as for path 1 for comparison purposes. The first observation is that the same regions (R1–R5) can be assigned in the OA figures, which indicate the level of deviation from the baseline reference (pristine condition) and from the assigned thresholds as shown in Figs. 11(a) and 12(a). One difference is that region R4 starts one set of data later (e.g. 170 test sets) for the second feature (F2) compared to F1 for the same path and

Fig. 11. (a) Outlier analysis (OA) and (b) principal component analysis (PCA) for path 2 – feature 1 (F1). Threshold 1 estimated through Monte Carlo technique and threshold 2 assigned to reflect changes in boundary conditions, outliers above thresholds represent damage, regions R1–R5 show progressive damage increase in the form of increasing Mahalanobis distance OA values and as separate PCA clusters (R1–R5).

Fig. 12. (a) Outlier analysis and (b) principal component analysis for path 2 – feature 2 (F2). Regions R1–R5 are clear in OA results and while PCA clusters can not be attributed to certain region.

A comparison between the two paths shows that, their behaviour is in general similar. Region R3 is the one which mostly draws the attention, since it is the one which shows a certain deviation from the normal condition. The key requirement here is the identification of the damage sensitivity of each path with respect to an early stage damage onset detection, namely area R3. The OA for path 1 and path 2 exhibits similar results except for the second feature (F2), which shows significantly higher levels of deviation for path 1. In addition, PCA shows a more distinctive separation between the resulting clusters for the first feature (F1) of path 1 compared to the same feature for path 2. Even though this is not very clear at this stage, one could in general conclude that path 1 exhibits a relatively higher damage sensitivity, especially at the area where the first notable damage seems to develop, in region R3. This was later verified from the lock-in images which showed that the first noticeable type of damage was in the form of patch debonding which initiated at the repaired bolted joint. This

would significantly affect path 1 more than path 2 (Fig. 5), hence justifying the higher damage sensitivity as observed from OA and PCA results.

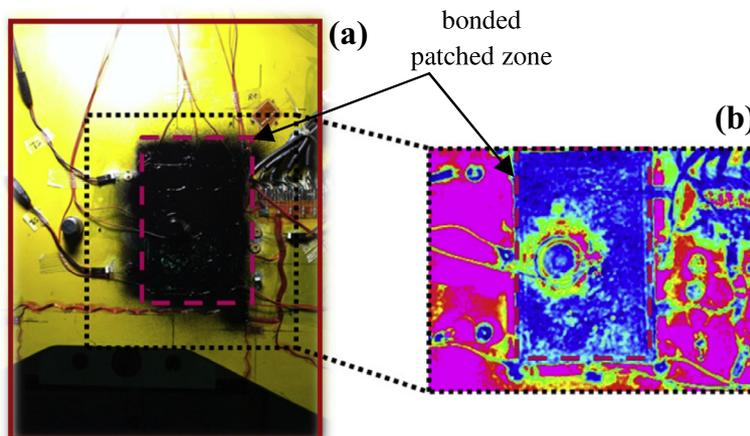
Starting with the first lock-in amplitude image in Fig. 16(b), the applied bonded patch is clearly identified. As may be observed next to the bonded patch, the piezoelectric sensors for Lamb wave monitoring may be discerned. The rivet/bolted joint thermal imprint is also clearly visible. Moreover, a relatively small high amplitude or stress concentration area around the rivet was acquired. The rest of the patched area does not exhibit any significant variations, suggesting a uniform temperature and stress distribution all over the bonded zone. At this stage, the artificially induced crack is not discernible, suggesting that the patch eliminates locally induced stress concentrations. At 50 kcycles, the phase and amplitude gradients become significant and in both lock-in (magnitude and phase) images (Fig. 17(a)) the crack was visible. In the phase image, the full length of the crack can be seen. This is not the case for the amplitude image, probably because the surface topology inhibits the observation of internal defects. As the load level increased, stress concentrations around the rivet became more pronounced. The relative phase and amplitude gradients increased, suggesting a substantial increase of the stress concentration in the region surrounding the rivet. At 330 kcycles (Fig. 17(b)) a dark region was detected in the amplitude image. The same region was clearly presented with bright colour by the phase one. With the increase in load level and fatigue progression this behaviour became more prominent with the enlargement of the dark region shown in the amplitude imprint as well as its gradual shifting towards the horizontal axis of the image (Fig. 17(c)). At 430 kcycles (Fig. 17(d)) the dark region on the amplitude image reached the right edge of the patch. This is verified by the phase image (430 kcycles), which shows an extended bright area which propagates to the tapered right edge of the patch.

Fig. 16. (a) Monitored area, (b) representative thermographic image.

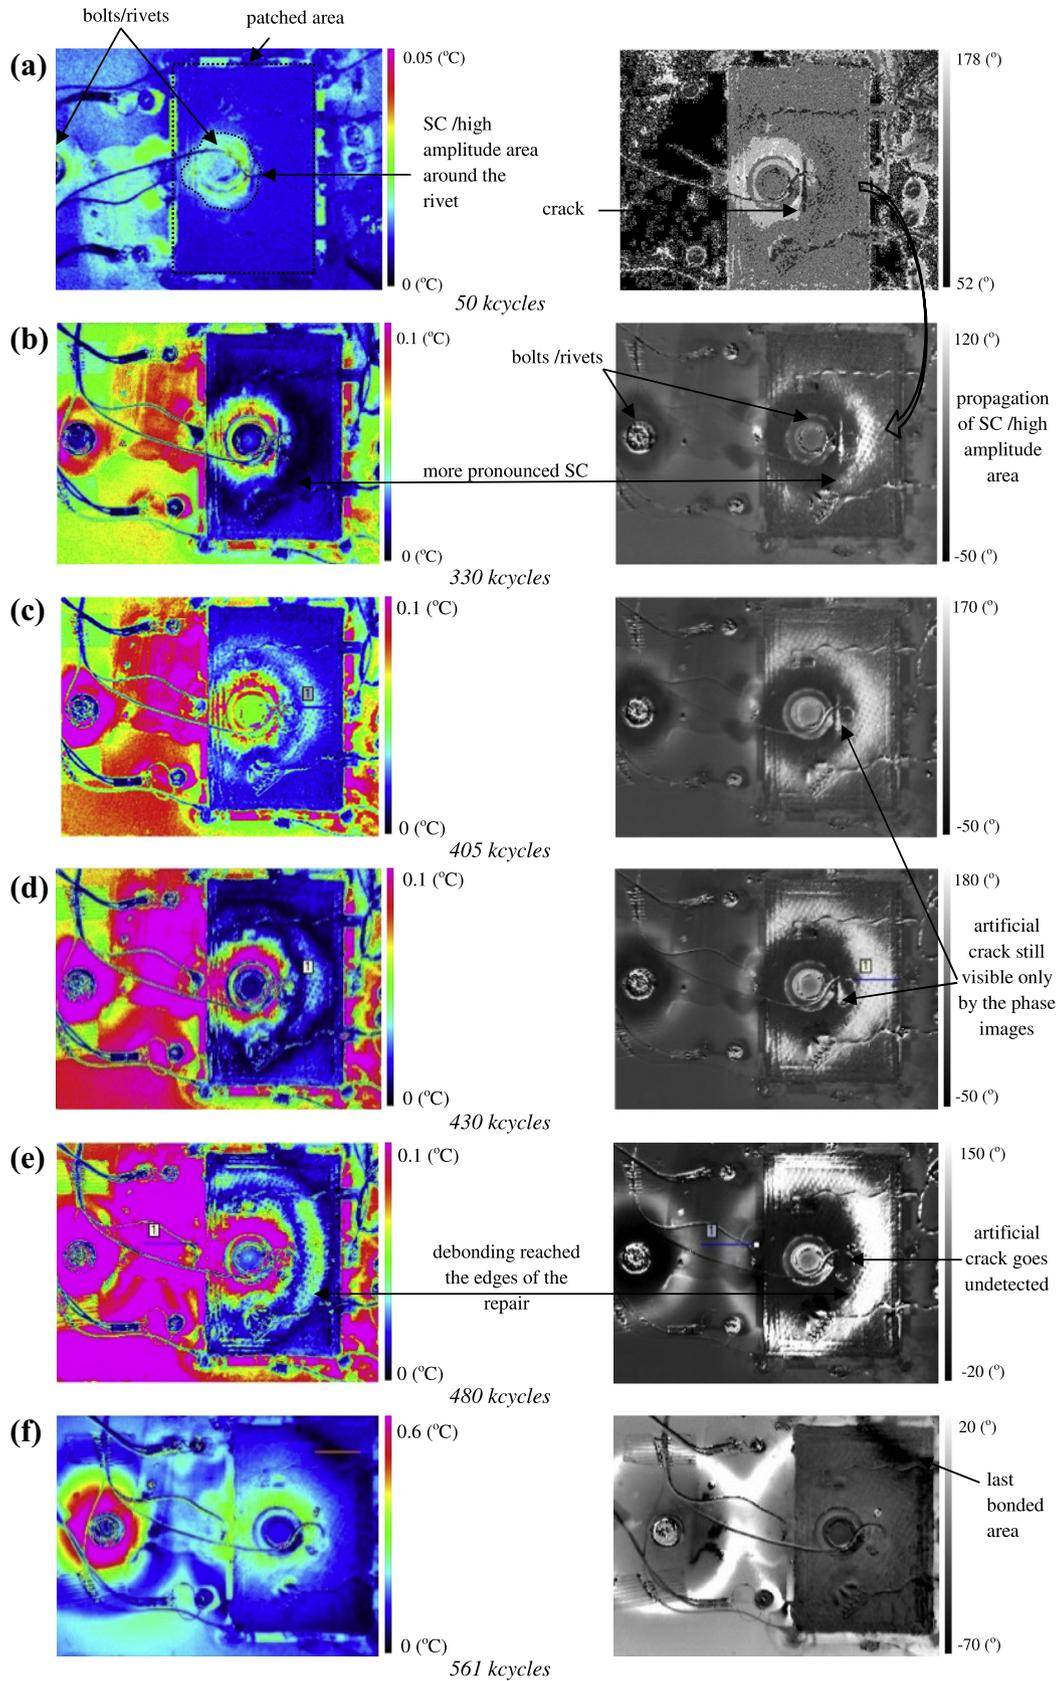
This gradual radial propagation of stress concentration areas with the same profile was noted, as fatigue loading continued. At 480 kcycles (Fig. 17(e)), the area with increased stress concentration caused by the bolted joint, reached the left (as indicated on the image) edge of the patch. The same behaviour consistently

Fig. 17. Amplitude (left-hand side) and phase (right-hand side) images.

continued up to the final loading step of the fatigue testing (Fig. 17(f)) at 561 kcycles. At the acquired last lock-in images (Fig. 17(f)), only a small dark region is presented on the right upper

corner of the patch. This was considered as the last bonded area of the patch. For this reason, it was decided to stop the test process and verify this observation with c-scanning of the patched area.

A closer examination of the whole lock-in image sequence denotes that besides stress concentration around the patched rivet, circularly-shaped high intensity areas were recorded around the patch-free rivet. It is noteworthy, that as the last recorded lock-in images indicate, the mechanical stresses/high amplitude areas have diminished from the patched rivet. This observation suggests the following (and probably complementary effects): (i) complete stress relaxation on the patched area and (ii) complete failure of the patch/substrate interface. The latter inhibits the visibility of high amplitude areas/stress concentrations around bolted joint which are clearly identified around the un-patched rivet area (Fig. 17(f)).

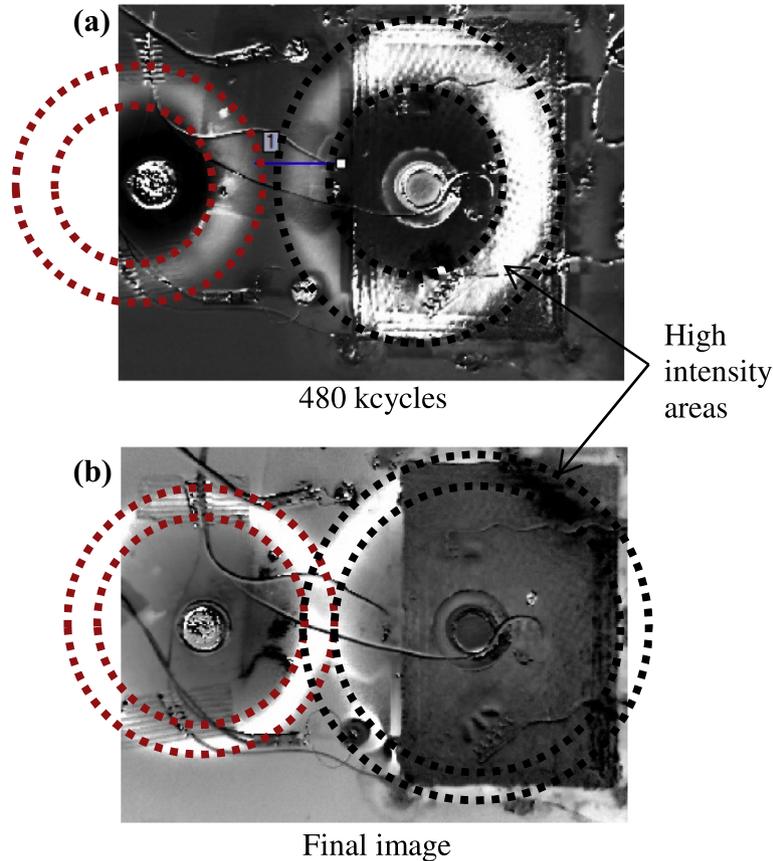
Fig. 18. Lock-in phase images at (a) 480 kcycles and (b) 561 kcycles (final stage).

stage. The stress concentrations around the bolted joints of Fig. 18(a) form patterns possessing a radial symmetry. These circular patterns indicate high amplitude areas/stress concentrations both in the unrepaired and the repaired rivet sites. Mechanically-induced stresses around the patched joint can be distinguished, due to the fact that the patch remains bonded on the substrate. However, this is not the case in the final recorded image (Fig. 18(b)). After the almost complete separation of the patch, the suggested high amplitude/stress concentration areas were not detected on the patched zone. To further elucidate the above statements, circles showing the presence (or absence) of stress concentration areas around the bolted joints were drawn (Fig. 18(a) and (b)). The centres of the drawn circles correspond to the position of the rivets (unpatched-left side and patched-right side).

Moreover, the juxtaposition of images in Fig. 18 denotes that the diameters of the figurative high amplitude/stress concentration

circles around the rivets have increased. This suggests that apart from the degradation of the patch/substrate interface, a second deterioration mechanism may be present; as the interrogated vertical stabilizer is a sandwich structure, it is highly probable that the local stress concentration also invoked the failure of the interface between the honeycomb and the aluminium skin. Ultrasonic imaging verified this hypothesis.

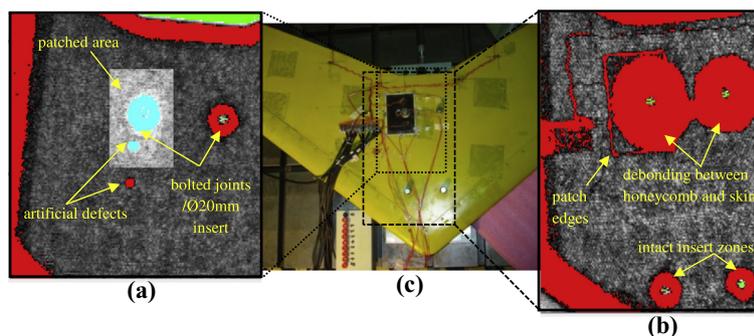
Fig. 19. Ultrasonic images of the stabilizer (a) prior and (b) post testing, (c) repaired wing stabilizer.

As is shown in Fig. 19(a) where the C-scan of the repaired stabilizer prior to testing is shown, the rectangle-shaped CFRP patch can be seen upon the $\varnothing 20$ mm insert. The patched and unpatched cylindrical insert, where the rivets are fixed are well discerned and, in addition, two artificially induced flaws (simulating manufacturing defects) were also visible. On the contrary, in the post-testing C-scan imaging, the patch goes totally undetected. Only the edges of the patch can be seen, at the very same external areas where sealant tape was placed to prevent from water penetration after immersion in the C-scan tank.

C-scanning inspection, prior to and after testing, verified this hypothesis. The post-failure ultrasonic image could not identify the patch, albeit it showed an extensive debonding between the skin and the underlying honeycomb core of the sandwich structure. The combined image where thermographic, ultrasonic and optical photographs are juxtaposed is also indicative of the honeycomb core/skin interlaminar failure, Fig. 20. Finally, post-failure optical images show the disruption of the film in most patch edges, except for those around the small remaining bonded areas as was observed via the evaluation of the thermographic images, Fig. 8.

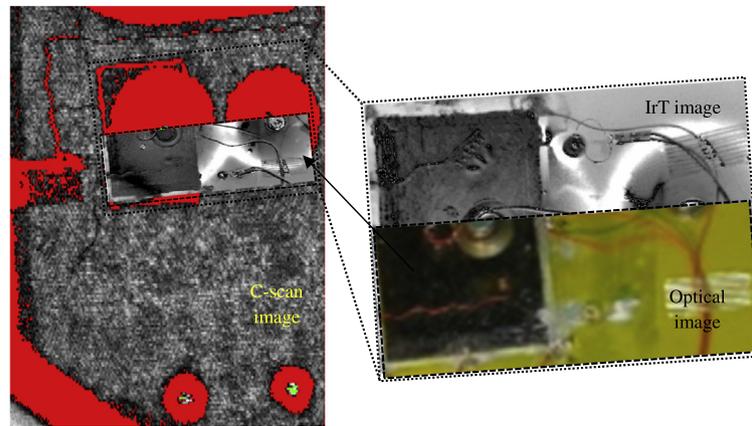
Fig. 20. Overlapping of ultrasonic, optical and thermographic images.¹
