EVALUATION OF REPAIR EFFECT FOR DETERIORATED CONCRETE PIERS OF INTAKE DAM USING AE ACTIVITY

TOMOKI SHIOTANI and DIMITRIOS G. AGGELIS*

Department of Urban Management, Graduate School of Engineering, Kyoto University, C1-2-236, Kyoto-Daigaku-Katsura, Nishikyo, Kyoto 615-8540, Japan; *Research Institute of Technology, Tobishima Corporation, 5472 Kimagase, Noda, Chiba, 270-0222, Japan

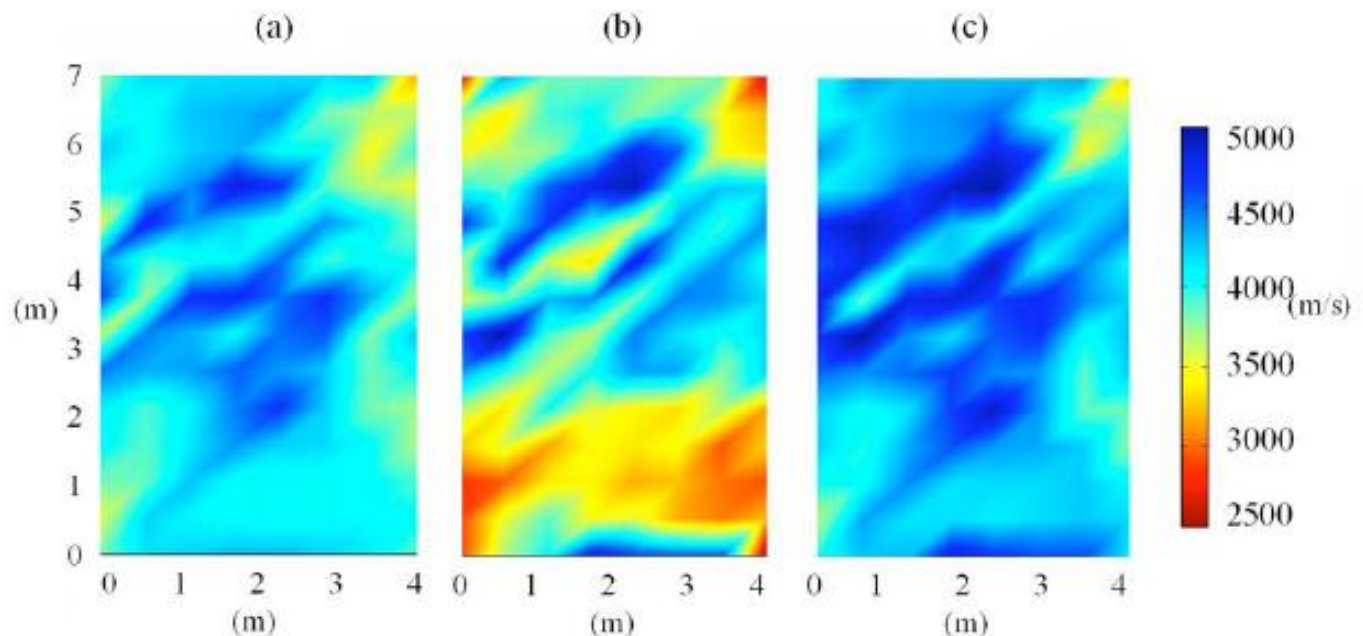
Fig. 4 Tomogram of a dam pier section examined (a) before, (b) after repair, (c) after complete hardening of grout.

In Fig. 4(a) the tomogram of a cross section of Pier 1 before injection of grout is presented. The general condition can be characterized satisfactory since the propagation velocity is generally higher than 3500 m/s, except in some small areas. However, two weeks after repair, the tomogram showed clearly decreased velocity, even as low as 2500 m/s (see Fig. 4(b)). This behavior was not expected since cementitious material replaced the voids. Even if the defects were not completely eliminated, the velocity was not supposed to decrease.

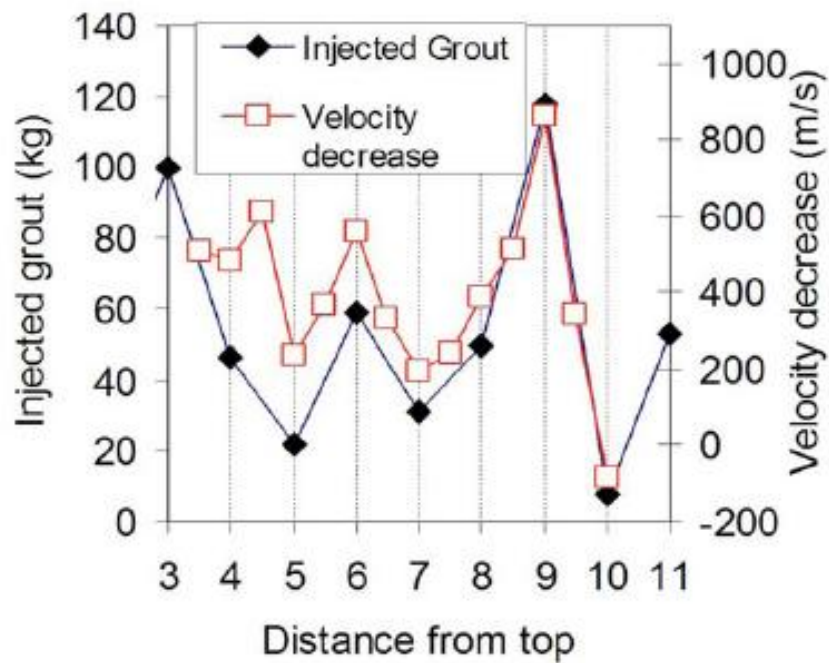
Fig. 5 Amount of grout and velocity decrease for different heights of pier 1.

According to the above discussion, the amount of grout is responsible for the initially observed velocity drop. This is confirmed by the correlation of the actual quantity of grout injected at different heights in the structure, with the velocity decrease at the same areas, depicted in Fig. 5. An excellent correlation is observed, since at the positions where a lot of grout was injected (e.g. 120 kg, 9 m from the top), at the same position, a velocity decrease of more than 800 m/s was measured.

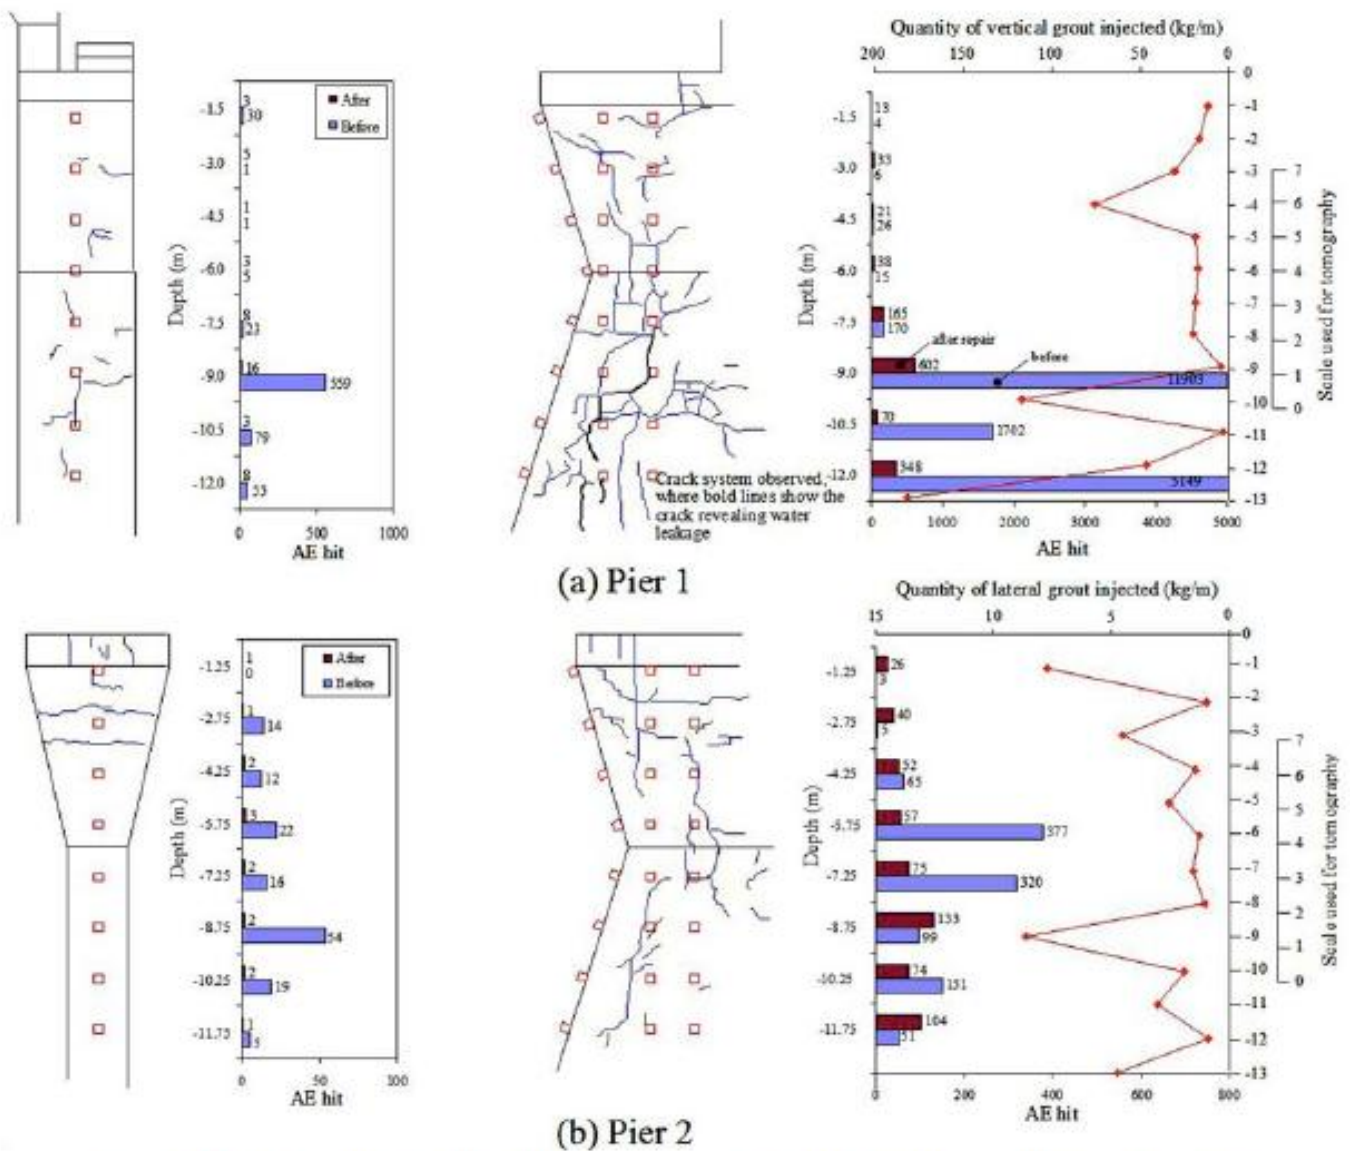
Fig. 6 AE hit activity with crack trace (Right: the left banks side, Left: rear side).

The source location algorithm failed to identify AE sources. Thus, the repair effect is discussed with AE hit activity. For Pier 1, Fig. 6a shows accumulated AE hits for each depth for the left bank side (right) and rear side (left). Especially for the left bank side, total AE hits of two allocated sensors at the same height are depicted with horizontal bars. In the chart, the injected quantity of vertical grout is drawn as well. Before repair, AE hit activity was intensively observed particularly below -9.0 m.

At these depths, a complicated and well-evolved surface crack system was observed, as well as water leakage from some macroscopic cracks among those (see bold lines in the figure), causing a large number of AE hits. A large amount of grout was injected vertically at those depths, implying that the macroscopic cracks were filled with the injection cement. AE activity after repair revealed decrease; i.e., from 5149 to 348 hits at -12 m and from 11903 to 602 hits at -9.0 m. The same trend could be found in the rear view (see the left graph in the figure) as AE hits decreased before and after repair.

The result for Pier 2 is shown in Fig. 6b. Steep changes of AE activity before and after repair were only derived around the middle height of monitoring range where 377 hits before repair decreased to 57 after at -5.75 m and 320 to 75 at -7.25 m (see the right chart in Fig. 6b). No correlation between the AE activity and the quantity of injected horizontal grout was observed.

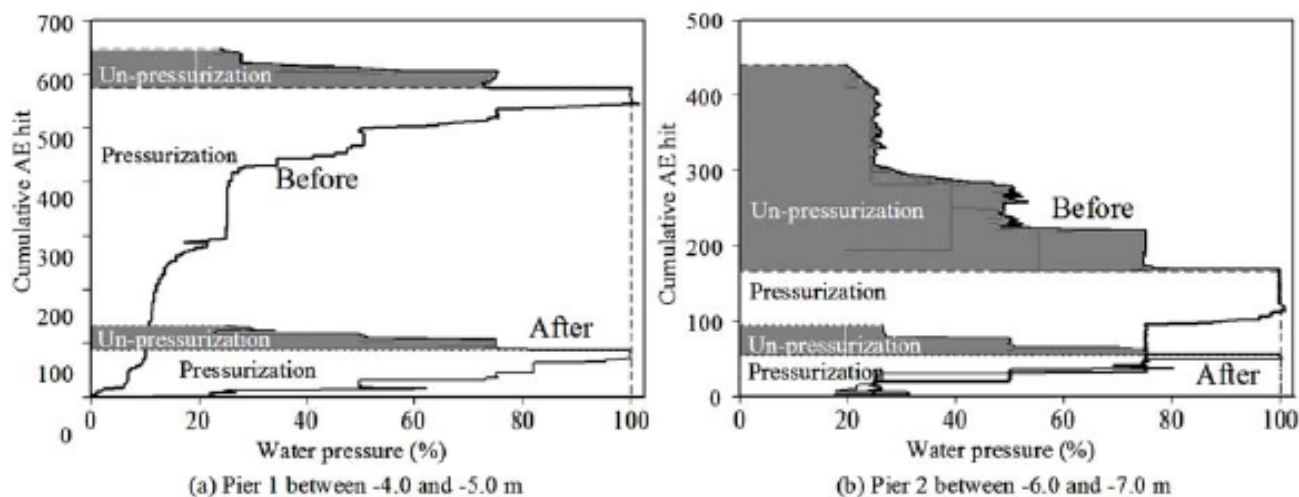
Fig. 8 AE hits activity during both of water pressurization and its reduction processes.

In Fig. 8a, AE activity of Pier 1 during both processes of water pressurization and its reduction is shown. Since the resulted Calm ratio of 0.11 before, increased to 0.35 after repair, recovery due to repair could not be assumed by the Calm ratio. For Pier 2, improvement after repair could not be obtained from Calm ratio, either (see Fig. 8b). However, the essential reduction of AE activity indicated simultaneous reduction of active sources.

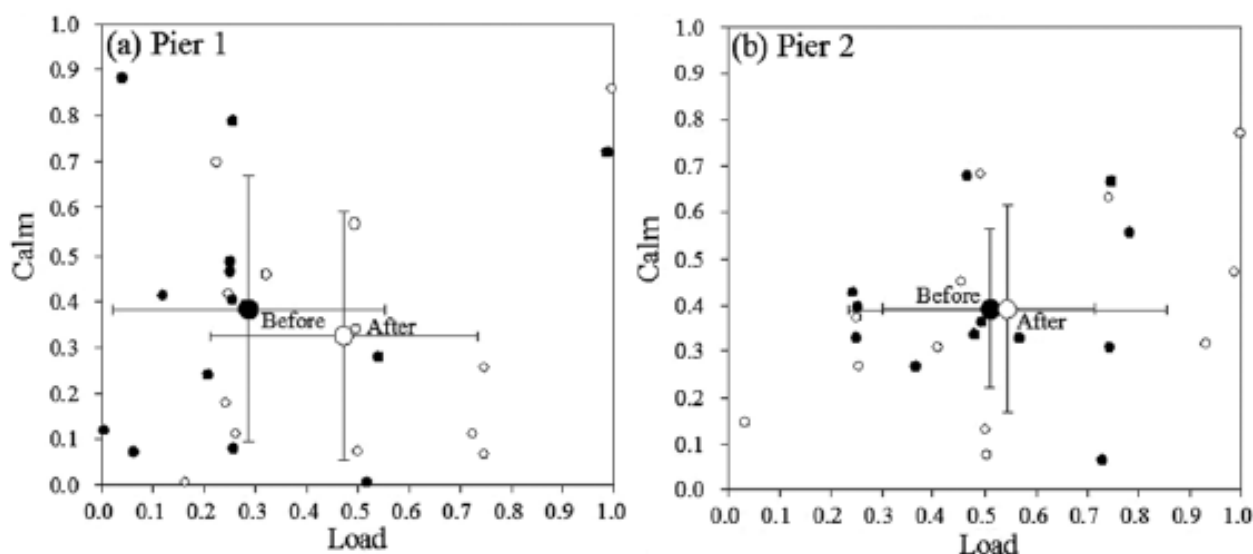
Fig. 9 Calm ratio and Load ratio based on ringdown count.

All derived ratios from both piers are plotted in Fig. 9. The small dots correspond to vertical zones of 1 m and are distributed over the chart; however, from the average of Load ratio a large difference appeared in Pier 1 between before and after, while only a slight difference was obtained in Pier 2. The figure also suggests that Calm ratio seems less sensitive to repair effect than Load ratio.

The above assumption can also be followed by AE related damage indices. As shown in Fig. 9, a large amount of increase in Load ratio was obtained in Pier 1 while only a slight increase in Pier 2. Thus, the recovery effect due to repair was obviously superior for Pier 1 than for Pier 2. However, from the point of view of soundness, Pier 2 was significantly healthier even from the original state (see the average before repair in Pier 2) and remained so despite the high recovery of Pier 1.

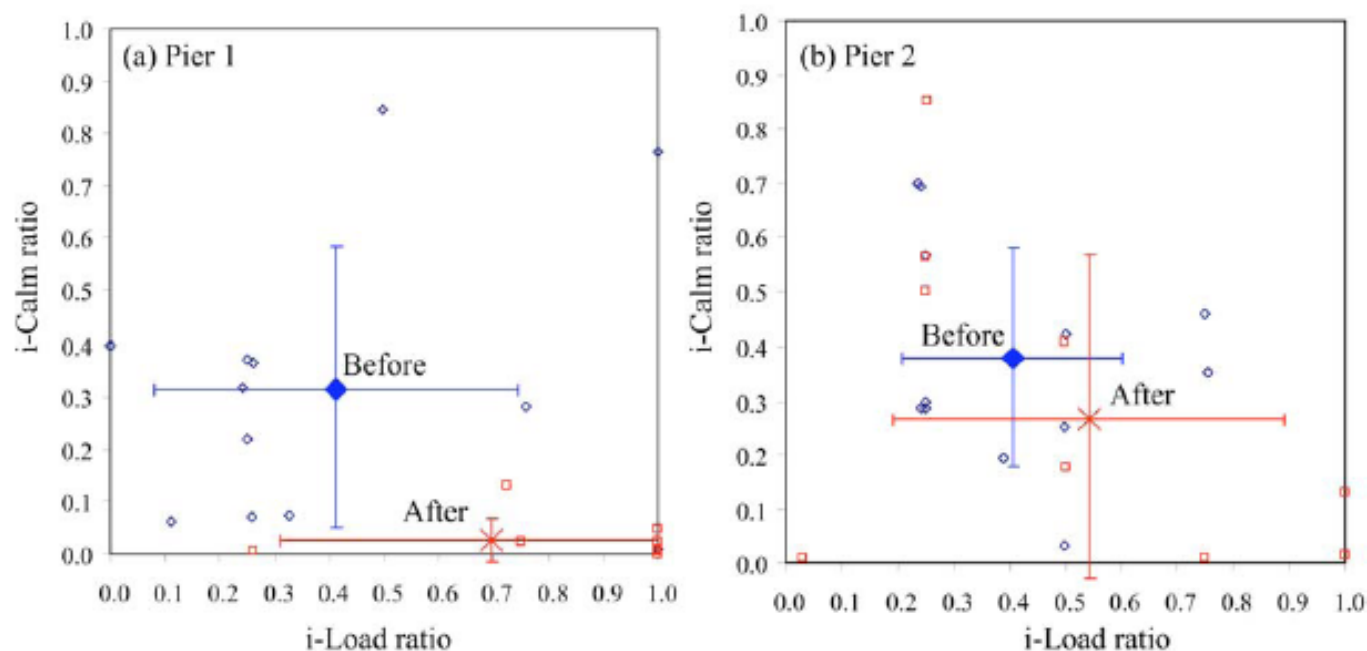
Fig. 11 Improved Calm (i-Calm) ratio and improved Load (i-Load) ratio to assess the recovery rate.

In reference to the AE activity data used in Fig. 9 and setting α as 10%, the i-Load and i-Calm ratios are obtained as shown in Fig. 11. In pier 1, the average coordinate shifted from (0.4, 0.33) before repair to the right bottom on the chart at (0.68, 0.03). This shift clearly indicates a high recovery rate after repair. Recovery can be also found in Pier 2 from (0.4, 0.4) to (0.52, 0.28), but not so dramatic as in Pier 1. As shown in Fig. 9, Calm ratio did not reflect the repaired condition effectively, as almost identical values were obtained before and after. By considering the number of AE hits, we can account for the recovery of the structure due to repair with the use of i-Calm ratio. It is noted that the use of $\alpha = 5\%$ results in the same trend as in 10%, suggesting the proper range of α in this case being 5 to 10%; however, to determine the appropriate value for other structures, further studies are necessary.
