*Cement &  
Concrete*

## Repair evaluation of concrete cracks using surface and through-transmission wave measurements

D.G. Aggelis, T. Shiotani \*

*Research Institute of Technology, Tobishima Corporation, 5472 Kimagase, Noda, Chiba 270-0222, Japan*

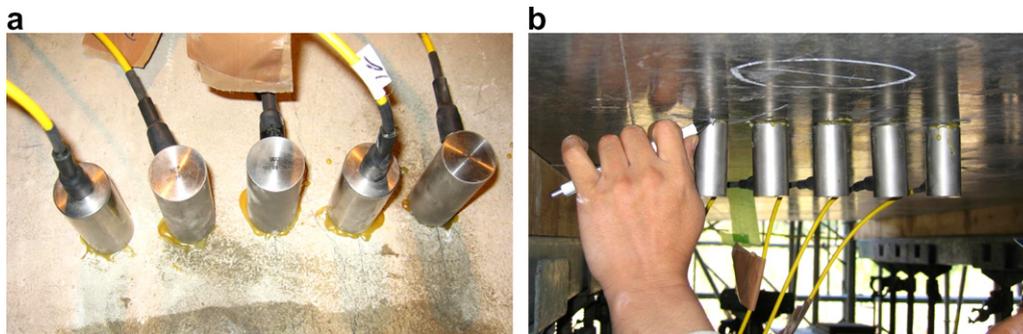
The experimental arrangement can be seen in Fig. 2. Totally 10 sensors were used; five on each surface in a way that the crack was between the 8th and 9th on the upper side, while the array was parallel to the axis of the structure. The sensors used were acoustic emission R6,

Fig. 3. (a) Photograph of sensor arrangement of the upper side and (b) excitation using lead break and sensor at the down side.

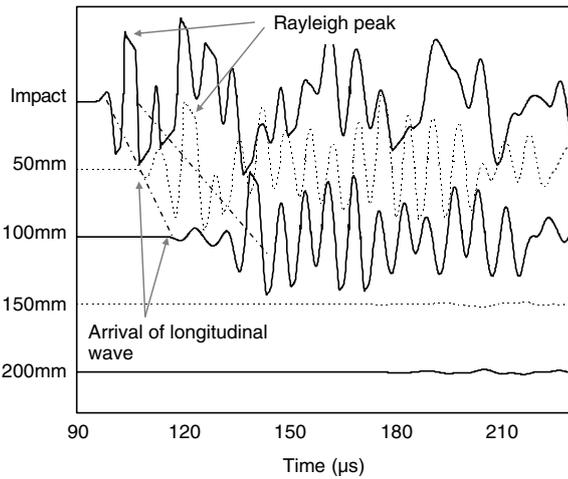
When the same sensor configuration was used to measure a portion containing a crack, different trends were observed, as shown in Fig. 6. The first three waveforms, collected before the crack, are quite clear, while after the crack the waveforms are hardly visible. This shows that a very small part of energy is transmitted through the crack. In Fig. 7a the same waveforms are depicted, with the two waveforms after the crack magnified by a factor of 20. It is obvious that no peak corresponds to the Rayleigh velocity of the material. Plotting the arrival time vs distance using the peaks closest to the expected time for the two last waveforms, results in weaker correlation as seen in Fig. 7b. Therefore, it seems that the Rayleigh wave does not survive after the crack, due to the discontinuity.

Fig. 6. Waveforms of surface measurements at different propagation distances for concrete with crack at 125 mm.

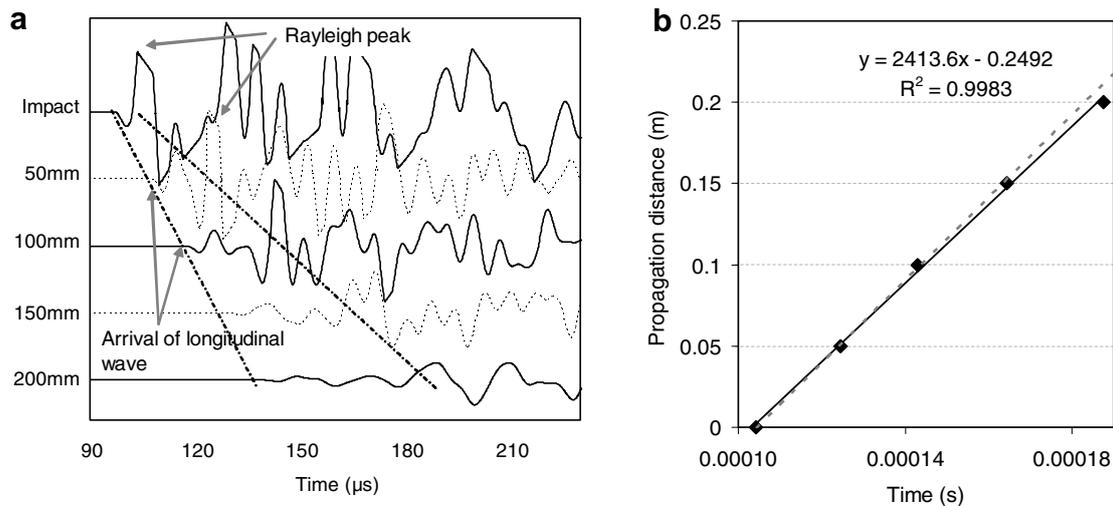
It is obvious that more energy is transmitted than before repair. The Rayleigh peaks can be distinguished due to their larger height after the initial P-wave arrivals even at the measurement points after the crack. Moreover, in Fig. 8b the correlation is almost as strong as the sound case of Fig. 5b, verifying that these peaks correspond to surface waves. Nevertheless, the velocity is calculated at 2414 m/s, about 250 m/s lower than the corresponding velocity of the sound material, most likely due to the propagation through the layer of epoxy inside the crack. This means that the last two points, corresponding to propagation of 150 mm and 200 mm are somewhat delayed. Indeed, excluding these points from the correlation, see the dashed grey line of Fig. 8b, leads to a velocity of 2605 m/s and an even higher correlation coefficient,  $R^2 = 0.9994$ . The lower velocity of 2414 m/s is certainly attributed to the repaired crack situation although the crack width is very small. As mentioned earlier, the crack width at the top was measured at 0.2 mm and the receiver array covered a space of 200 mm. Consid-

In any case, the above results are a certain indication that the surface layer was filled in significant degree, to allow Rayleigh waves to propagate. Rayleigh measurements were repeated on the opposite side (bottom), and similar results were observed. Accordingly the propagation was restored showing that the epoxy material was sufficiently injected into the whole thickness of the structure although it was impregnated only from the upper surface.

Fig. 8. (a) Waveforms of surface measurements at different propagation distances for concrete with epoxy filled crack at 125 mm and (b) correlation plot of distance to Rayleigh peak arrival time.

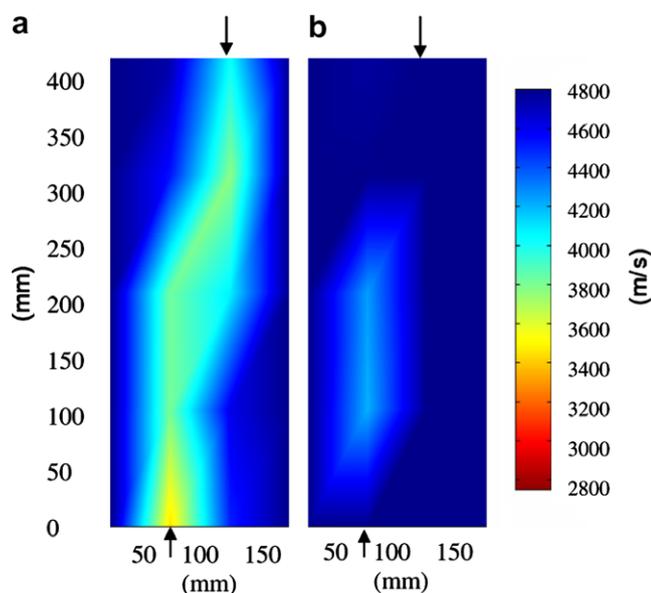
Applying this procedure to the cross section containing a crack before repair, it was quite visible that there was a significant discontinuity in the interior. In Fig. 11a one can observe the tomogram of the crack in hand. The yellow<sup>1</sup> colored area corresponds to a velocity of around 3500 m/s, being greatly influenced by the through-the-thickness crack. The tomography result gives also an insight of the internal pattern of the crack, due to the loop

Fig. 11. Velocity tomograms of the vicinity of the crack (a) before and (b) after repair. The arrows correspond to the actual position of crack openings.

procedure employed for the calculation of the shortest path traveled in any case [40]. Indeed in the specific case, the top and bottom openings of the crack differ by 50 mm in horizontal distance. As seen, for some areas the crack decreased the apparent velocity to 70% of the intact state velocity.

In Fig. 11b, one can observe the tomogram of the same cross section after injection with epoxy. It is seen that wave propagation is facilitated and only some small tracks indicate the existence of crack that could be due to the fracture process zone that expands some cm from both sides of the crack, as mentioned earlier. Comparison of the image before and after, makes obvious that whatever discontinuity was initially present, was almost eliminated after repair, implying that the impregnation was successful. Most of the previously troublesome area seems thus eliminated, while a small remaining track of the discontinuity is related to a velocity of around 4200 m/s, 84% of the intact state, which is much elevated compared to the before repair situation. The same tomography procedure was applied to other cracks exhibiting in any case the much improved condition after impregnation.

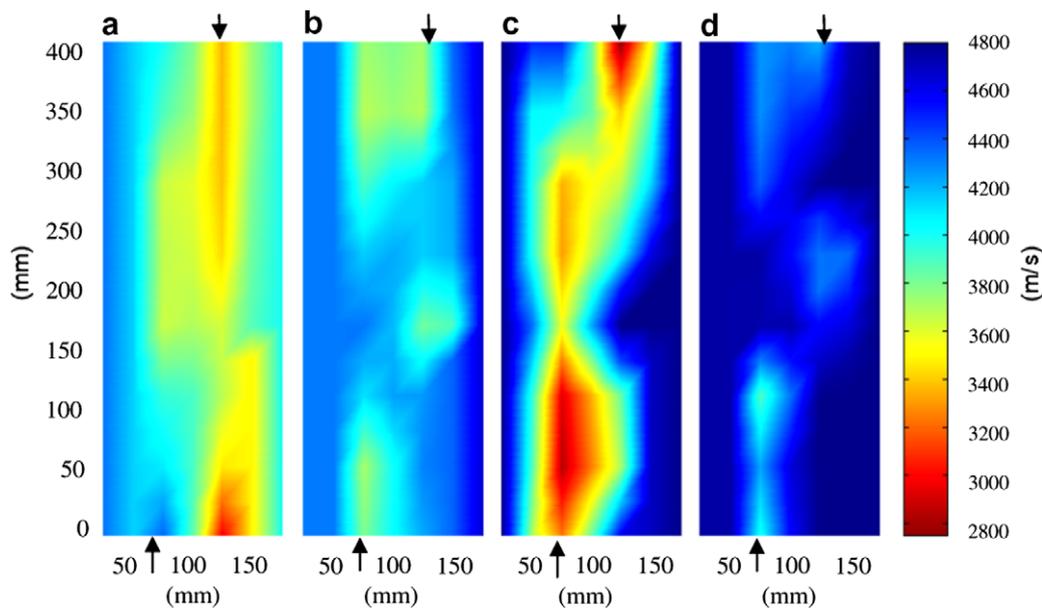
Fig. 13. Velocity tomograms of the vicinity of the crack for (a) 10 kHz before repair, (b) 10 kHz after repair, (c) 100 kHz before repair, and (d) 100 kHz after repair. The arrows correspond to the actual position of crack openings.

the defect, since as mentioned above, the crack in this case was not exactly vertical, but slightly inclined. Also, as the color variation implies, the difference of maximum to minimum for Fig. 13a is 31%, while for Fig. 13c the difference is 49%. This shows that, propagation at higher frequencies is more sensitive to the damage than lower frequencies. The interaction between inhomogeneity parameters, such as size and content, with stress wave velocity and attenuation is not easy to understand. However, in the specific case of this continuous through-the-thickness defect, the velocity of higher frequencies is more sensitive and therefore, appropriate for assessment of the repair effect. It is possible that much shorter wavelengths could interact more strongly with the crack thickness (or the epoxy layer after repair) leading to more accurate results. The inherent difficulty of this case, however, lies to the larger attenuation that makes the propagation of high frequencies troublesome.
