Construction and Building Materials 48 (2013) 1261-1265

Infrared thermographic inspection of murals and characterization of degradation in historic monuments

This work presents recent results of infrared thermographic assessment of murals at the "Monastery of Molybdoskepastos" in the Ioannina region (Greece). Infrared thermography is a real-time technique based on monitoring the temperature variation on the surface of materials and structures. This method identifies and interprets differences of surface temperature in the material, enabling the evaluation of damage distribution and accumulation. Infrared thermography is a non-destructive, full field and non-contact technique allowing the characterization of degradation in buildings including historic monuments.

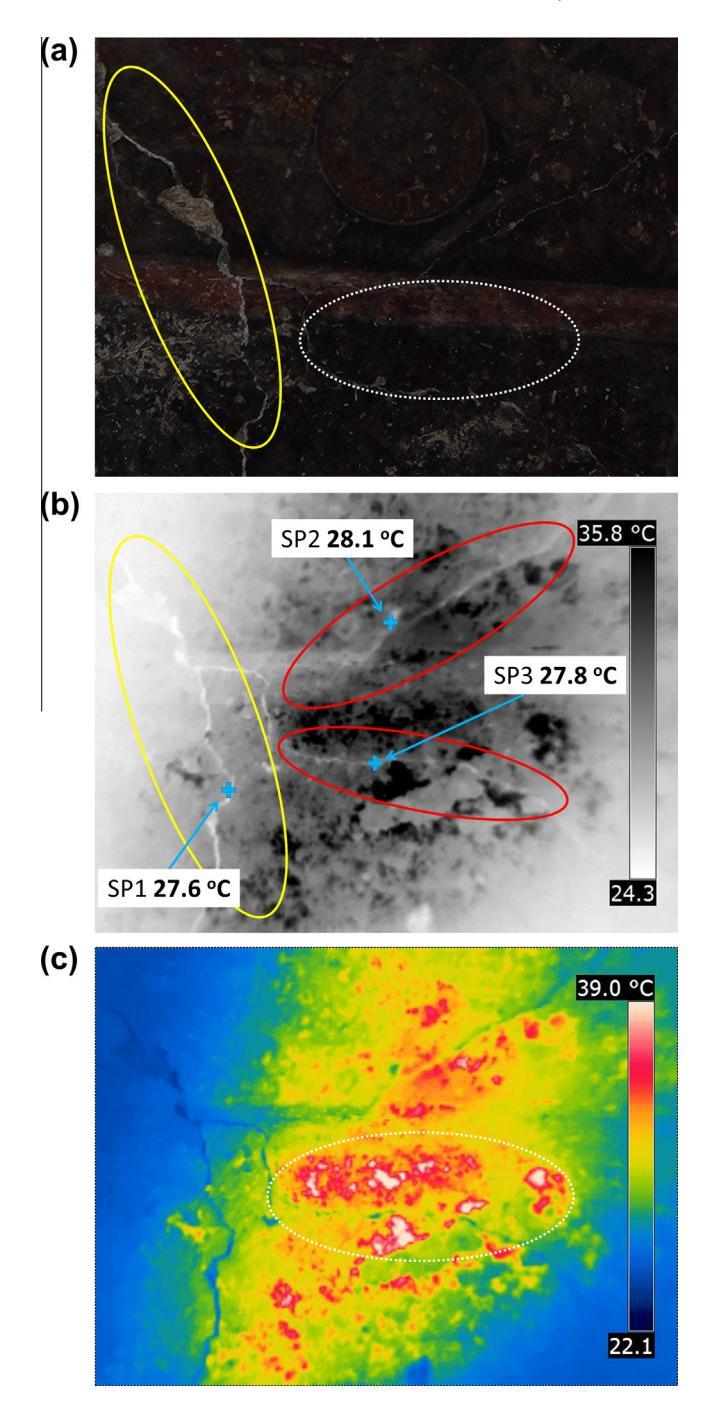
Fig. 4. (a) Murals on roof of the "Monastery of Molybdoskepastos", (b) thermograph of the dome indicating cracks and (c) IR image of the dome indicating delaminations.

One of the areas that have been inspected in this survey is the dome of the monastery (Fig. 4a). Considering the fact that the dome is five meters above the floor, it is very difficult an optical inspection to be applied. Therefore, "graduated heating thermography" was used for the damage characterization of this mural. On the photograph (see Fig. 4a) there are many critical and surface cracks, while on the thermograph (Fig. 4b) the severity of the cracks can be observed. The visible crack is indicated with yellow circles in both Fig. 4a and b. Moreover, in Fig. 4b additional cracks which are hardly visible, show up clearly in the thermograph and are pointed out with red circles. In addition, comparing the Fig. 4a and b can be deduced that cracks indicated with red circles are not only surface damages but they are as critical as the cracks with yellow circle. This can be assumed from the same temperature variation illustrated in both types of cracks which is clearly indicated with exact temperatures of the spots in Fig. 4b.

Additionally, the infrared thermography inspection revealed the existence of delaminations and detachments on the mural of the dome. To elucidate this, the accumulated heat in the part of the mural that can be observed in Fig. 4c, indicates that this part of the mural has been detached. This extended detached area is marked with white dot-line circle in Fig. 4a and c. In order to further highlight the remarkable temperature variation in the

The thermographic inspection of the mural on the dome resulted that this area requires immediate restoration in order to prevent additional irreversible damage.

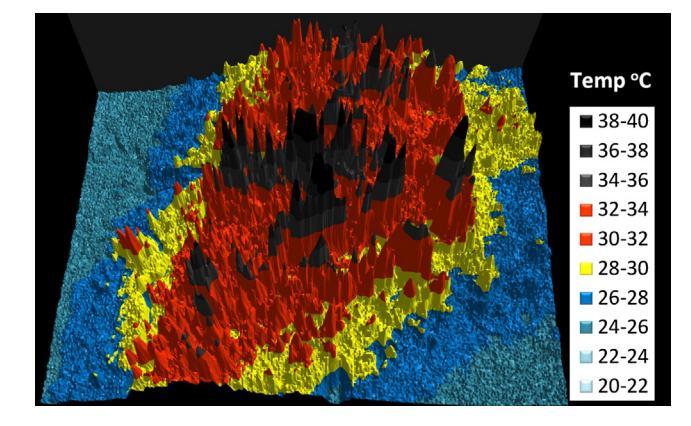
Fig. 5. Three dimension (3D) temperature mapping of the dome.

Fig. 5 illustrates the distribution of inspected area temperatures in a 3D graph. The *xy* surface in the graph shows the pixels of the thermograph and the *z* axis indicates the temperature of each pixel. The detached area is depicted with grey and black colors which correspond to the temperature range of 34–40 °C.

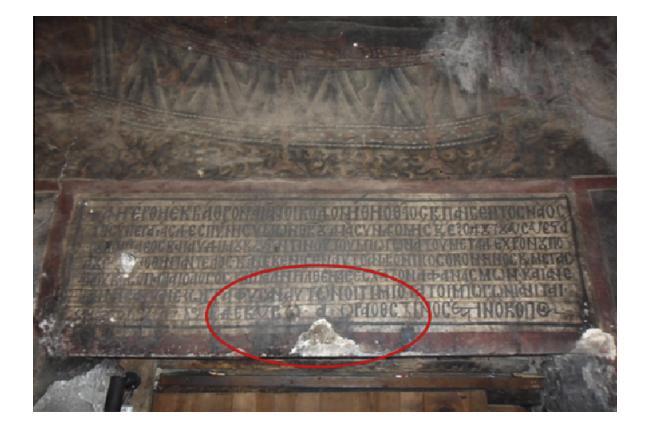
Fig. 6. The donor's inscription.

Another area of interest that has been examined is the donor's inscription above the west gate of the church. Donor's inscription provides very useful information about the year of church's foundation and further historical details. A part of this inscription has been destroyed as it can be seen in Fig. 6. The inspected area was chosen near the destroyed part of the inscription in order to assess the possible existence of further damage (see in Fig. 6 red circle).

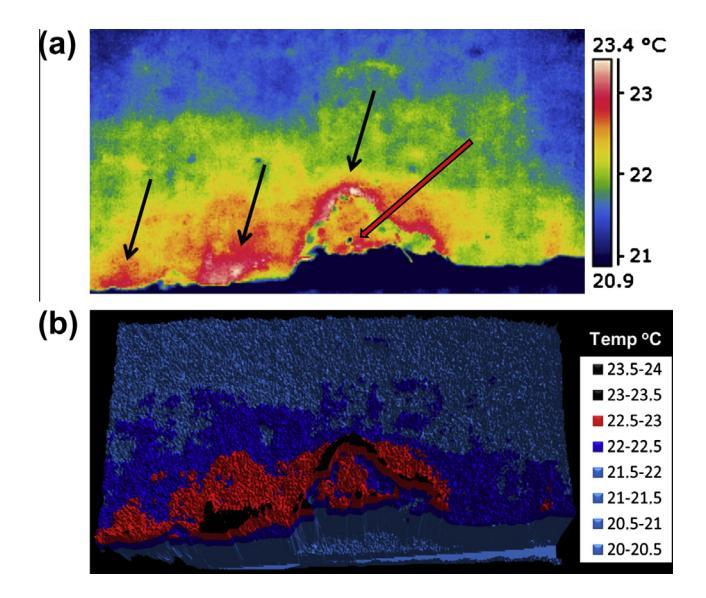
Fig. 7. (a) Thermographic image depicting part of the donor's inscription and (b) 3D temperature mapping of the donor's inscription.

The donor's inscription was evaluated with LWIR and MWIR cameras employing all the aforementioned thermographic methods. Concerning the graduated heating thermography method, the increment of the temperature near the area of the destroyed part of the mural discloses three detached regions (indicated by black arrows) as it can be seen in Fig. 7a. The region indicated with red arrow corresponds to the destroyed area in which has been revealed an older donor's inscription (see Fig. 6). In this region, an increment of temperature can be observed. This is due to the different depth and material type. Therefore, this indication in the thermograph was not considered as subsurface damage or delamination. The experimental data of the thermograph in Fig. 7a was also illustrated in a 3D temperature mapping plot. As can be noticed from the Fig. 7b, the black areas corresponded to the range of 23-24 °C reveal more clearly the presence of delamination and detachments.

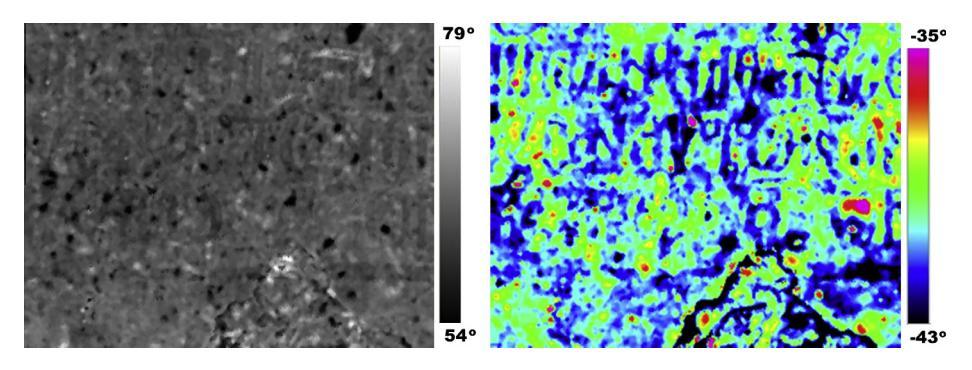
Fig. 8. Lock-in phase images present the substances of the fresco where the donor's inscription is painted.

The second method that had been applied was the lock-in thermography which has been contacted by a MWIR camera. In Fig. 8 it can be observed an assortment of different shape and geometry patterns due to the phase variation depicting the substances of the fresco used to paint the mural, such as straws, wires and gravel. The implementation of this method has resulted in the better assessment of the fresco's substances.

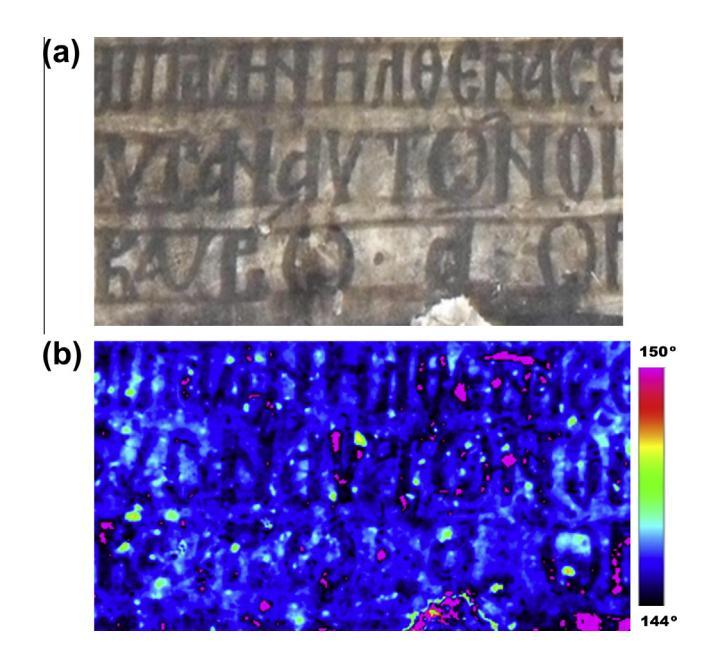
Fig. 9. (a) Digital image of a part of the inscription and (b) pulsed phase image with in-depth defects.

The mid wavelength infrared band has been used in the third thermographic method. Pulsed phase thermography revealed very interesting results concerning the in-depth defects. Fig. 9 depicts the digital photo and the phase thermographic image of the inscription. According to the IR image (Fig. 9b) the magenta spots correspond to subsurface defects not visible in the digital image (Fig. 9a). These intense variations in the obtained thermographs can be attributed to the historical elements. To elucidate this, in one indoor area of the church, where some murals were partially destroyed, preexistent murals have been revealed. As it can be

observed in Fig. 10, there is presence of holes caused by hagiographers in order to fasten up the new murals. More specifically, the magenta subsurface defects shown in Fig. 9b correspond to a significant variation in phase of about 5 degrees compared to the phase of visible letters. These spots of Fig. 9b have not the same shape or geometry with the holes of Fig. 10 due to the fact that the holes beneath the inscription are partially filled with fresco. In addition, it should be mentioned that the holes was made by hand, therefore their orientation do not follow an exact pattern. Therefore, the PPT has the potential to detect in-depth defects.

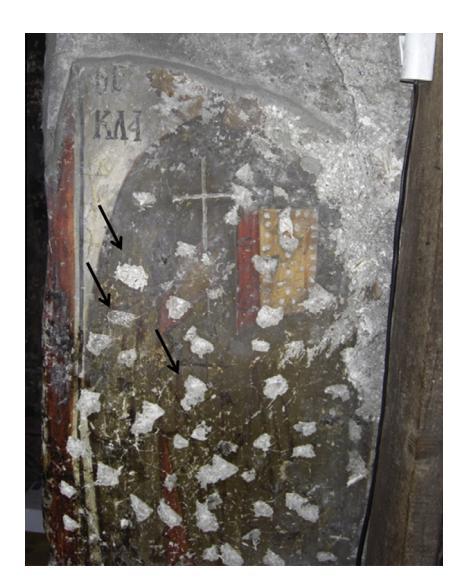
Fig. 10. Mural with artificial holes.
