Continuous debonding monitoring of a patch repaired helicopter stabilizer: Damage assessment and analysis

The present work focuses on the structural health monitoring of an aluminium vertical helicopter stabiliser with a pre-introduced crack which was repaired with an adhesively bonded composite patch. The structure was monitored under bending fatigue and its performance was evaluated with Lamb waves, lock-in thermography and ultrasonic testing. Outlier analysis of Lamb waves captured the onset and progress of the damage in the form of patch debonding, enabling the identification of five damage-severity regions. Principal component analysis showed distinctive clusters that corresponded to different damage levels while the application of principal curves on the selected features proved to be an additional damage detection index. Amplitude and phase lock-in images accurately captured the onset and evolution of the damage in the form of patch debonding and honeycomb/skin debonding in agreement with the damage indices obtained from Lamb waves. C-scan further validated the damage mechanisms that were captured by the other methods.

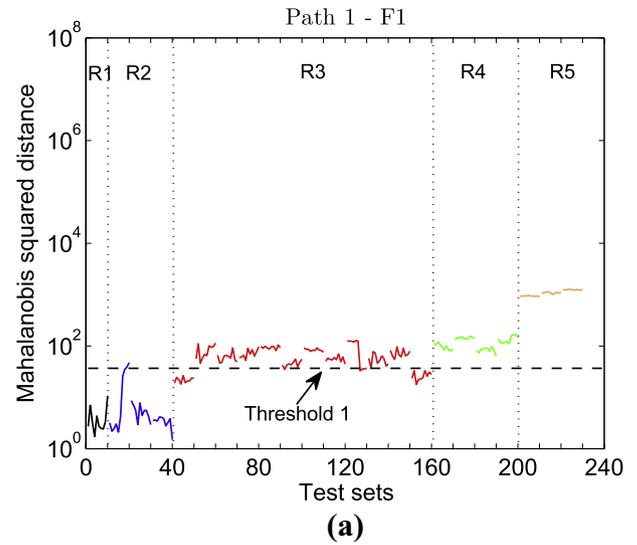
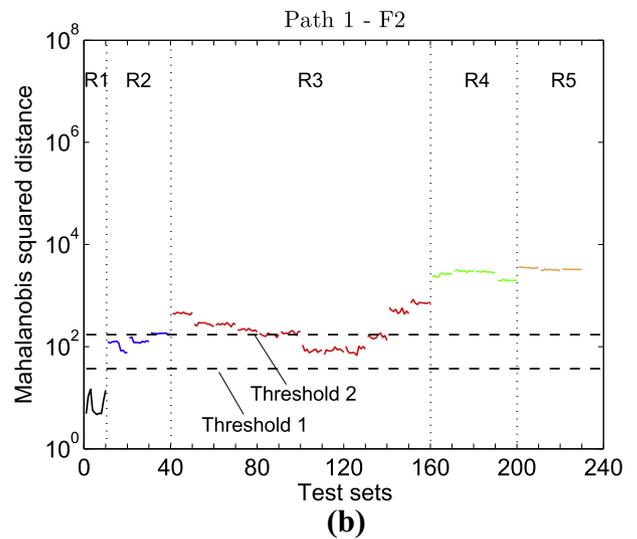
Fig. 14. (a) Outlier analysis at the first 10 principal components for path 1, corresponding to feature 1 (F1) and (b) feature 2 (F2).

Feature 1 (F1) in Fig. 14(a) shows that the results are more representative of the assumption made for the OA on the original time signals in Section 4.1; it verifies that region R2 is not indicative of damage. This means that regions R1 and R2 are indeed labelled as inliers (below the threshold 1) while region R3 is very close to the threshold only slightly flagged above it without any considerable variation. In this case there was no need to assign threshold 2. It is only after 480,000 cycles that OA gives clear outliers (regions R4 and R5). On the other hand, feature 2 (F2) shown in Fig. 14(b) illustrates a slightly different behaviour, almost similar to the OA of the respective path/feature for the original time signals although the values of the deviation are smaller due to the change in the number of the dimensions of the feature (10-dimensional instead of 50-dimensional).

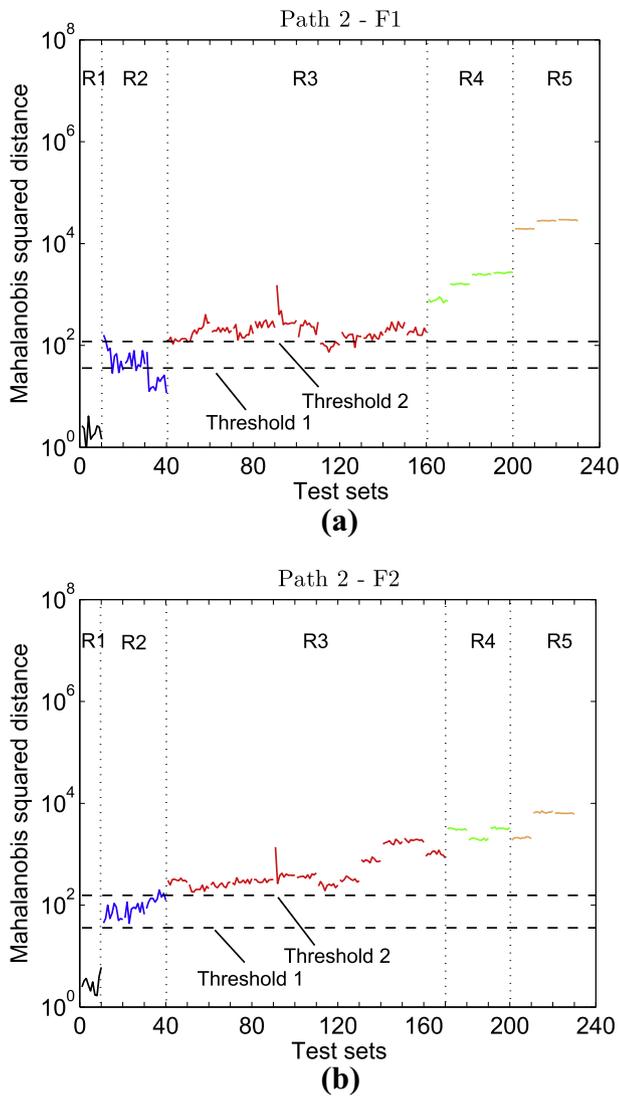
Fig. 15. (a) Outlier analysis at the first 10 principal components for path 2, corresponding to feature 1 (F1) and (b) feature 2 (F2).

Fig. 15 illustrates the same OA results for propagation path 2. Feature 1 (F1) exhibits a similar behaviour for the same feature F1 of path 1, exhibiting lower deviation from the normal condition and the thresholds than what the respective original time signal showed in Section 4.1. In addition, regions R1 and R2 are below the threshold 1 and threshold 2, respectively, while region R3 is very close to threshold 2, exhibiting a relatively steady behaviour.

In a similar way as with propagation path 1, R4 and R5 (above 480,000 cycles) are clearly flagged as outliers while the boundaries between the two regions are quite distinctive. On the other hand F2 exhibits a similar behaviour with the feature taken from the original time signal, without any underlying difference. The main assumption derived here is that at least F1 for both paths shows an improved behaviour and represents in a more reasonable way the structural integrity of the stabilizer. This is attributed to the fact that among the whole tested data set, only the main principal components were taken into consideration, which account for the highest percentage of the variance, hence carrying most of the vital information needed, while leaving out any other parameters that could have corrupted the signals, such as noise or temperature variation.
