EVALUATION OF REPAIR EFFECT FOR DETERIORATED CONCRETE PIERS OF INTAKE DAM USING AE ACTIVITY

TOMOKI SHIOTANI and DIMITRIOS G. AGGELIS*

Department of Urban Management, Graduate School of Engineering, Kyoto University, C1-2-236, Kyoto-Daigaku-Katsura, Nishikyo, Kyoto 615-8540, Japan; *Research Institute of Technology, Tobishima Corporation, 5472 Kimagase, Noda, Chiba, 270-0222, Japan

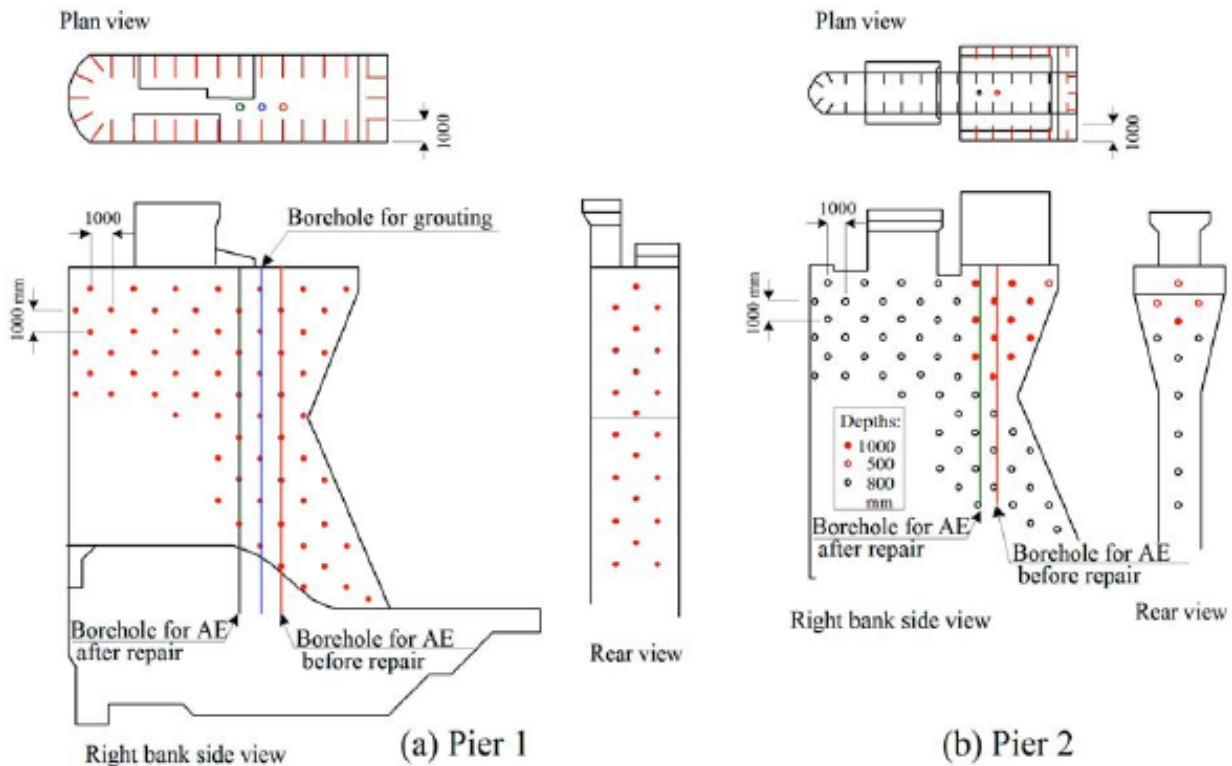
The concrete piers described herein are referenced as Pier 1 and Pier 2. Two directions of grouting were used: (i) vertical grouting to fill the internal damaged areas, (ii) horizontal grouting to fill the interface between the old and replaced concrete along both sides. Specifically, a vertical borehole with 50-mm diameter was drilled only for Pier 1, whereas many horizontal boreholes with 20-mm diameter from both bank sides (only to shallow depth ranging from 800 to 1000 mm) were made in both piers. The arrangement of the boreholes can be seen in Fig. 1.

Fig. 1 (a) Grouting maps for Pier 1; (b) Pier 2.

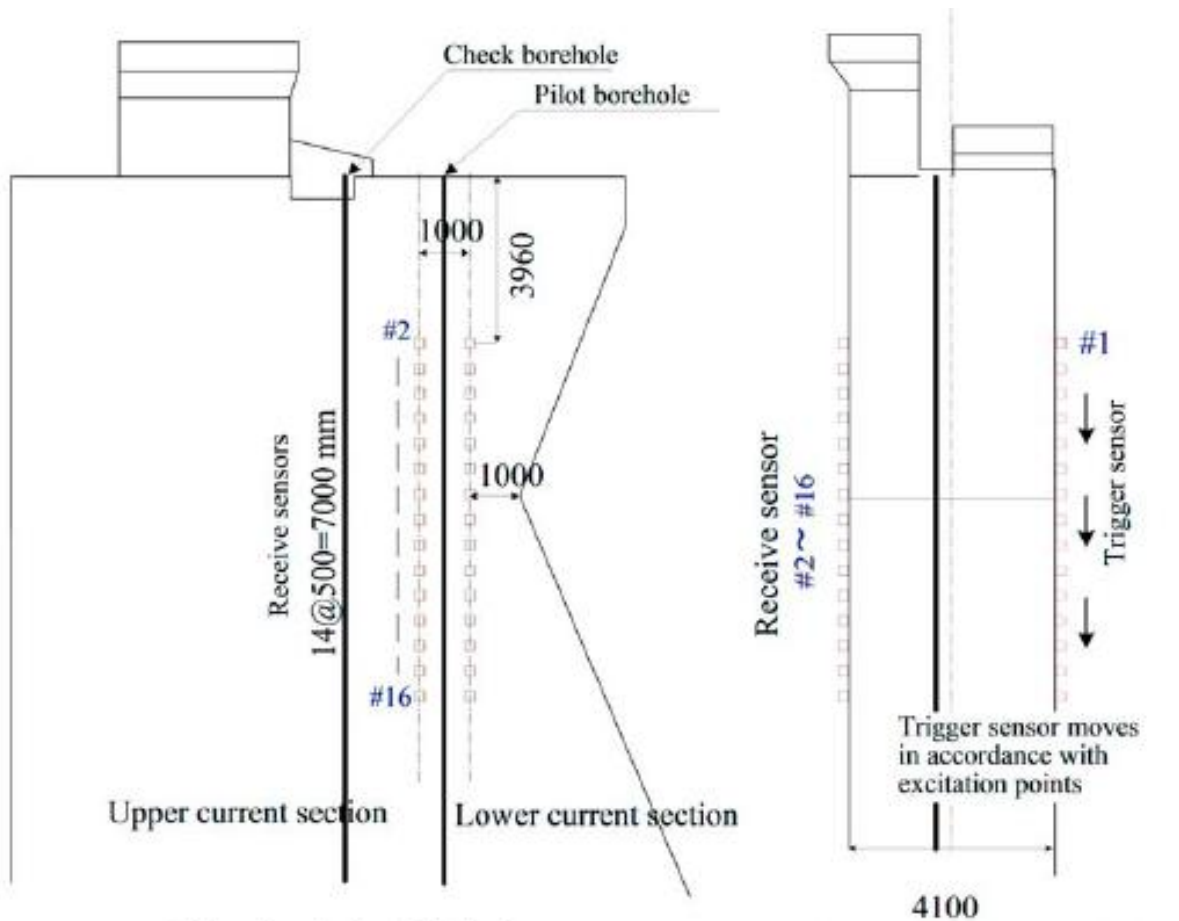
Side view in the right bank Back side (lower current side) view
Fig. 2 Sensor array for tomography in Pier 1.

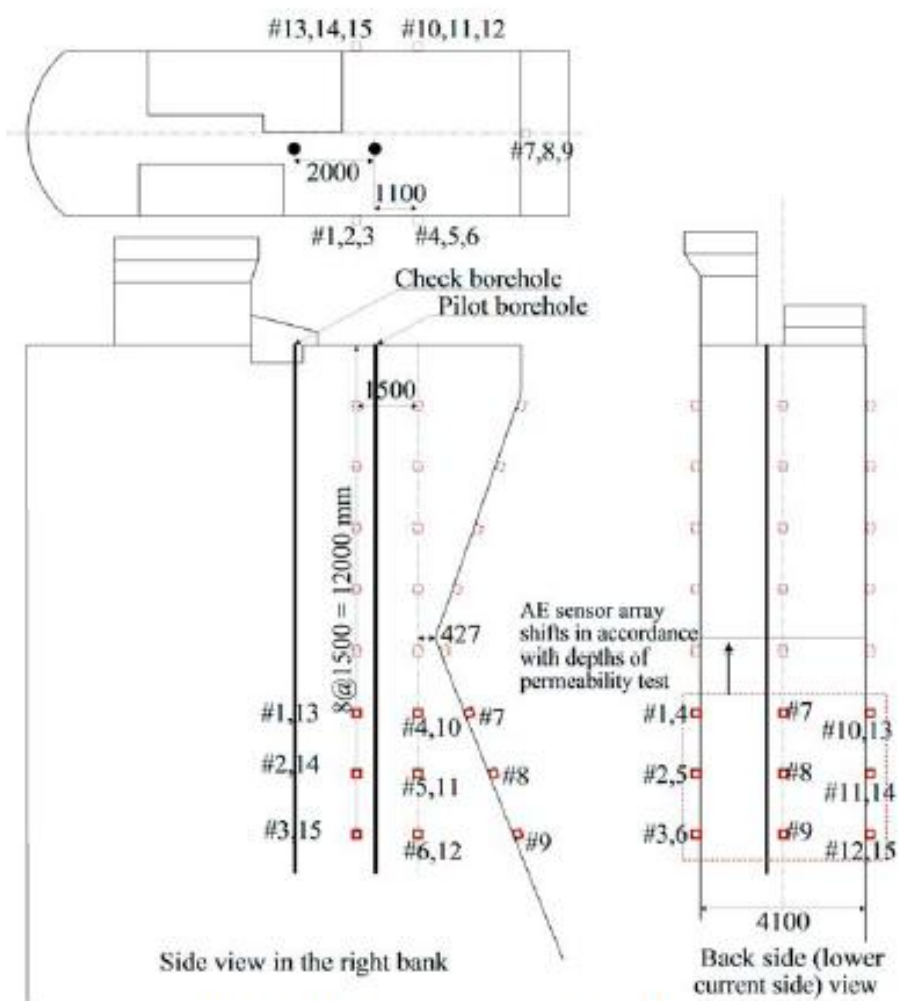
Side view in the right bank Back side (lower current side) view
Fig. 3 AE sensor array in Pier 1.

To study if the grouting material filled the cracked or void areas, permeability tests were carried out by means of a water pump. AE monitoring was conducted during the application of water pressure. As shown in Fig. 3, 6 sensors on each side and 3 sensors on the back side were set with 1.5-m spacing, making a total of 15 sensors. The permeability of concrete was monitored in intervals of 1 m in depth, together with AE monitoring. The AE signals detected with AE sensors (R6I, PAC) were amplified 40 dB and the signals over 40 dB were acquired by DISP AE system (PAC) to study their AE parameters as well as waveforms.

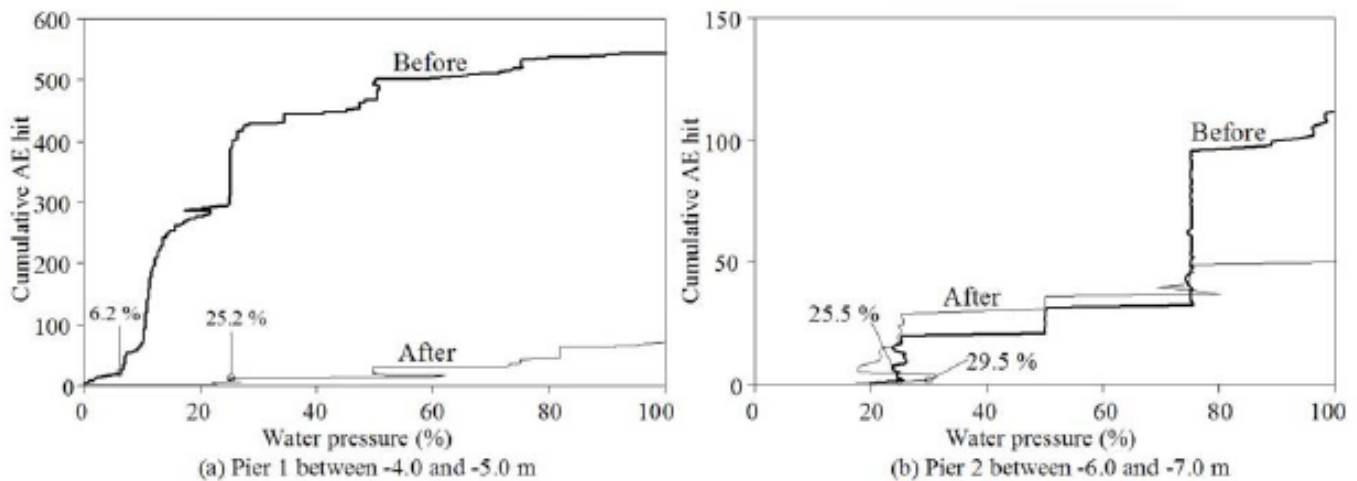
Fig. 7 AE hit activity with water pressurization process.

In Fig. 8a, AE activity of Pier 1 during both processes of water pressurization and its reduction is shown. Since the resulted Calm ratio of 0.11 before, increased to 0.35 after repair, recovery due to repair could not be assumed by the Calm ratio. For Pier 2, improvement after repair could not be obtained from Calm ratio, either (see Fig. 8b). However, the essential reduction of AE activity indicated simultaneous reduction of active sources.
