*Cement &  
Concrete*

## Repair evaluation of concrete cracks using surface and through-transmission wave measurements

D.G. Aggelis, T. Shiotani \*

*Research Institute of Technology, Tobishima Corporation, 5472 Kimagase, Noda, Chiba 270-0222, Japan*

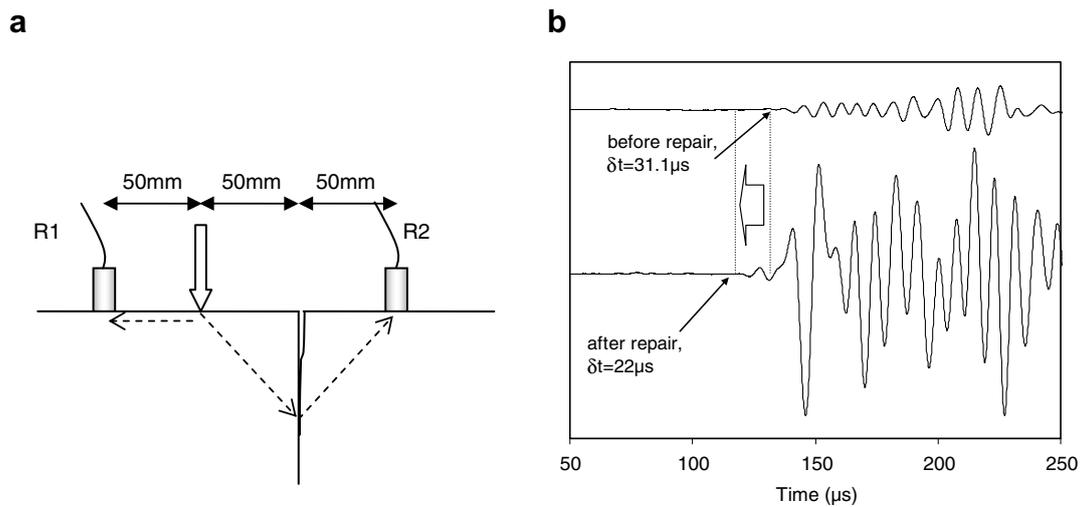
see Fig. 4a. This configuration was used (similar as in [6]) in order to estimate the difference between cracked and repaired state. The transit time of the signal, see Fig. 4b for the case before repair, corresponds to the depth of 59.5 mm, although the metal reinforcement depth is 45 mm. Therefore, it is possible that the actual onset of the diffracted wave through the rebar was weak enough and not detectable. After the impregnation with epoxy, similar measurement led to the waveform that can also be seen in Fig. 4b. An increase of energy is expected [28] since stress waves pass also through the zone provided by the repair agent. Apart from the apparently higher energy transmitted, the onset is much earlier, corresponding to a crack depth of 23 mm. However, an empty portion of that size and at that point is not likely, since the injection was conducted by the same surface that also the wave measurements were conducted. This result should be attributed to the fracture process zone that affects the longitudinal as well as the Rayleigh waves and is discussed in the next section. Anyway, it was obvious in the specific case that using the conventional one-sided ultrasonic measurement of the diffracted wave, crack properties could not be evaluated.

Fig. 4. (a) Schematic representation of one-sided crack depth measurements and (b) waveforms of the receiver after the crack (R2).

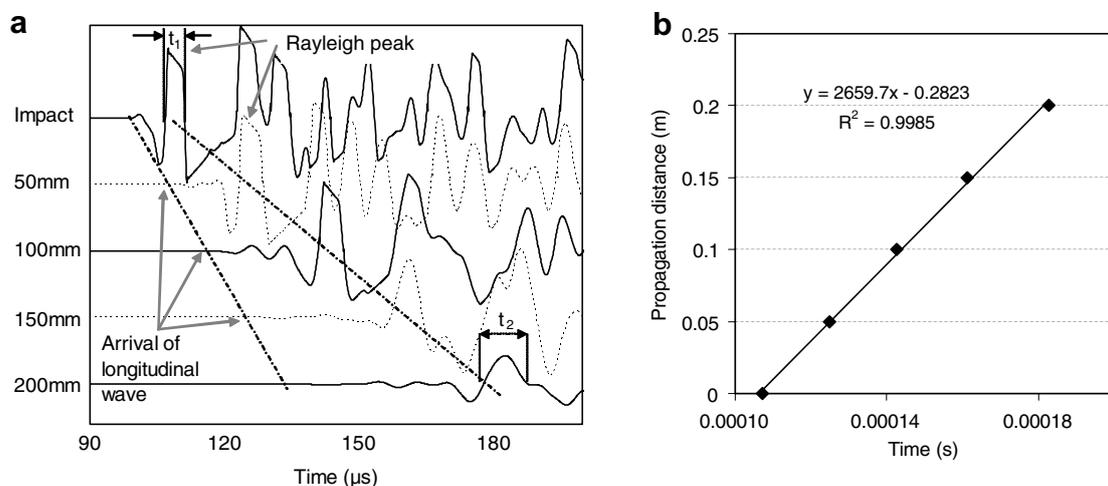
was first conducted on sound material. In Fig. 5a the response at different distances from the excitation can be seen. Near the impact, the amplitude is too strong and therefore is saturated; however this does not cause considerable experimental scatter in the determination of the peak time as will be seen in Fig. 5b. The Rayleigh wave is generally easily detectable since it corresponds to a strong peak following the first arrival of the longitudinal wave which is of certainly lower amplitude [6,29]. Plotting the arrival time of the peak with respect to distance, as seen in Fig. 5b, yields the propagation velocity which is the slope of the line. Since the material is sound with no defects, there is no variation in the Rayleigh velocity and according to the distance, the peaks' arrivals is strongly correlated with the time. The high Rayleigh velocity of about 2660 m/s is indicative of the sound internal condition of the material that has not yet suffered any deterioration. Indeed, the P-wave velocity was measured at around

Fig. 5. (a) Waveforms of surface measurements at different propagation distances for sound concrete and (b) correlation plot of distance to Rayleigh peak arrival time.

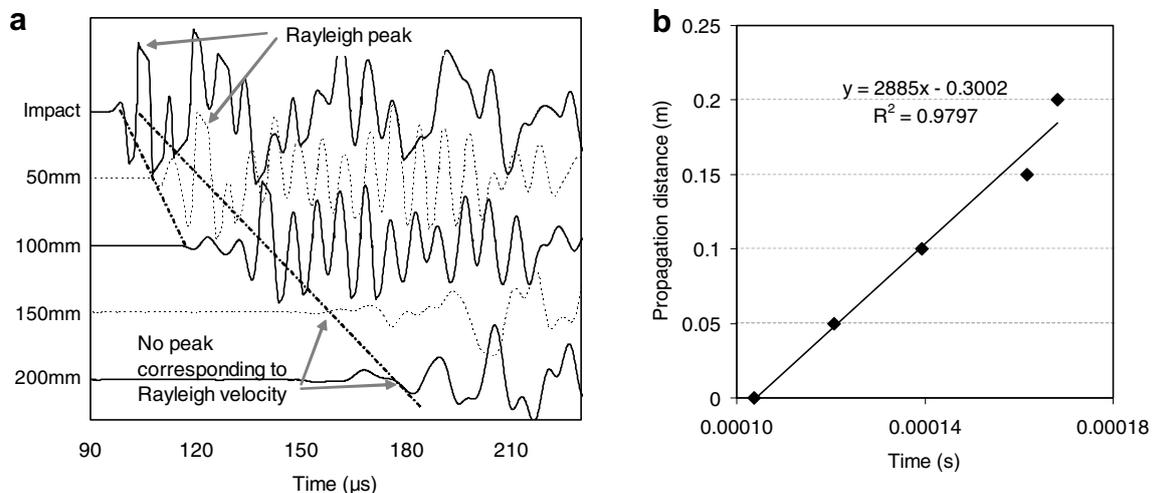
When the same sensor configuration was used to measure a portion containing a crack, different trends were observed, as shown in Fig. 6. The first three waveforms, collected before the crack, are quite clear, while after the crack the waveforms are hardly visible. This shows that a very small part of energy is transmitted through the crack. In Fig. 7a the same waveforms are depicted, with the two waveforms after the crack magnified by a factor of 20. It is obvious that no peak corresponds to the Rayleigh velocity of the material. Plotting the arrival time vs distance using the peaks closest to the expected time for the two last waveforms, results in weaker correlation as seen in Fig. 7b. Therefore, it seems that the Rayleigh wave does not survive after the crack, due to the discontinuity.

Fig. 7. (a) Waveforms of Fig. 6 (these corresponding to 150 mm and 200 mm are magnified by 20) and (b) correlation plot of distance to Rayleigh peak arrival time.

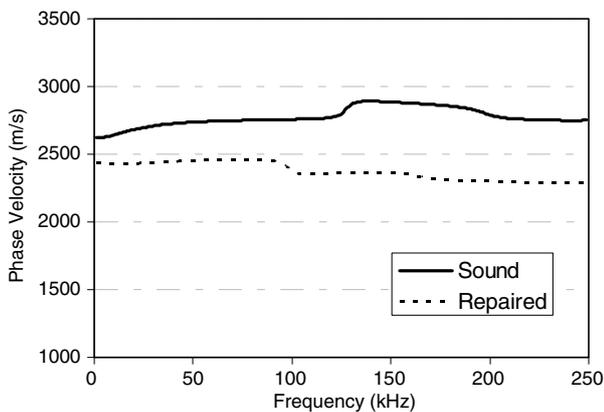
Fig. 9. Concrete phase velocity of Rayleigh waves vs frequency.

length. In this case, it seems reasonable that all the frequencies are delayed (lower curve for “repaired”) due to the presence of the epoxy through the whole thickness of the deck. Therefore, horizontal propagation of Rayleigh waves on shallow as well as larger depths is influenced by the same vertical layer of the lower mechanical properties of the epoxy and are therefore delayed in a similar way. However, a higher discrepancy of the curves above 100 kHz can be noticed and it will be explored later in the analysis.

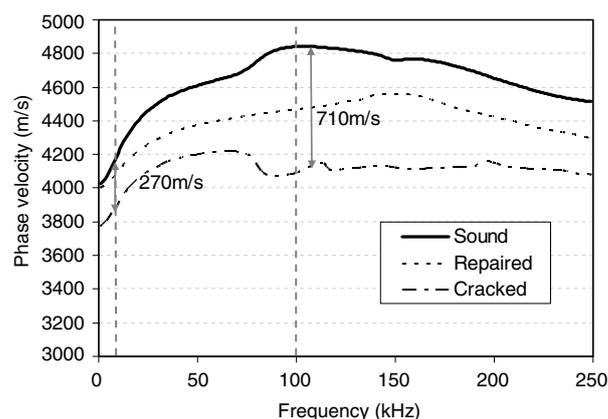
Fig. 12. Concrete phase velocity of longitudinal waves vs frequency.

velocities are depicted in Fig. 12. The specific curves are calculated from diagonal paths; 6–5, as seen in Fig. 2 for the cases of: sound material, path containing a crack and the same path after filling with epoxy. It is seen, similarly to the Rayleigh wave curves, that the velocity of sound material increases with frequency up to 100 kHz, while the cracked path results in much lower curve. Low frequencies around 10 kHz exhibit phase velocity of 3800 m/s, 270 m/s lower than the intact state. Correspondingly, frequencies at the vicinity of 100 kHz, present even greater discrepancy of more than 700 m/s (4100 for cracked and 4800 m/s for intact). The velocity of the repaired material is in any case in between. Since the velocity differences between the cracked, the repaired and the sound situation are not the same for each frequency component but seem to be highlighted for frequencies around 100 kHz, it was assumed reasonable to repeat the tomography procedure using velocities of different frequencies. Therefore, for all different wave paths (total number 50) between each impact point and receiver, the corresponding dispersion curve was calculated. Then for any selected frequency the corresponding phase velocity of all the wave paths was picked and fed to the tomography software. Herein, two indicative cases are discussed corresponding to lower and higher frequency bands acquired, namely 10 kHz and 100 kHz as seen in Fig. 12. In Fig. 13a and b one can observe the tomogram of the region of interest before and after the impregnation for 10 kHz, while Fig. 13c and d concern the case of 100 kHz. The frequency of 10 kHz corresponds to the low frequency limit of the acquisition setup and therefore, tomograms of lower frequencies are not presented although they can be obtained. On the other hand, after propagation through the deck of 419 mm the signal did not contain enough energy content above 100 kHz, therefore the use of higher frequency for tomography would result in questionable reliability. For both frequencies the repair effect is obvious, elevating the average velocity of the cells by 300 m/s for the case of 10 kHz and by about 450 m/s for 100 kHz. The areas showing the defect are substantially eliminated in both cases. However, the tomogram of 100 kHz seems more accurate concerning the location of

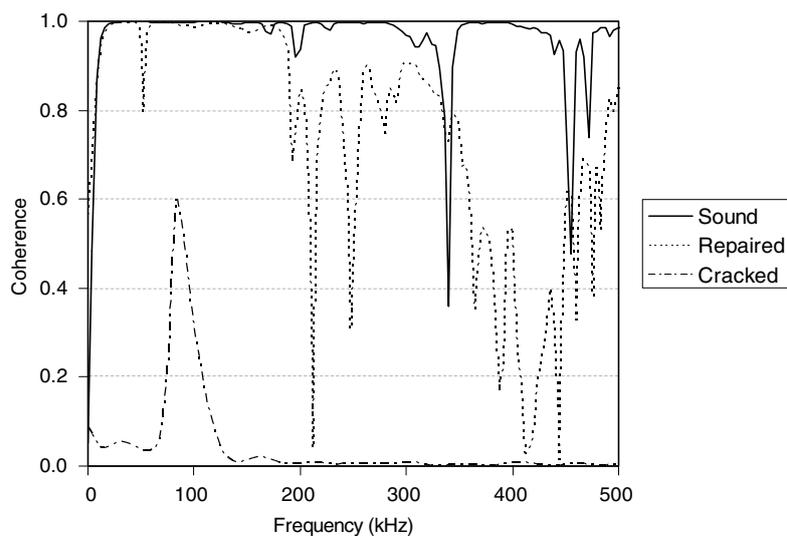
Fig. 14. Coherence function between signals collected at different states of concrete.

is observed up to 200 kHz. It is interesting to see that for the case of cracked material, due to the large thickness of the crack, the signal seems so distorted that the coherence function exhibits very low values for the entire range although there was no source of external noise.

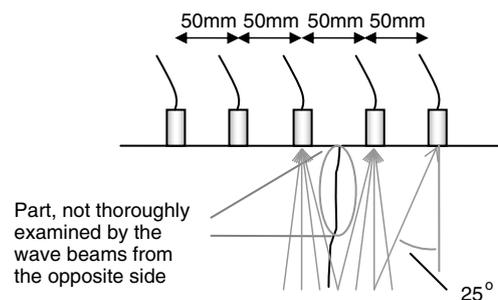
In the tomography measurement many combinations of impact and receiving points lead, as mentioned, to a number of 50 different wave paths that are considered adequate for a cross section of 419 mm × 200 mm. However, due to the specific geometry, the interaction of the wave beams with the near surface portion of the crack is limited, as can be seen in Fig. 15. In fact, considering straight wave paths, the near the surface part of the crack, that is not crossed by any beam, is about 60–70 mm deep. Since the density of the wave beams is low for this shallow layer, Rayleigh waves analysis was also essential. At the cracked state, the identification of Rayleigh waves was not possible, as a result of the discontinuity. After application of epoxy, the Rayleigh wave propagation was restored and Rayleigh peaks were identified clearly. Such a behavior

Fig. 15. Detail about interaction of wave beams with the near surface part of the crack.

demonstrated that at least a large portion of the surface layer of 35–40 mm was successfully filled, allowing the propagation of energy in the form of surface waves. In a big concrete structure this information obtained relatively easy and fast is considered adequate, although further detail should be desirable through more accurate correlations between the amplitude and frequency of the Rayleigh wave and the crack depth filled with epoxy. This would be of more importance in case there is no access to both sides. At that point the amplitude or frequency content of the Rayleigh waves should be used for the characterization of the crack from one side. Such correlations have been studied for metals [20] but for concrete there is still limited work [19,22]. Further investigation concerning the accurate characterization of the crack depth and degree of filling is currently undertaken by the authors combining numerical parametric study with experimental results of surface measurements on concrete material.
