Prasanna Karpur,<sup>1</sup> Theodore E. Matikas,<sup>2</sup> Mark P. Blodgett,<sup>3</sup>  
Jay R. Jira,<sup>4</sup> and Drew Blatt<sup>4</sup>

## Nondestructive Crack Size and Interfacial Degradation Evaluation in Metal Matrix Composites Using Ultrasonic Microscopy

**REFERENCE:** Karpur, P., Matikas, T. E., Blodgett, M. P., Jira, J. R., and Blatt, D., "Non-destructive Crack Size and Interfacial Degradation Evaluation in Metal Matrix Composites Using Ultrasonic Microscopy," *Special Applications and Advanced Techniques for Crack Size Determination, ASTM STP 1251*, J. J. Ruschau and J. K. Donald, Eds., American Society for Testing and Materials, Philadelphia, 1995, pp. 130-146.

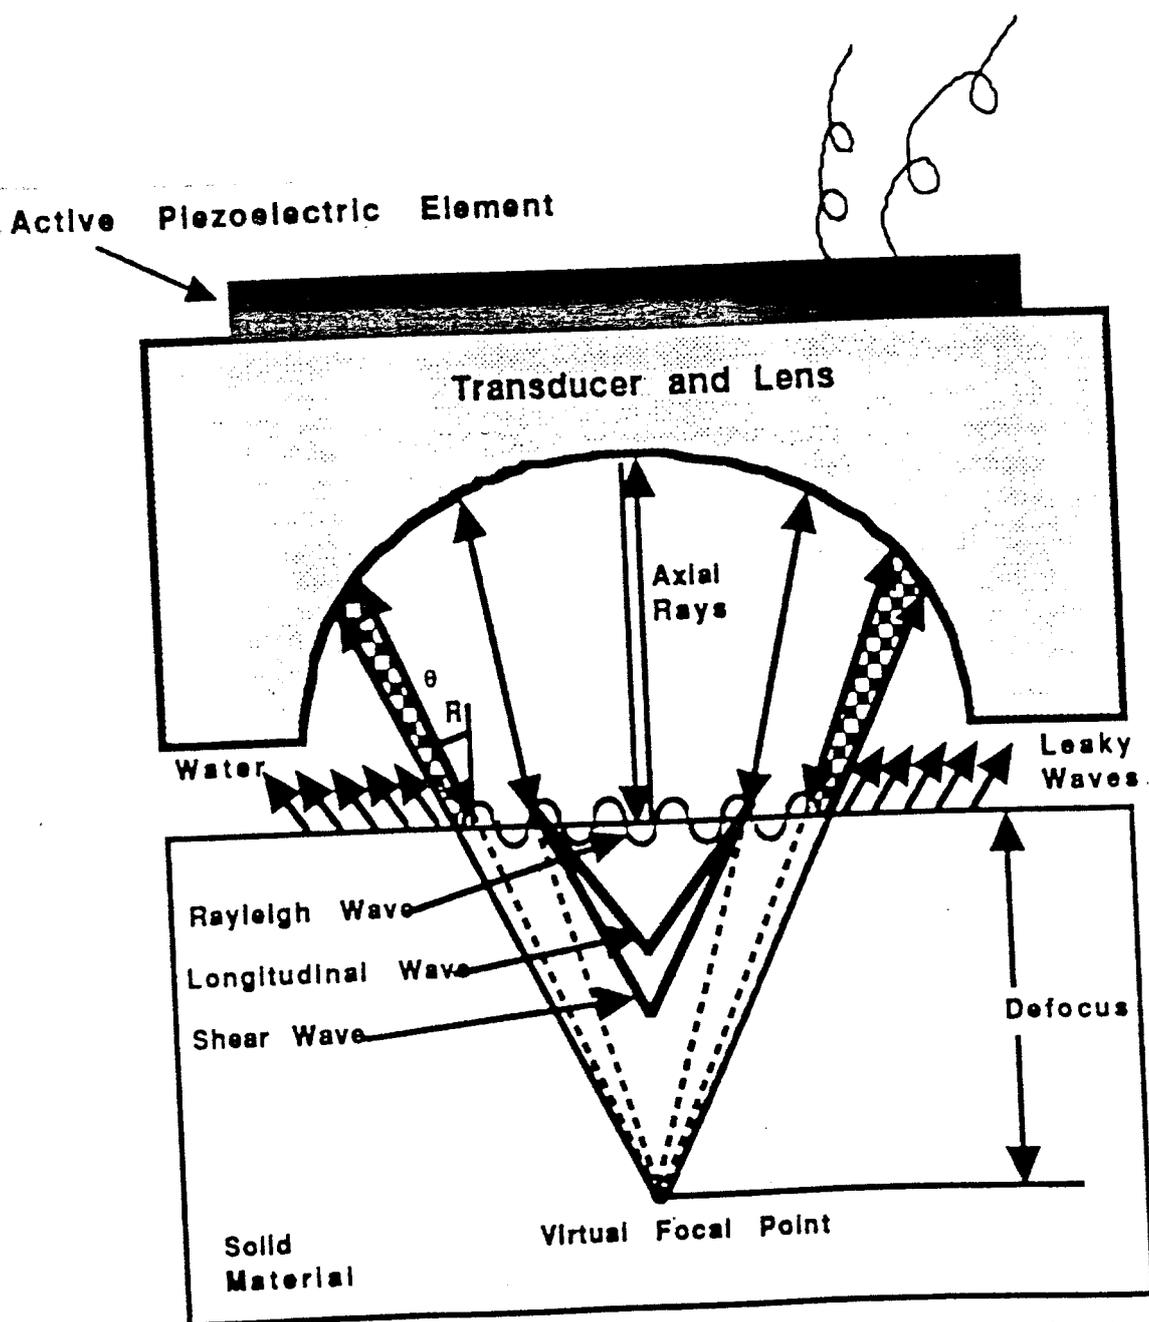
A SAM transducer is schematically shown in Fig. 1. The transducer has a piezoelectric active element situated behind a delay line made of silica crystal oriented such that the 1-1-1 axis is parallel to the direction of sound propagation. The thickness of the active

element is suitable to excite ultrasonic signals (with a nominal frequency of 50 MHz in this case) when an electrical spike voltage is delivered to the piezoelectric element. The silica delay has a spherical acoustical concave lens (Fig. 1) which is ground to an optical finish. The numerical aperture (NA, ratio of the diameter of the lens to the focal distance) is 1.25 for the transducer used for this study. An NA of more than 1 (or F number, focal distance/diameter, of the lens less than 1) is essential for the SAM technique to effectively generate and receive surface waves in the specimen being imaged.

FIG. 1—Schematic of a SAM. The diagram shows the active piezo electric element, focusing lens, and the Rayleigh wave generated due to the sharp focusing of the ultrasonic beam.

The principle of operation of a SAM transducer is based on the production and propagation of surface acoustic waves (SAW) as a direct result of a combination of the high curvature of the focusing lens of the transducer and the defocus of the transducer into the specimen [7,14]. The contrast of the images obtained using SAM is based on the attenuation and

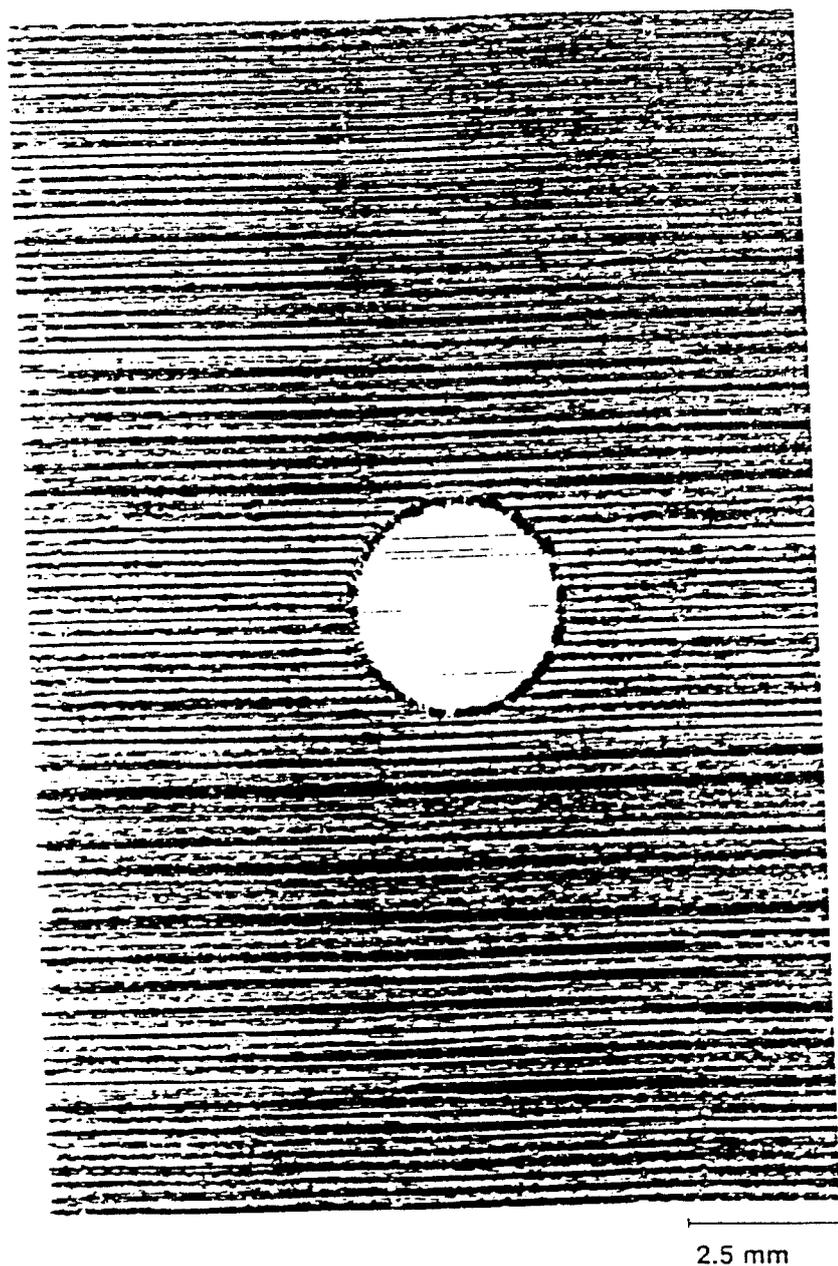
odically interrupted and the specimen was scanned using the SAM to evaluate the development of damage during the life of the specimen. After each SAM evaluation, the specimen was returned for further fatigue cycling. The fatigue cycling was terminated after the third interruption at  $9.66 \times 10^5$  cycles. For this test, the composite consisted of a cross-ply layup of fibers in the [0/90]<sub>n</sub> configuration. Prior to testing, a SAM image was made of the specimen to establish the initial integrity of the material. The pretesting image is shown in Fig. 2a and shows no damage to the interfaces prior to testing.

FIG. 2a—The SAM image of a Ti-15Mo-3Nb-3Al-0.2Si (weight percent) specimen before an isothermal (650°C) fatigue test.

After the initial scan, the specimen was fatigued isothermally at 650°C with a maximum remote stress of 200 MPa applied at 1 Hz along the fibers with reference to the image in Fig. 2a. The fatigue test was stopped after  $1.54 \times 10^5$  cycles or approximately 43 h at the specified high temperature. One matrix crack could be seen on each side of the hole. One

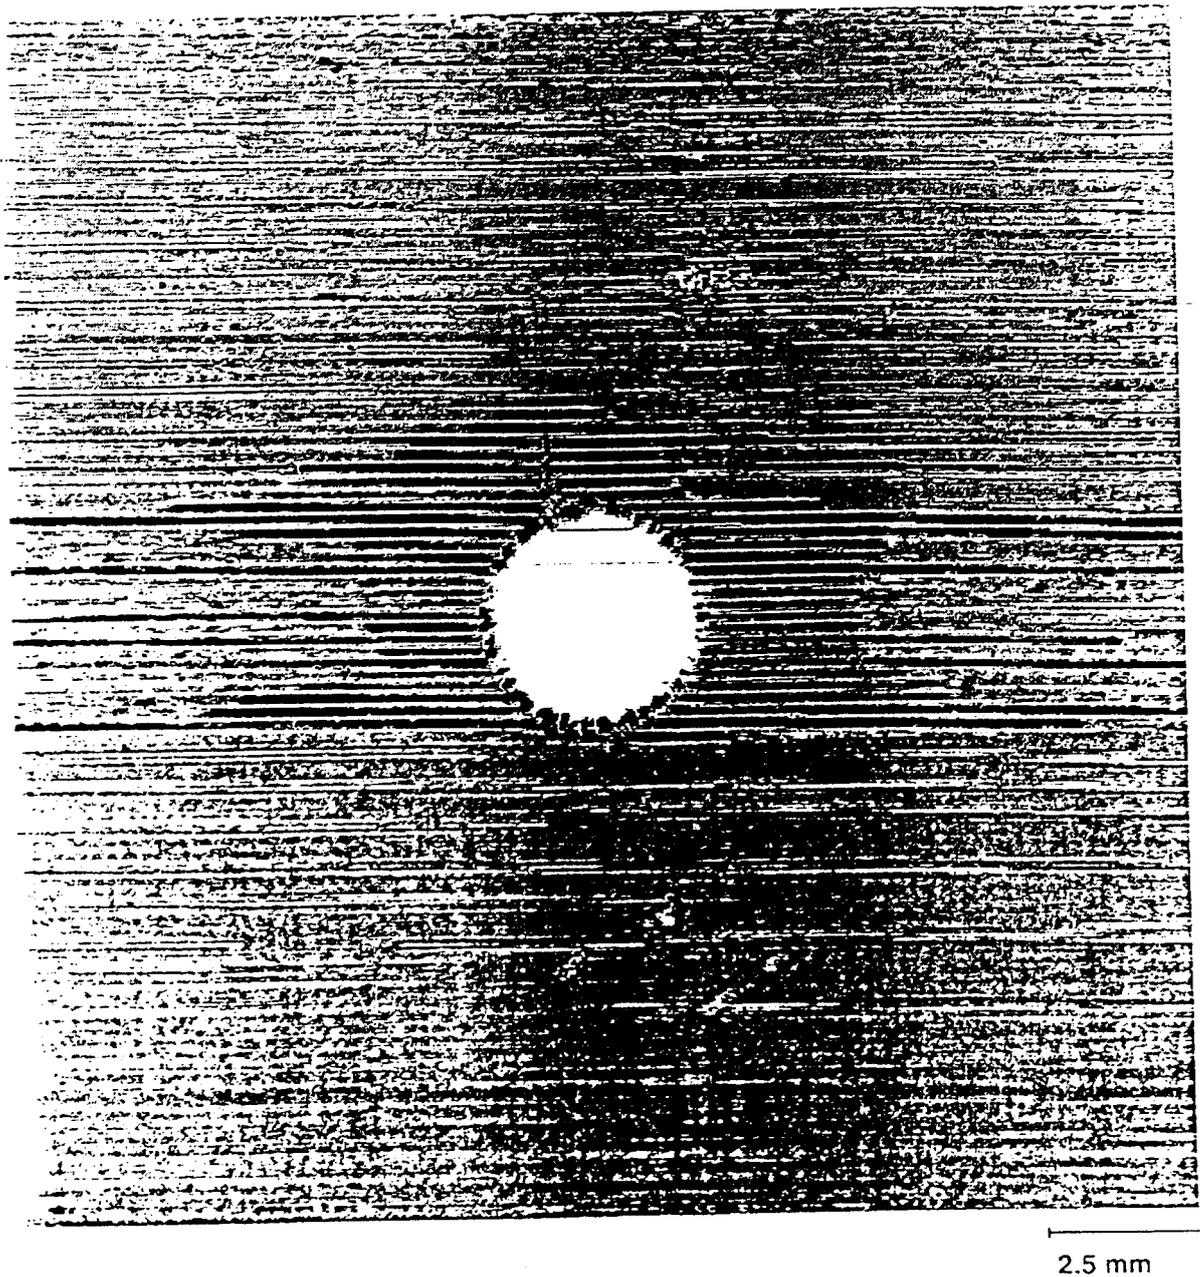
FIG. 2b—The SAM image of the Ti-15Mo-3Nb-3Al-0.2Si (weight percent) specimen in Fig. 2a after  $1.54 \times 10^7$  cycles or approximately 43 h of isothermal (650°C) fatigue test.

crack initiated earlier in the test and had a surface length of 2.36 mm from the edge of the hole while the crack on the other side had reached a length of 0.54 mm from the edge of the hole. The specimen was removed from testing and imaged using the SAM. The resulting image is shown in Fig. 2b. In this figure, the damage (as indicated by the high contrast regions) originates at the top and bottom of the hole and proceeds away from the hole along the fibers. The damage is also seen to originate at the crack plane, where the crack exposes the interior of the specimen to the environment. The actual crack length is longer than the length over which the high contrast region is observed. This difference corresponds to approximately three fibers at each crack tip and appears to be related to the relatively recent extension of the crack into this region and perhaps the consequential shorter duration over

which the environment has had access to those fiber-matrix interfaces. The shorter crack on one side of the hole is only beginning to develop an affected zone and is barely visible in the ultrasonic image although the crack extends about three fiber diameters at the surface.

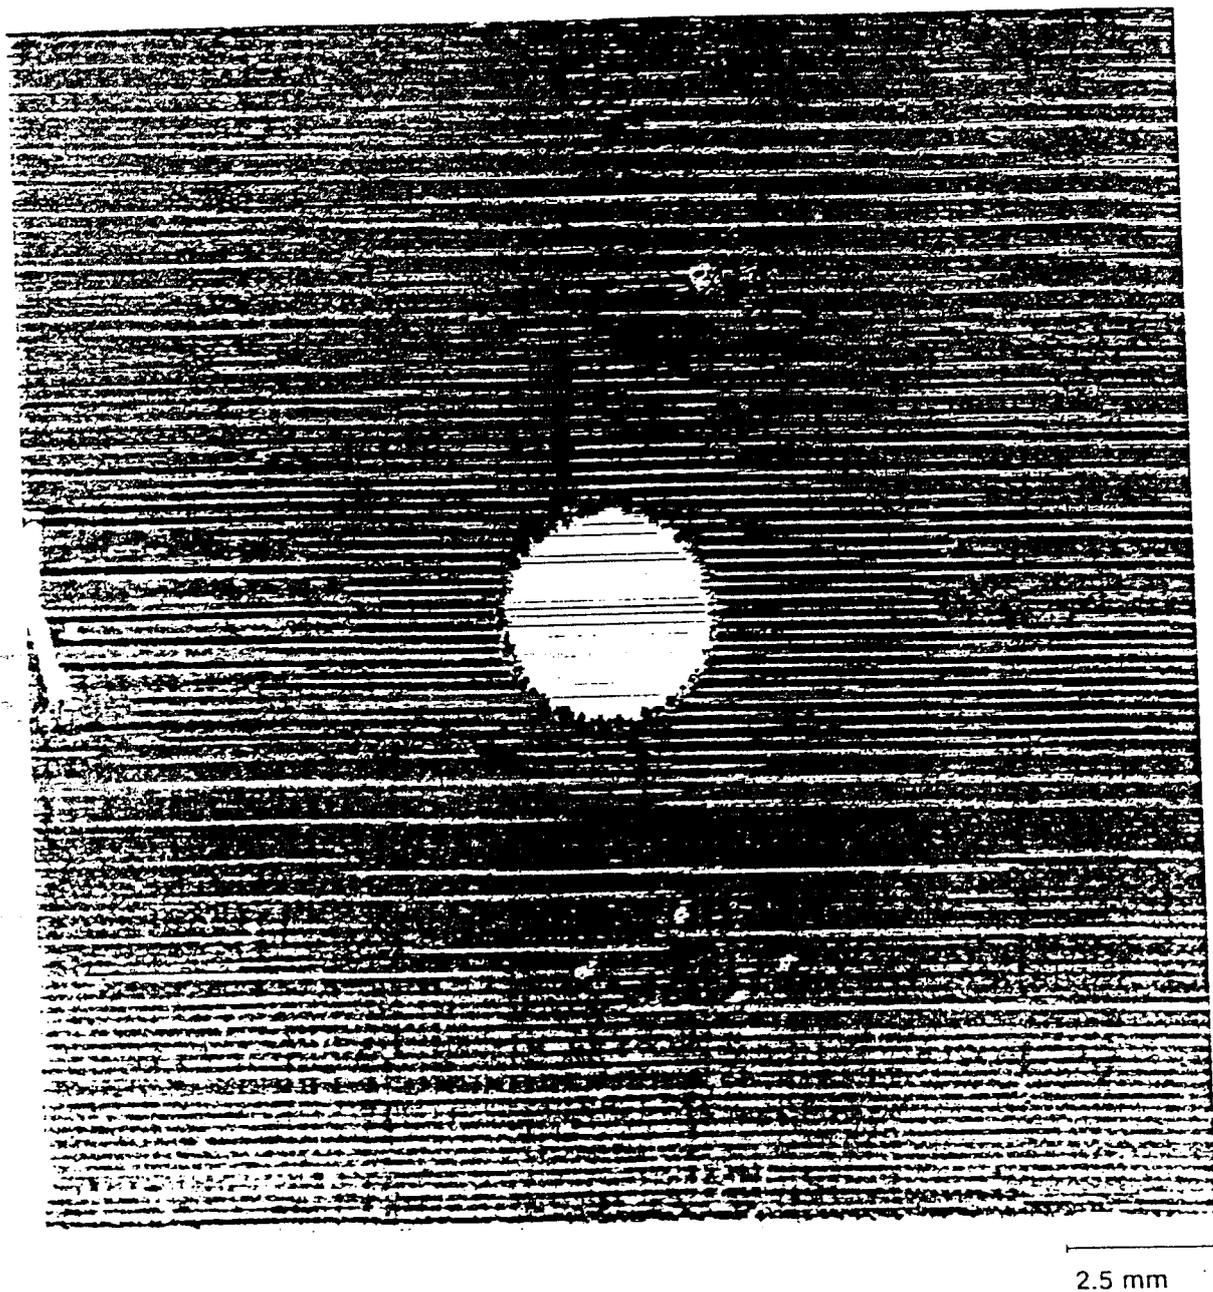
FIG. 2c—The SAM image of the Ti-15Mo-3Nb-3Al-0.2Si (weight percent) specimen in Fig. 2a after  $2.51 \times 10^6$  cycles or approximately 70 h of isothermal (160°C) fatigue test.

Figure 2c is the SAM image after an additional  $9.66 \times 10^4$  cycles were applied for a total of  $2.51 \times 10^6$  cycles and total time of 70 h at the specified high temperature. In this figure, the cracks on each side of the hole can be seen clearly. The larger crack had grown to a surface length of 2.88 mm from the edge of the hole while the crack on the other side had reached a length of 1.77 mm from the edge of the hole. The region of high contrast has expanded along the cracks as well as to the left and right of the hole. However, in the SAM

image in Fig. 2c, the last three fibers at the tips of both the cracks did not show any interfacial damage.

The invaluable information that can be obtained from SAM in specimens tested at elevated temperatures is demonstrated clearly in Figs. 2 to 5. The interfacial degradation and damage evident in Fig. 2c, Fig. 3, Fig. 4a, and Fig. 5 were also corroborated by metallography. It is evident from the combination of SAM image and metallography that the extent of fiber coating damage was greatly increased where the fibers were continuous (load carrying) and exposed to the environment due to matrix cracking. The fiber ends exposed along the notch did accumulate some damage along the fiber-matrix interface but to a much lesser extent because they were in a stress free condition. This phenomenon in combination with larger damage near high stress areas such as the notch tips and hole circumference indicates that (1) when the stresses are negligible at the edge of the specimen, the interfacial degradation and damage is minimum even though the fiber/matrix interface was exposed to the temperature cycling during the entire duration of testing, and (2) the interfacial degradation is related directly to the fiber and matrix stresses which increase near the notch tip.

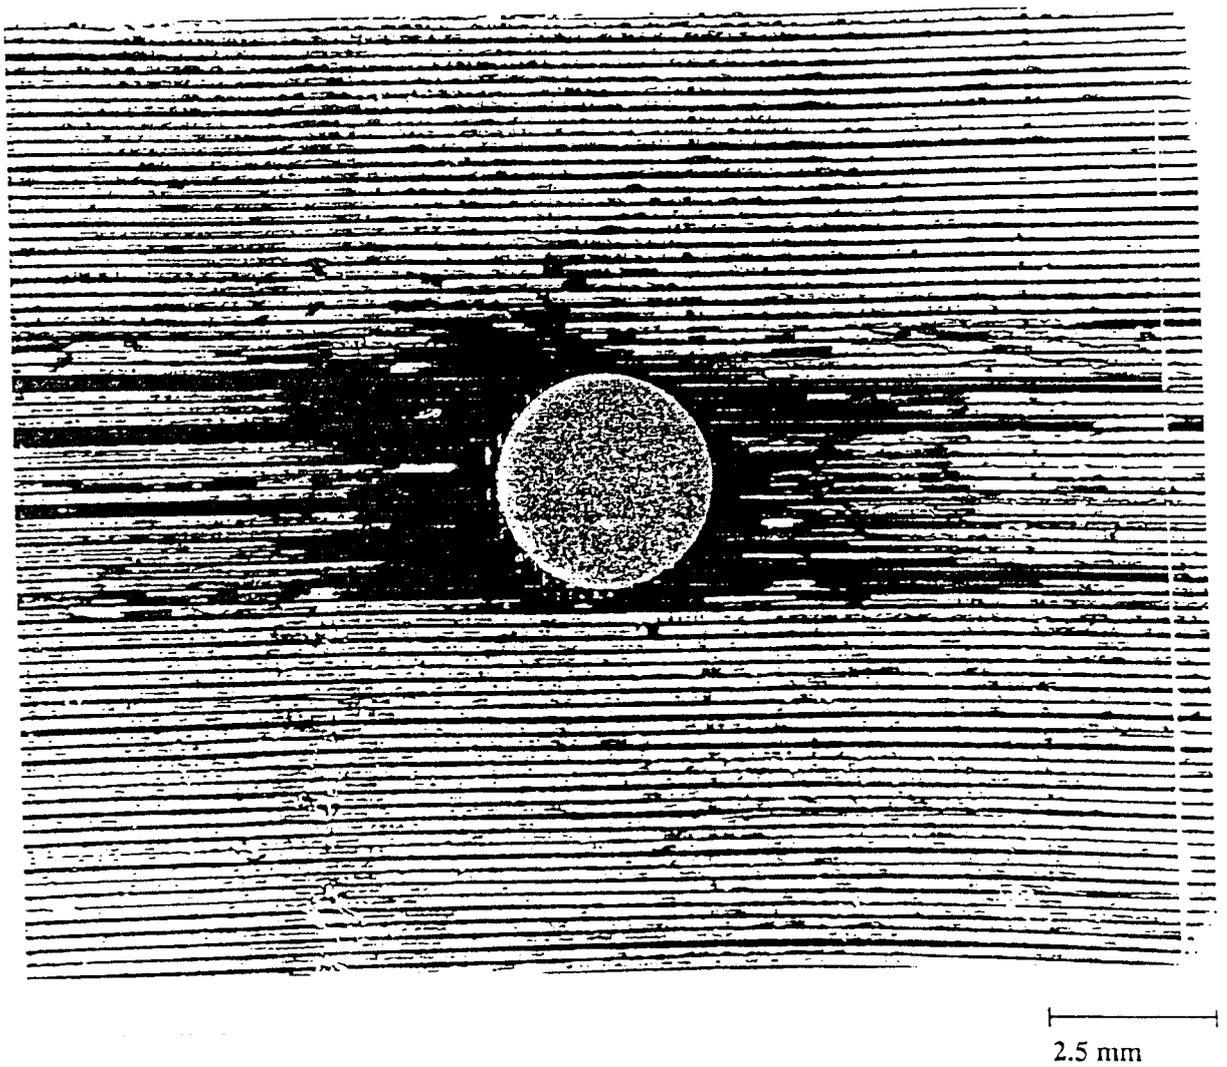
FIG. 2d—Metallography of specimen in Fig. 2a through 2c.

To substantiate the indications made by the SAM, the outer layer of matrix material on Specimen 1 was etched away using a saturated solution of tartaric acid in 10% bromine in methanol. The etched specimen was cleaned ultrasonically in acetone, photographed, and is shown in Fig. 2d. Throughout most of the exposed layer of fibers, the outer coatings of the fibers have remained intact and appear white. The dark regions above and below the hole indicate the cracking of the coating. In most cases, when the environmental exposure time is maximum, the coatings have been removed completely, exposing the dark silicon carbide fibers beneath the coating. The cross-ply ( $90^\circ$ ) fibers in the second layer can also be detected. From the metallographic image in Fig. 2d, the hypothesis of gradual degradation of the interface is suggested because the interfaces of the fibers cut by the circumference of the hole were exposed the longest to the severe environmental conditions and show enough damage to lose the interfacial coating during cleaning. However, the longer and older of the two cracks show some damage to the interface whereas the shorter crack shows almost no damage in the metallography although ultrasonic images indicate otherwise. Plans are un-

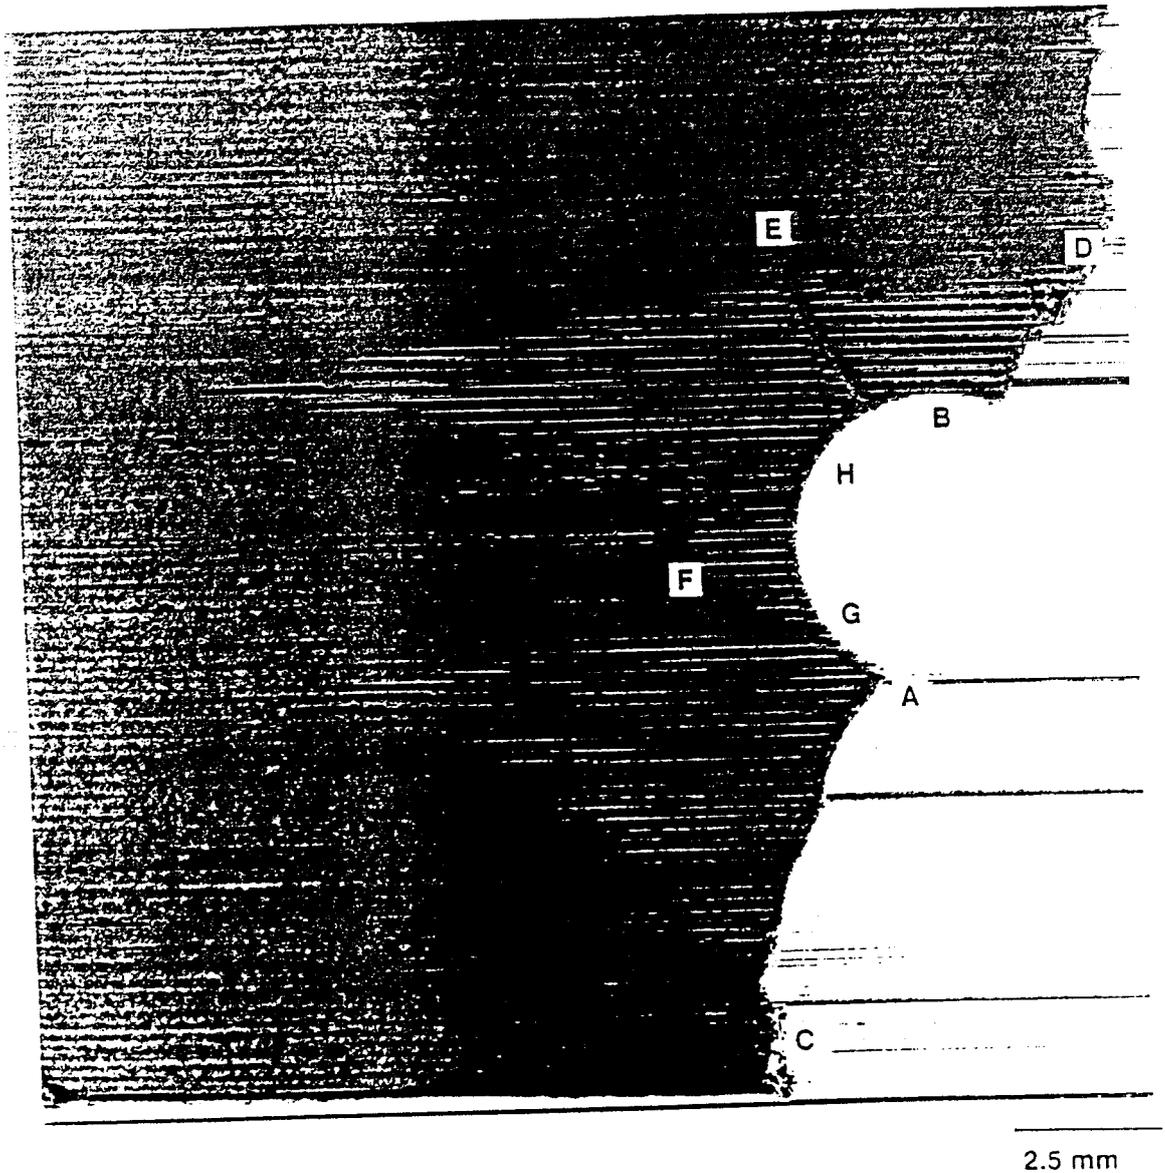
Figure 3 is a SAM image of Specimen 2. The fractured edge of the specimen including the remaining portion of the circular hole is on the right-hand side of the figure. Four cracks initiated around the hole, with one crack on each side of the hole dominating and eventually leading to failure. One of the nonfailure cracks, labeled E, is visible in Fig. 3. Note that the fiber locations are easily distinguished throughout the SAM image.

A region of high contrast, evident in Fig. 3, appears to extend along the fibers. The shape of the high contrast regions suggest that both the local stresses and the duration of exposure to the high temperature environment influence the extent of damage. The zones labeled A and B on the figure are regions of stress concentration near the notch. Cracks initiated in this region, exposing the interior of these regions to the environment early in the fatigue life. Consequently, the largest affected length of fibers appear to originate near A and B. In contrast, the affected fiber length between G and H is considerably less, even though the fiber ends at the hole were exposed to the environment from the beginning of the test. The geometry of the notch leads to fiber stresses in this region which are considerably smaller in magnitude than the stresses near A and B. It appears that the different stress state in this region has affected the rate of environmental interaction. The zones beginning at labels C and D and extending to each edge of the specimen are the regions of fast-fracture. In this region, the SAM did not detect strong differences from the virgin material. Finally, in the crack growth region shown by CA, BE, and BD, a gradient of affected fiber lengths is evident, presumably related to the duration of exposure after matrix cracking. These observations indicate that the effect detected by the SAM is related to both stress and exposure duration.

FIG. 3—The SAM image of a Ti-15Mo-3Nb-3Al-0.2Si (weight percent) specimen after an isothermal (650°C) fatigue test ( $1.82 \times 10^5$  cycles).

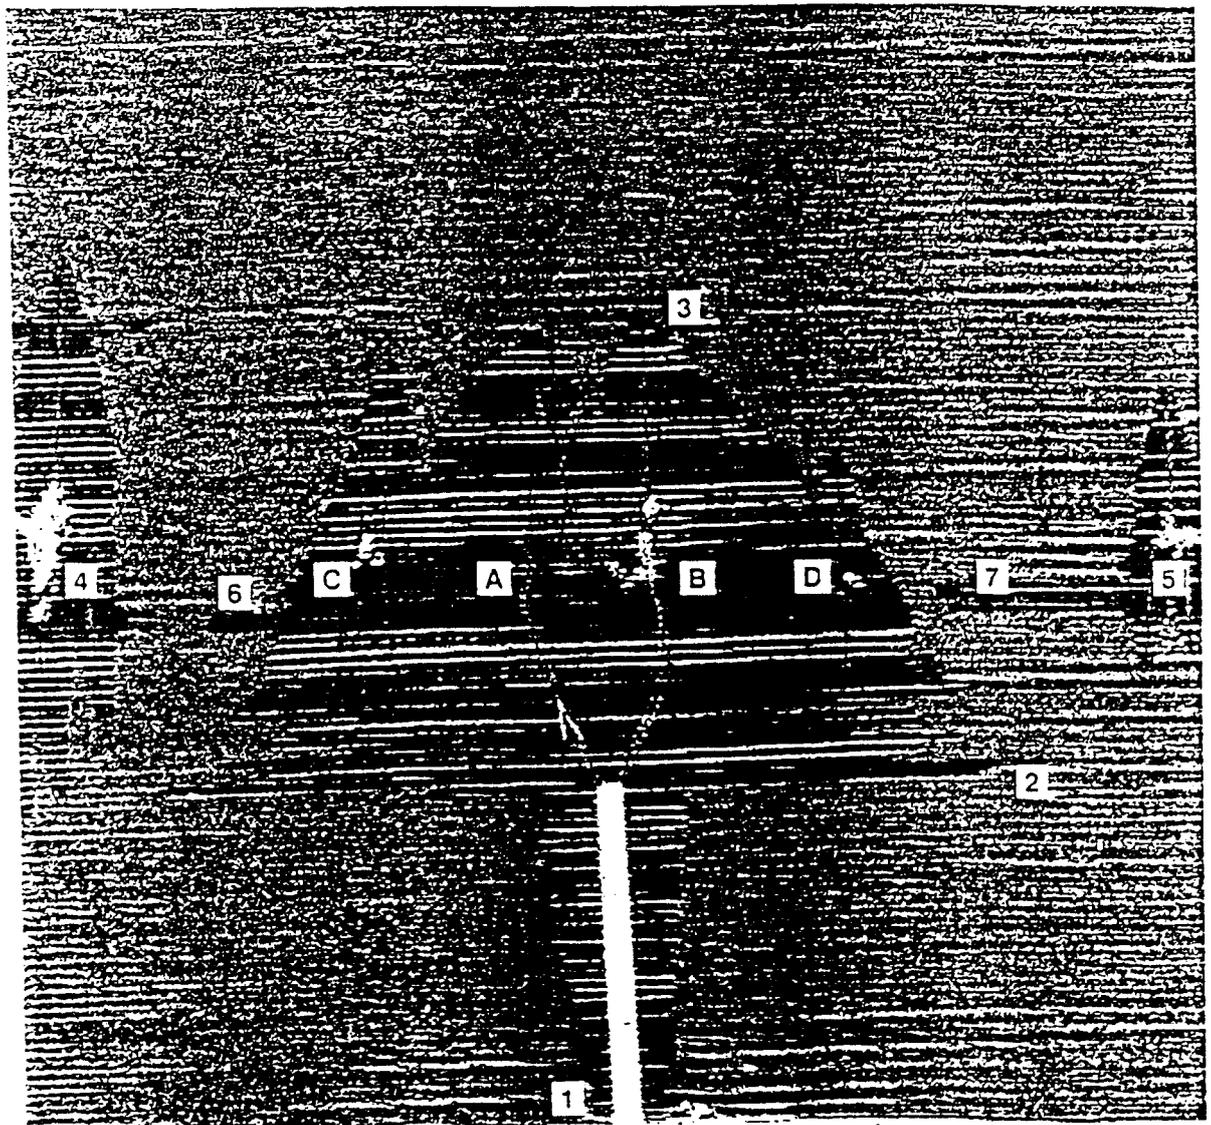
The effects of the stress, temperature, and duration of exposure to elevated temperature can be seen clearly in Fig. 4a. The image is labeled to show seven zones, 1 through 7. Also, cracks are labeled A through D. In zone 1, where the effect of stress is gradually increasing toward the notch tip, the interface shows corresponding increasing lengths of degradation. The interfacial degradation and damage at the tip of the notch (zone 2) show a sudden increased length indicating that the stress in the first continuous fiber and the total time of exposure to elevated temperature have a devastating combined effect on the integrity of the interface. At zone 3 where the matrix crack tip is growing, the pointed shape of the interfacial oxidation followed by "parabolic" growth of the damage profile indicates that at the crack tip, the interfacial damage is not instantaneous. Zones 4 and 5 are cracks growing from the site of spot welds used to secure thermocouples. The zones show similar crack and interfacial damage mechanism as zones 1, 2, and 3. In addition, the areas labeled 6 and 7 on Fig. 4a show the process where interfacial damage from zone 4 as well as zone 5 are

FIG. 4a—The SAM image of a Fe-15Mo-3Nb-3Al-0.2Si (weight percent) specimen after the specimen was exposed to 14 612 thermomechanical cycles over 36 days (0.0056 Hz).

approaching the interfacial damage from cracks A, B, C, and D (C and D are cracks growing from unintentional weld spots on the surface). This behavior indicates that similar growth and merging behavior around cracks A, B, C, and D has resulted in the large mushroom shaped interfacial degradation and damage zone around the slot and the cracks.

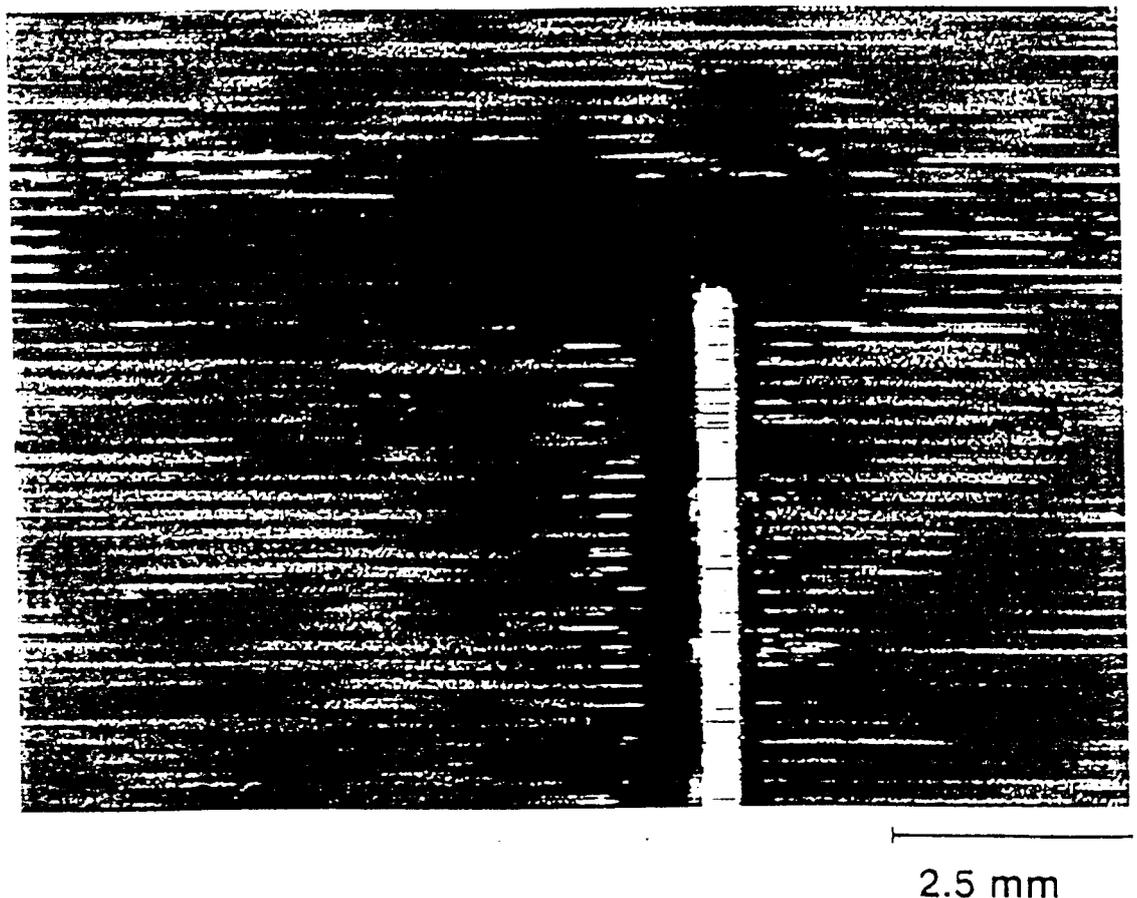
Figure 5 shows the SAM image of the specimen after 35 733 cycles were applied. The image clearly shows the two cracks, which are also visible to the naked eye, growing from the tip of the notch. Each crack has an average projected crack length of 8.9 mm. The distinct ultrasonic feature (dark areas) evident around the EDM notch and to a greater extent around the cracks indicates possible environment degradation of the carbon rich fiber-matrix

FIG. 5—The SAM image of a SCS-6/Ti-6Al-2Sn-4Zr-2Mo specimen after 35 733 cycles at 0.00833 Hz.

interfacial region. To confirm this, the matrix was etched away using a saturated solution of tartaric acid in 10% bromine in methanol. A visual inspection of the first layer of fibers after matrix removal showed a pattern of darkened fiber coatings that exactly matched the ultrasonic signature from the SAM.

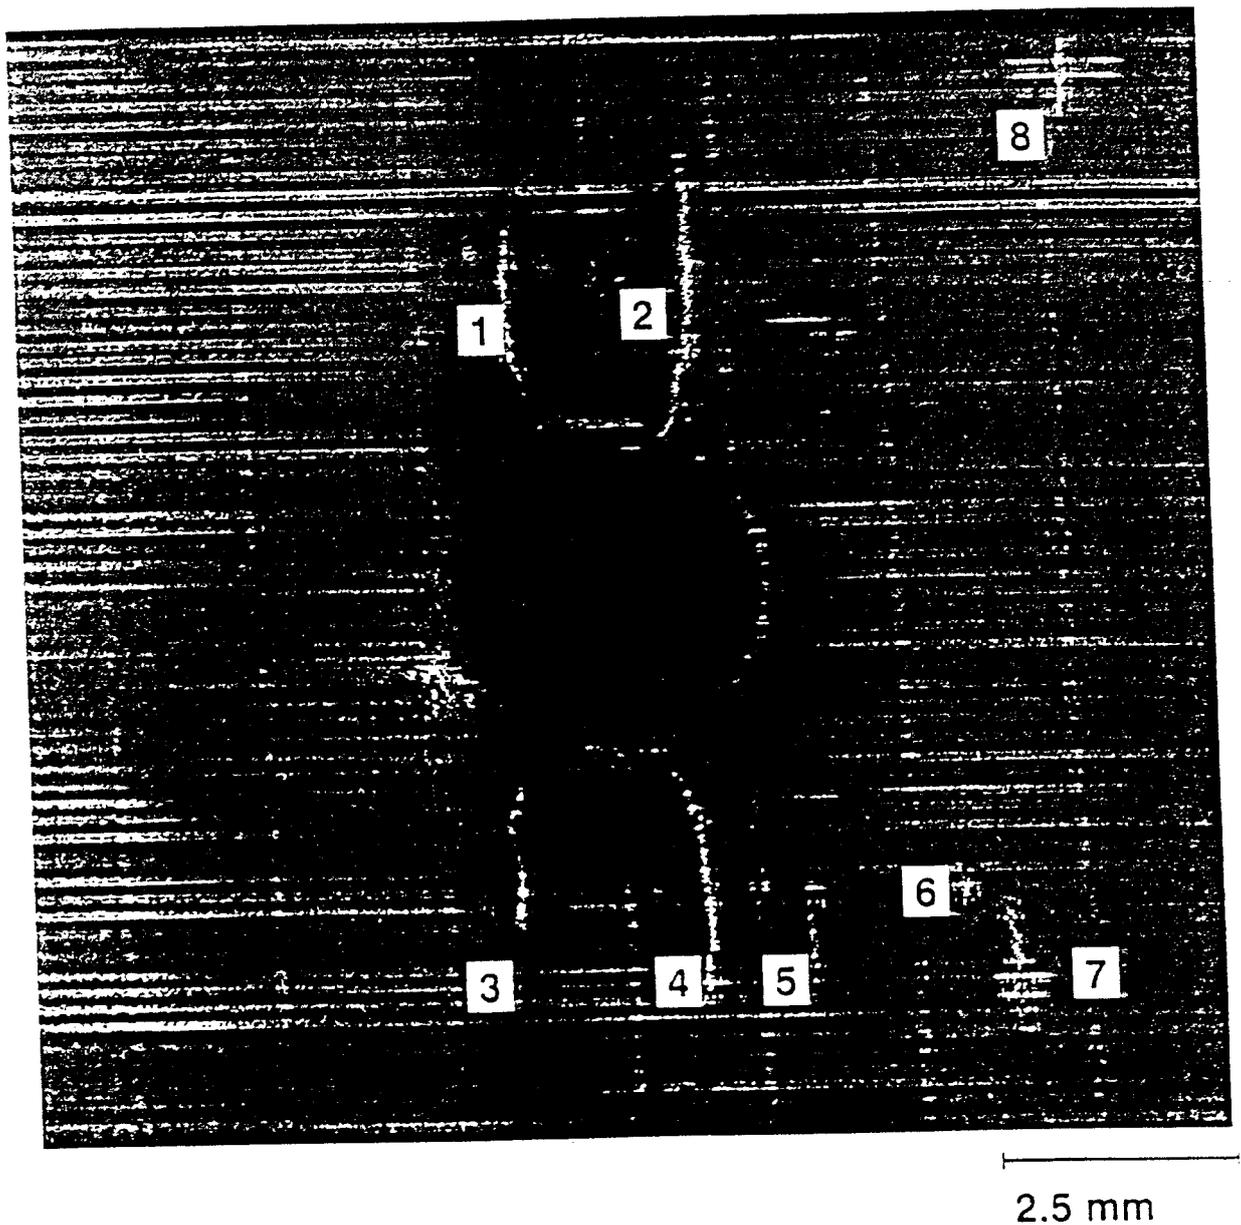
Figure 6 shows the SAM image of a typical specimen after fatigue cycling at room temperature. It is clear from the figure that the primary cracks grew radially from the notch but turned to follow a direction perpendicular to the loading axis within a distance of one radius of the hole. Some secondary cracking can be seen near the primary cracks although these cracks formed later in the fatigue life and did not appear to participate in the final fracture. The locations of the fibers in the first layer can be seen easily as well as the location of a crossweave binder material used to hold the fibers in place during consolidation.

FIG. 6—The SAM image of a SCS-6/Ti-24Al-11Nb (atomic percent) specimen after room temperature.

The utility of SAM for the assessment of room temperature fatigue behavior of SCS-6/Ti-24Al-11Nb composite can be seen from Fig. 6. The SAM technique can easily detect primary cracking in the composite which normally can also be easily observed visually on the surface. However, the SAM also detects the presence of secondary cracking which is not always as evident as the primary cracks.
