# Construction and Building Materials

## Combined use of thermography and ultrasound for the characterization of subsurface cracks in concrete

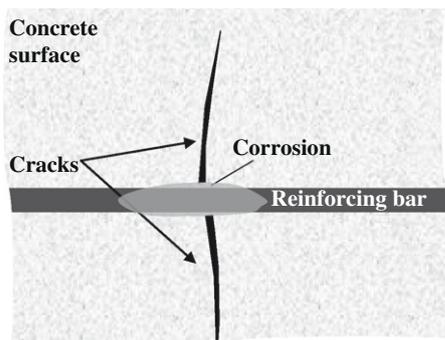
Fig. 1. Development of subsurface cracks by corrosion of rebar.

Subsurface cracking in concrete structures may occur due to corrosion of reinforcement if environmental agents penetrate into the material [3]. The layer of oxides formed on the bar, applies additional stresses in the concrete matrix, resulting in its cracking. These cracks propagate with the increase of corrosion, as well as due to thermal cycles and external loading (see Fig. 1). However, they are not visible until they break the surface. Therefore, their assessment by visual inspection is not possible until late. When they break the surface they accelerate the deterioration through the direct channel the crack supplies to water penetration in the structure. It is reasonable that an NDT methodology is demanded for the early assessment of the material's condition in order for

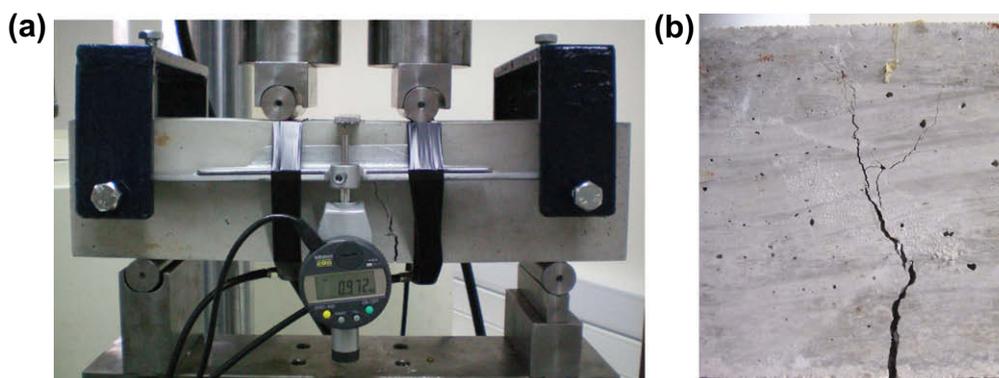
Fig. 2. (a) Experimental setup for four-point bending and (b) typical crack in SFRC.

In the present study, steel fiber-reinforced concrete prism specimens were subjected to four-point bending. This resulted in visible cracks propagating from the bottom, tensile side to the top. Due to the fiber action, the specimens were not separated in two parts and the crack was halted before reaching the compression side. An infrared camera was used to scan this side of the specimens at the cooling down stage after heating in an oven. The specimens were also examined by one-sided elastic wave measurements by means of resonant acoustic emission sensors in order to estimate the influence of the crack on basic wave parameters. The specific elastic wave problem was also numerically modelled in order to expand to different frequencies and crack geometries and propose suitable experimental parameters for in situ use.

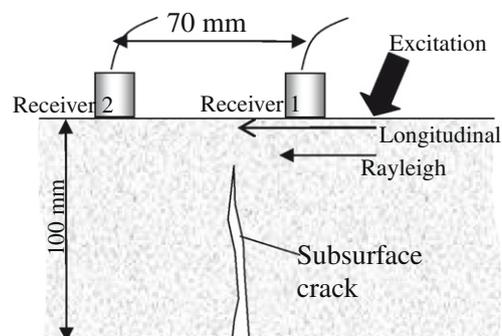
Fig. 3. Experimental setup for one-sided wave measurements.

The experimental setup for the elastic wave measurements is depicted in Fig. 3. Two sensors were placed on the intact side of the specimen at a distance of 70 mm. The excitation was conducted by pencil lead break which introduces a frequency band up to approximately 200 kHz. The sensors were common acoustic emission transducers (Physical Acoustics, PAC R6), with nominal maximum sensitivity around 60 kHz with very good response up to 150 kHz, and diameter of 15 mm. The sampling frequency of the acquisition board was set to 5 MHz. This kind of ultrasonic set up is commonly used in monitoring of concrete structures [4,10].

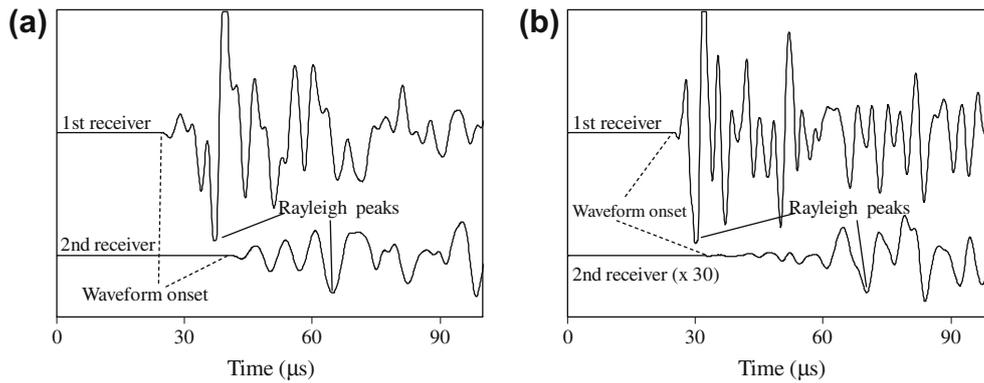
Fig. 4. Typical waveforms for (a) sound material and (b) subsurface cracked material.

Wave velocity was measured by the time delay between the waveforms collected at the different sensors. Typical waveforms recorded on sound material are depicted in Fig. 4a. For pulse velocity determination the first disturbances (wave onsets in Fig. 4a) were used. The onset corresponds to the longitudinal wave which is the fastest type. Rayleigh wave velocity was measured by the strong characteristic peaks (see again Fig. 4a) of the Rayleigh waves which stand higher than the initial longitudinal arrivals due to their higher energy [16]. Fig. 4b shows typical waveforms for the case of a subsurface cracked concrete specimen. The waveform of the 1st receiver is similar to the intact case; however, the waveform recorded by the second receiver is much lower in amplitude and therefore for presentation purposes it is magnified by 80 in the figure. In some cases with severe cracking it was difficult to discriminate the Rayleigh peak. However, this shows that the crack has cut through the whole cross section. The measurements were repeated 20 times by slightly translating and rotating the receivers' array around the crack in order to study also the exper-

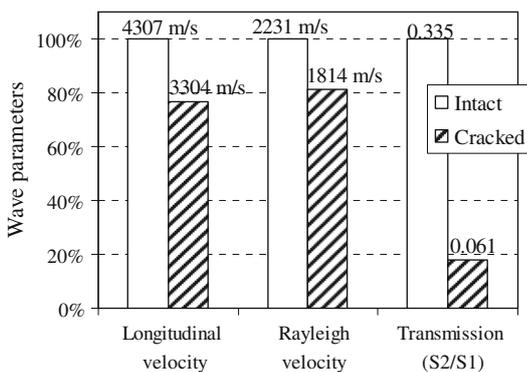
Fig. 5. Measured elastic wave parameters.

The longitudinal wave velocities measured on healthy SFRC specimens averaged at 4307 m/s. The average velocity measured on the portion of the specimens with subsurface damage, decreased by more than 20% to 3304 m/s, as can be seen in Fig. 5. Rayleigh wave results were similar, since the velocity was decreased by 19% from 2231 to 1814 m/s. Apart from wave velocities another parameter which is very sensitive to damage is the attenuation which is connected to the amplitude of the waveforms. Due to different mechanisms such as absorption, scattering and geometric spreading, the 2nd receiver receives lower amplitude than the first. In addition to that, the existence of the subsurface crack, depending on its location, causes the reflection of a major part of the wave energy further reducing the amplitude on the second receiver. Considering the absolute maximum amplitude recorded by the 2nd receiver divided by the amplitude recorded by the 1st, the ratio is 0.335 for sound material. In the case of subsurface damage, this ratio decreases to 0.061, being reduced by more than 80% (see Fig. 5). This is another case that shows the high sensitivity of attenuation parameters to the existence of damage [17].

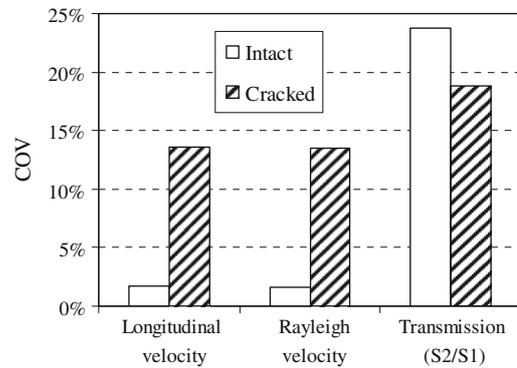
Fig. 6. COV for different elastic wave parameters.

taking a number of individual measurements will result in a slight statistical variation on the measured properties compared to the case of a more homogeneous material. Furthermore, in case of damaged concrete, the random shape of the cracks is expected to increase the variability. This is due to different parameters like the angle of wave incidence on the crack, and different crack-bridging points. Fig. 6 shows the experimental scatter, expressed by the coefficient of variation, COV (standard deviation divided by the average of 20 measurements). The experimental scatter for both longitudinal and Rayleigh is strongly increased for cracked material. The sound concrete exhibits very similar measurements with COV less than 3%. However, for the cracked concrete, COV is about 14%. On the other hand the COV of the amplitude measurements was already high enough (more than 20%). This is reasonable due to the known sensitivity of attenuation on the microstructure. Concerning the cracked material this parameter was slightly decreased. In general it can be said that when the equipment is set in the field for monitoring, instead of just one, a more representative number of measurements can be taken, providing another very sensitive-to-damage parameter; besides the velocity value drop which may be around 20%, as seen in Fig. 5, the scatter of the velocity measurements (COV) increases much more clearly (i.e. approximately 400%) when damaged material is examined.

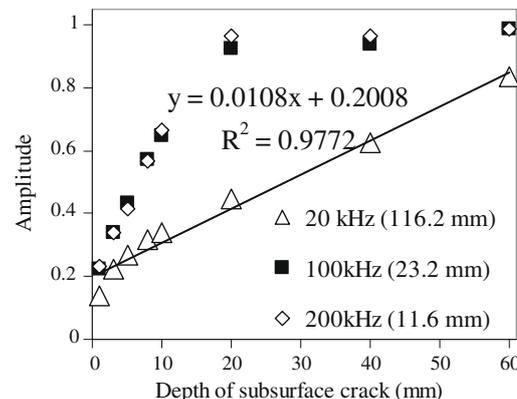
Fig. 8. Amplitude vs. depth of subsurface crack. (The number in parenthesis correspond to the wavelength.)

From the parameters examined, amplitude proved the most sensitive to the depth of the crack. It is briefly mentioned that P-wave velocity was hardly influenced even for the shallowest crack of 1 mm, while Rayleigh wave velocity exhibited a decrease of 5% when the low frequency of 20 kHz was applied. Fig. 8 shows the

amplitude of the 2nd receiver's waveform for different depths of crack after normalization to the amplitude of the 2nd receiver for sound material. The amplitude decreases strongly, especially for very shallow cracks reaching a value approximately 20% of the sound case. As the healthy part below the surface increases (the depth of crack increases), the amplitudes of the 100 and 200 kHz waves are restored to the reference level, meaning that these frequencies lose their sensitivity for cracks deeper than 20 mm (see Fig. 8). However, the amplitude of 20 kHz shows a slow rate of increase until even the subsurface crack of 60 mm depth. The amplitude vs. depth line can be roughly considered linear, showing that a positive estimation may be conducted based on the amplitude of the wave which proves to be the most sensitive parameter in order to characterize the depth of the crack. This is in accordance to the experimental measurements, which, as presented in Fig. 5, show that the amplitude of the wave is the most sensitive parameter to the underlying damage. Simulations for deeper cases were not conducted since the cracks considered in this case, originate from

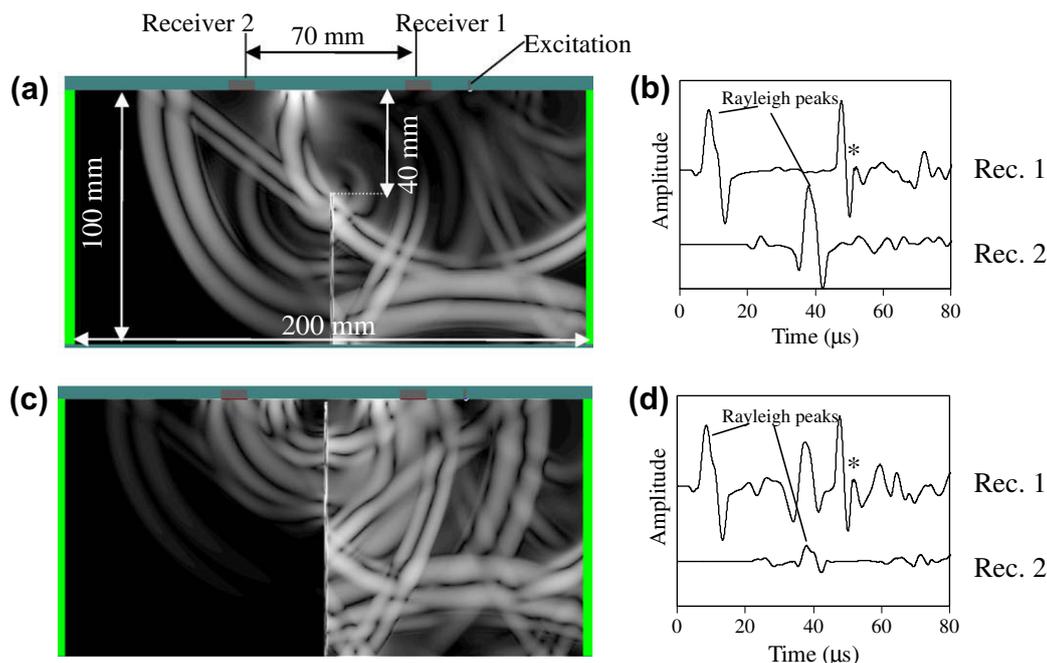
Fig. 7. (a) Snapshot of the displacement field for a specimen with a subsurface crack  $40 \text{ mm}$  below the surface and (c)  $1 \text{ mm}$  below the surface, (b) and (d) waveforms obtained for the simulation of (a) and (c) correspondingly. The excitation is one cycle of  $200 \text{ kHz}$ .

The geometric model was of rectangular shape with  $100 \text{ mm}$  thickness to resemble the experimental specimen, see Fig. 7a. The mesh size of the calculation was set to  $0.2 \text{ mm}$  much smaller than the longitudinal wavelength of  $43 \text{ mm}$ , and the Rayleigh of  $24 \text{ mm}$  ensuring accurate solution. In order to reduce the calculation time, the specimen's length was reduced to  $200 \text{ mm}$  and infinite boundary conditions were applied to the opposite sides, cancelling the reflections from the edges. The two simulated receivers were  $15 \text{ mm}$  long to resemble the actual transducers and were placed on the top side of the specimen with a separation of  $70 \text{ mm}$ . The receivers computed the average lateral displacement on their defined length. The simulated cases concerned the crack-free geometry as well as geometries with subsurface cracks. The intact layer between the surface and the crack (depth of crack) was varied, namely at  $60, 40, 20, 10, 8, 5, 3$  and  $1 \text{ mm}$ . The crack had a thickness of  $1 \text{ mm}$ . Fig. 7a shows the displacement field for the specimen with a subsurface crack  $40 \text{ mm}$  below the surface. The snapshot corresponds to time  $32 \mu\text{s}$  after the excitation of one cycle of  $100 \text{ kHz}$ . Fig. 7b shows the waveforms obtained after the completion of the simulation of this case. The characteristic Rayleigh cycle can be distinguished for both receivers. In the case of the 2nd receiver, the initial longitudinal arrivals are clearly seen before the Rayleigh cycle since the path is sufficiently long for the individual modes to be separated due to different velocities. The second strong cycle recorded by the first receiver (marked by an

asterisk) is the reflection of the longitudinal wave from the bottom side of the beam.

Fig. 7c shows the corresponding case of a subsurface crack,  $1 \text{ mm}$  below the surface, while the waveforms are included in Fig. 7d. Since the crack is close to the surface only a small amount of energy can propagate towards the 2nd receiver. The displacement field is distorted while the waveform of the 2nd receiver is much lower in amplitude since most of the energy is reflected back

by the discontinuity. In any case the Rayleigh contribution is clear on both receivers and velocity measurements are enabled. The longitudinal reflection is again seen on the response of receiver 1, as well as another strong cycle earlier at approximately  $40 \mu\text{s}$ , which is the reflection of the Rayleigh on the crack. This reflection was not present in Fig. 7b because the depth to crack was long enough to allow most of the energy to propagate.

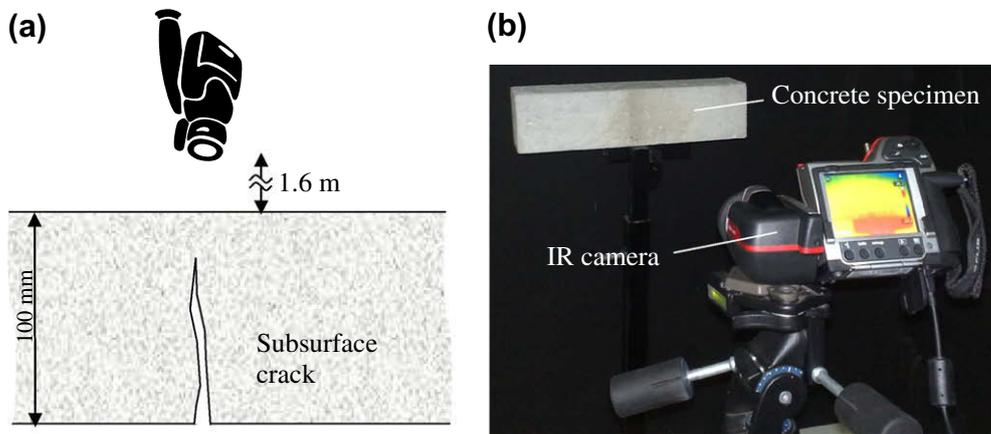
Fig. 9. Representation (a) and photograph (b) of the IR thermography experimental setup.

The experimental setup constituted from an infrared camera and an oven. The infrared camera was the Flir T360. The main characteristics of the infrared camera are summarized in Table 1. The energy source employed for the heating of the specimens was an oven with temperature range 20–200 °C.

Four specimens were heated in an oven for 3 h at 90 °C. The infrared camera was placed at 1.6 m distance from the specimens, as seen in Fig. 9a and b. The thermal emissivity of concrete is 0.92 [6] and there was no need to paint the surface. Experiments were conducted in laboratory under constant conditions of air tempera-

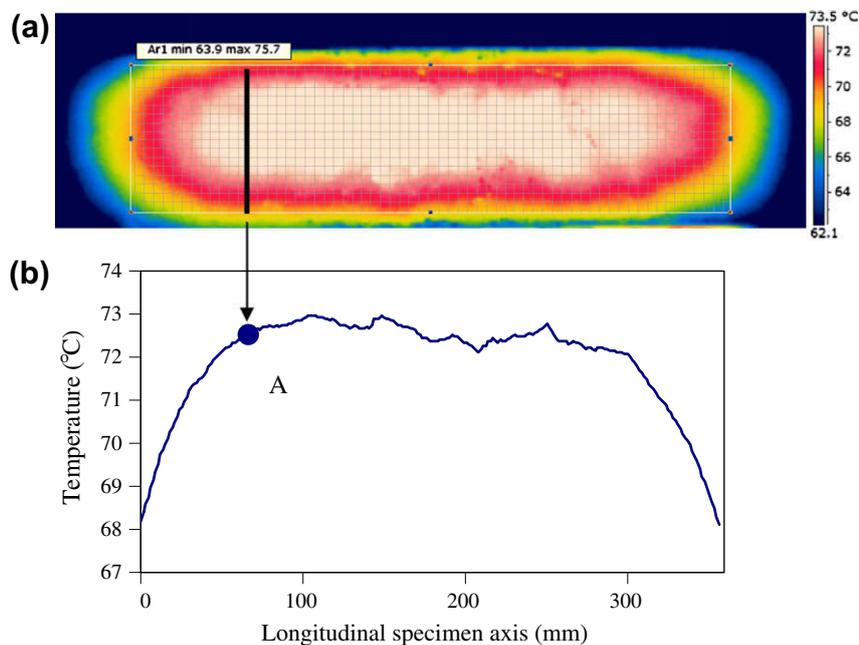
Fig. 10. (a) Thermograph of an intact specimen and (b) average temperature for the axis of specimen.

Fig. 10a shows the thermograph of a healthy specimen. The temperature field is homogeneous in the center of the specimen while there is accelerated cooling near the edges of the specimen. In order to enhance the detection, the scanned area was divided with a mesh size of 1.5 mm. This was done in order to obtain a deterministic parameter connected to the geometry of the specimen that indicates the position of the possible defect. Concrete usually has some visible surface defects like air bubbles that can act as temperature release points. Therefore, they are also captured by the infrared camera and may mislead the characterization. In order to reduce this possibility, the average temperature of the nodes of each vertical line of the mesh was calculated. A small surface defect like air bubble can locally change the temperature reading of only a few nodes. However, these nodes cannot change the average value of the vertical line which is made up by the temperature of 50 nodes. This average temperature line for the sound specimen is depicted in Fig. 10b. As an example, a specific point (e.g. A in Fig. 10b), is calculated as the average of all the points included in the corresponding vertical bold line of Fig. 10a. The temperature line remains approximately constant for the center of the specimen while closing at the edges it decreases smoothly. This

line of average temperature will prove useful for the case of subsurface damage, where the anomaly imposed to the temperature field is not much stronger than the anomaly of small surface defects.

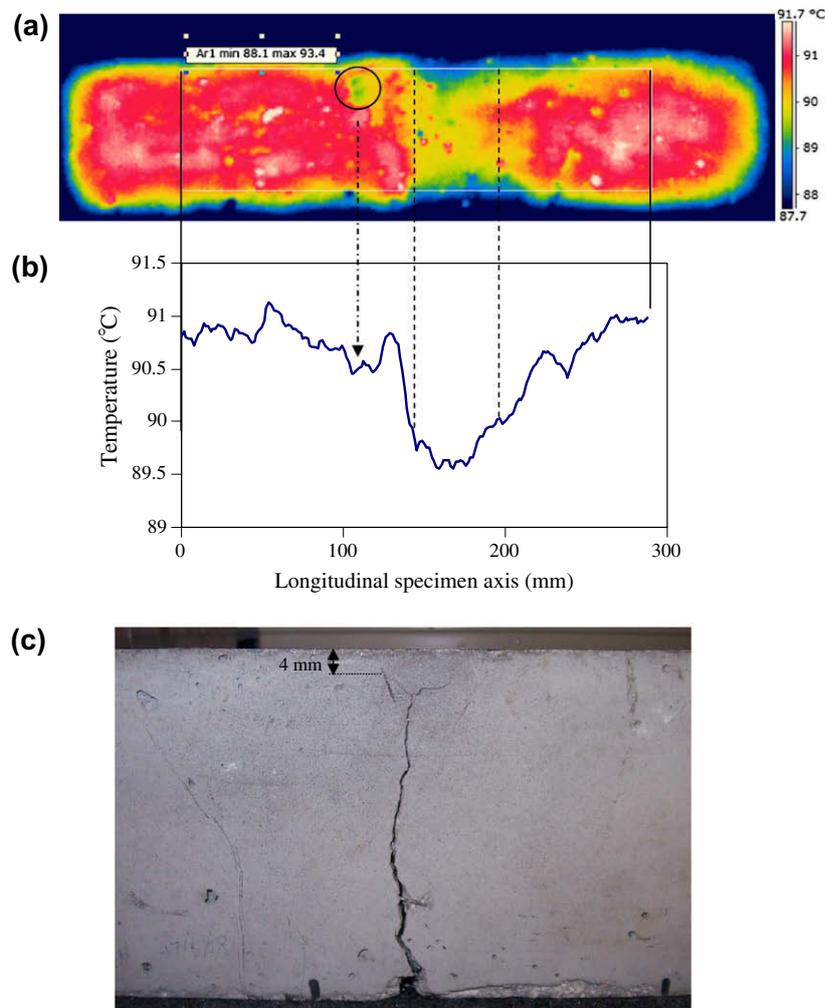
Fig. 11. (a) Thermograph of a specimen with 2 mm center deflection, (b) average temperature for the axis of specimen and (c) side view of the specimen.

Fig. 11a shows the thermograph of a subsurface cracked specimen. The temperature field shows a considerable variation on the area of the defect. In this case the crack corresponds to the middle specimen deflection of 2 mm. For a span of approximately 40 mm the temperature is lower by more than 1 °C than the rest of the specimen. The image by itself is indicative of the subsurface defect area. This can be confirmed by the average temperature line in Fig. 11b that clearly shows a wide local minimum at the area of 150–190 mm, which would be the area to examine by ultrasonic sensors in an actual case. It is mentioned that in certain locations due to small surface anomalies, as indicated by the circle in Fig. 11a, the temperature is similar to the temperature on top of the defect. However, these points create a moderate local minimum on the temperature curve and therefore cannot “mask” the characterization of the defective area. Fig. 11c shows the side view of the specific specimen. The crack split close to the top side

increasing the subsurface anomaly and favoring the characterization by infrared radiation. The crack tip was approximately 4 mm below the surface.

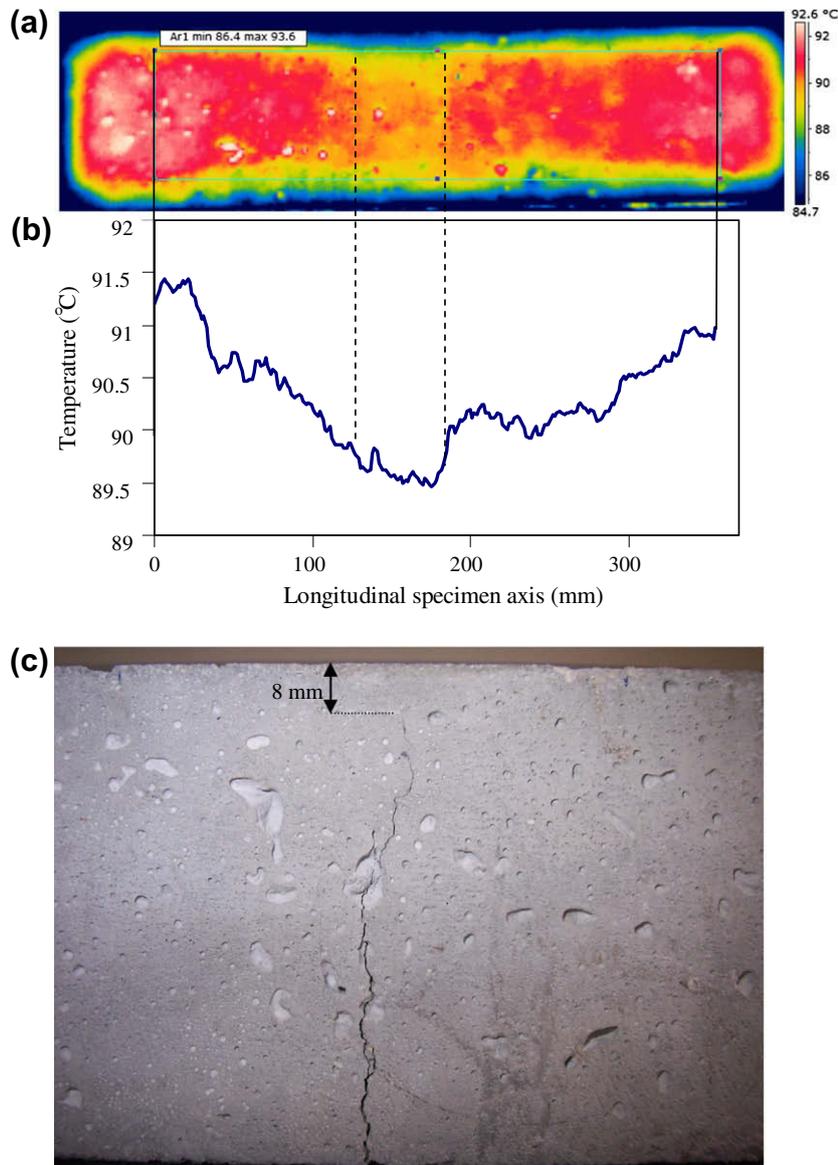
Fig. 12. (a) Thermograph of a specimen with 1.5 mm center deflection, (b) average temperature for the axis of specimen and (c) side view of the specimen.

The thermograph obtained for a crack created until the mid span deflection of 1.5 mm, is seen in Fig. 12a. The lower temperature field near the center of the specimen is again visible in the thermograph and the curve of Fig. 12b shows a clear minimum again indicating safely the troublesome area to be examined by ultrasound, although the crack was approximately 8 mm below the surface, as seen in Fig. 12c.

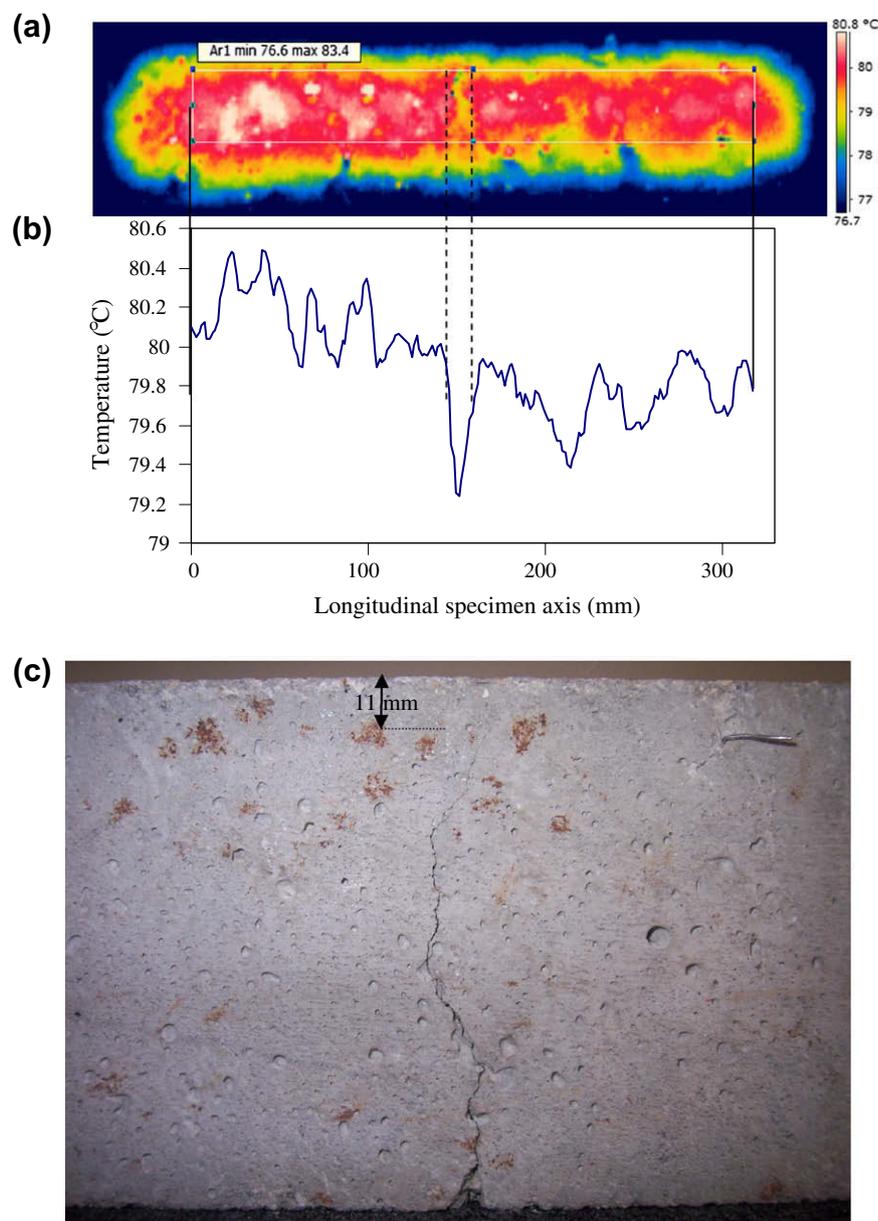
Fig. 13. (a) Thermograph of a specimen with 1 mm center deflection, (b) average temperature for the axis of specimen and (c) side view of the specimen.

The last case concerns the smallest crack, corresponding to mid span deflection of 1 mm. The temperature field is not clear in this case, since the anomaly imposed by the subsurface defect is less than 1 °C, see Fig. 13a. There are several other fluctuations of the same range and eye examination of the thermograph could lead to different suspicious points due to surface defects. In this case the average curve proves a strong tool because of the sharp local minimum at the position of the defect, which is also global minimum (Fig. 13b). The minimum at 150 mm corresponds to the position of the tip of the crack. The crack tip is approximately

11 mm below the surface, as seen in Fig. 13c. If another strong minimum is observed, as for instance the minimum on 210 mm in Fig. 13b, the specific position can also be scanned by ultrasonics for safety reasons, since the measurements take just a few minutes. In case there is no subsurface defect this will be safely demonstrated by the wave parameters which will not be influenced.

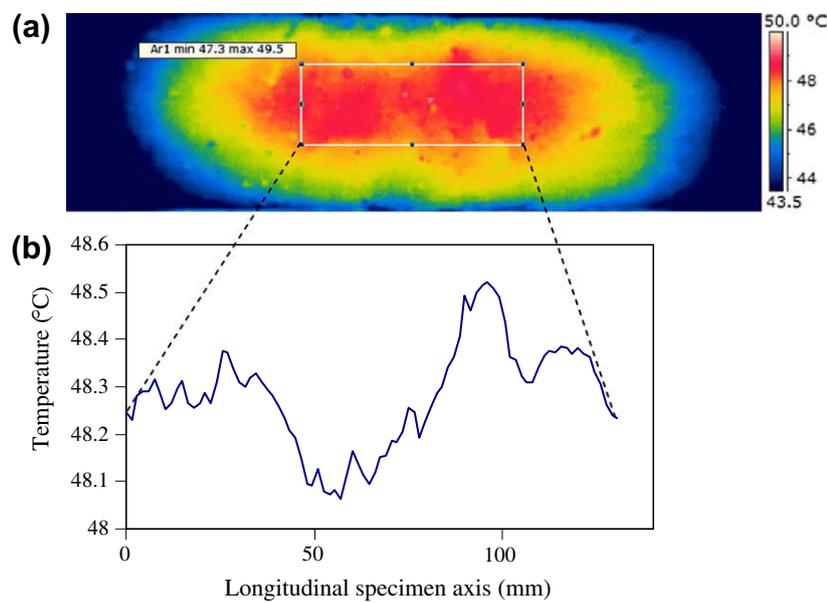
Fig. 14. (a) Thermograph of a specimen with 2 mm center deflection and (b) average temperature for the axis of specimen.

Specifically, Fig. 14a shows the thermograph of the specimen with 2 mm deflection and Fig. 14b shows the average temperature line in the white rectangle of Fig. 14a. The drop of temperature is exhibited by the wide minimum around 50 mm. The difference is small but it can be recorded due to the sensitivity of the camera.

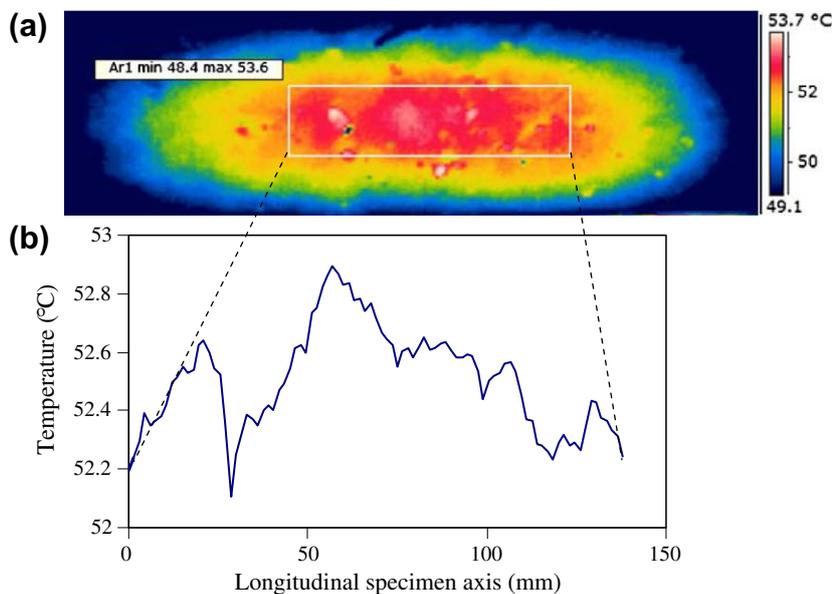
Fig. 15. (a) Thermograph of a specimen with 1.5 mm center deflection and (b) average temperature for the axis of specimen.

Additionally, the specimen with deflection 1.5 mm is depicted in Fig. 15a. Although a sharp minimum is exhibited in the temperature curve of Fig. 15b at 30 mm, which actually corresponds to the position of the crack tip, it is evident that a few centimeters to the left (start of the axis), as well as after 100 mm the temperature decreases due to heat convection from the sides. This demonstrates that larger specimens should be examined in order to exclude the edge effects.
