Real-Time Debonding Monitoring of Composite Repaired Materials via Electrical, Acoustic, and Thermographic Methods

S.A. Grammatikos, E.Z. Kordatos, T.E. Matikas, and A.S. Paipetis

Keywords aerospace composites, non-destructive evaluation, repair

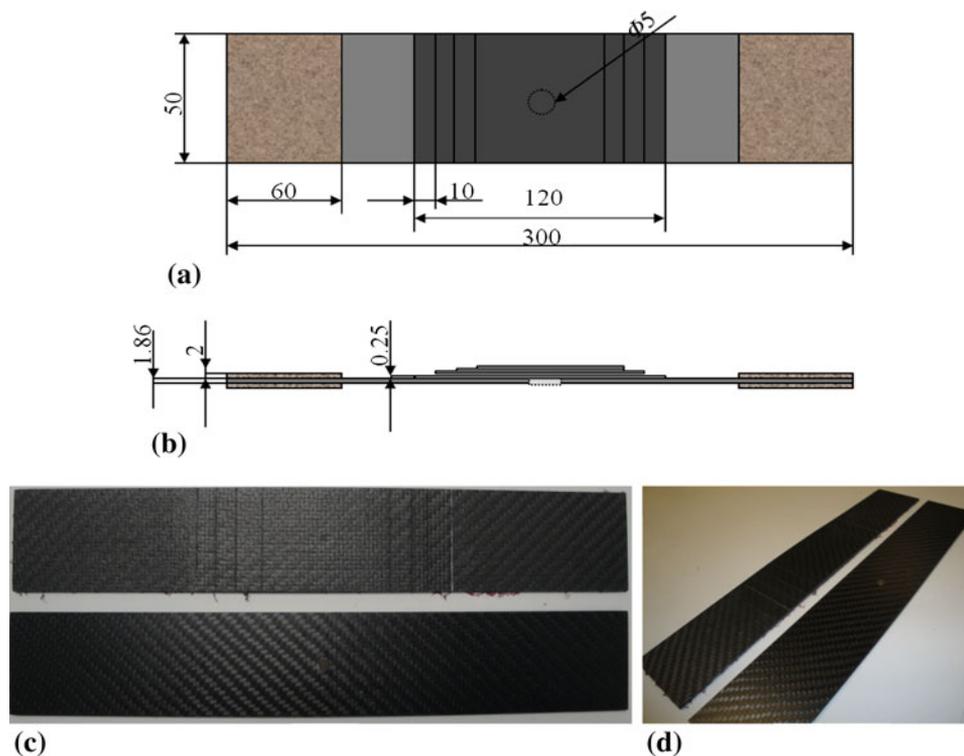
Fig. 1 (a, b) Schematic configuration of the employed specimen, (c, d) snapshots of both front (patched) and back side of the specimens

The patch was applied in layers using the conventional wet lay-up, using a tapered geometry in order to minimize the high shear stress fields at the edges of the repair. The pre-impregnated layer dimensions were $120 \times 50 \text{ mm}^2$ (1st ply), $100 \times 50 \text{ mm}^2$ (2nd ply), $80 \times 50 \text{ mm}^2$ (3rd ply), and $60 \times 50 \text{ mm}^2$ (4th ply) (Fig. 1). Curing of the patch on the substrate was performed in an autoclave as follows: (i) reaching 0.98 bar vacuum condition, (ii) increase of vacuum pressure to 6.2 bar, (iii) increase of temperature at $120 \text{ }^\circ\text{C}$ with $3 \text{ }^\circ\text{C}/\text{min}$ rate, (iv) retaining stable vacuum pressure and temperature for 10 min, (v) decrease of temperature at $80 \text{ }^\circ\text{C}$ with $-3 \text{ }^\circ\text{C}/\text{min}$ rate, and finally (vi) vacuum pressure release. In Fig. 1, the final

coupon configuration is depicted. Finally, $50 \times 60 \text{ mm}^2$ end tabs were attached on the composite coupons using high shear adhesive (Epibond 1590 A/B, Huntsman), in order to prevent failure at the gripping area.

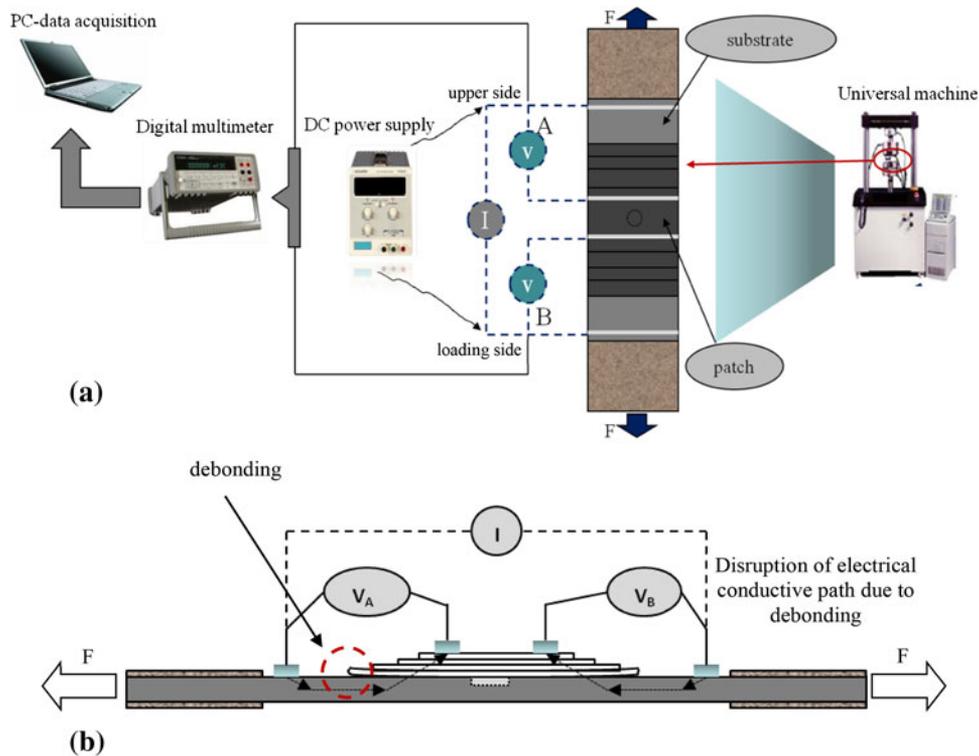
Fig. 2 (a) EPCM experimental setup, (b) EPCM measurement approach

For the EPCM measurements, electrically conductive contacts at specific locations were applied on the surface of the coupons using a conductive silver paint (Fig. 2). Commercially available silver paint and silver-loaded tape (RS-components) (Fig. 2a) were subsequently used in order to connect the cables of the multimeter (Agilent Technologies) connected to a PC for data acquisition and the DC power supply (XANDREX HPH 18-10DC). 150-mA direct current was injected in the specimen during mechanical loading and the electrical potential variation was concurrently recorded on both sides of the notch (V_A and V_B) (Fig. 2b).

As is shown in Fig. 2(b), the electrically conductive path between the substrate and the repair is formed through the patch/substrate interface. Apart from the conductive primary reinforcement, i.e., the carbon fibers, the electrical continuity between the repair and the substrate was enhanced in the transverse direction by the electrical conductive network formed by the CNTs in the matrix of the patch. As the conductive path includes the interface of the patch and the substrate, any changes in the form of debonding are expected to affect it directly. More analytically, as the debonding front propagates, the electrical potential values are expected to change monotonically. Thus, the evolution of the debonding during mechanical testing should result in the increase of the resistance or the potential drop between the measuring points.

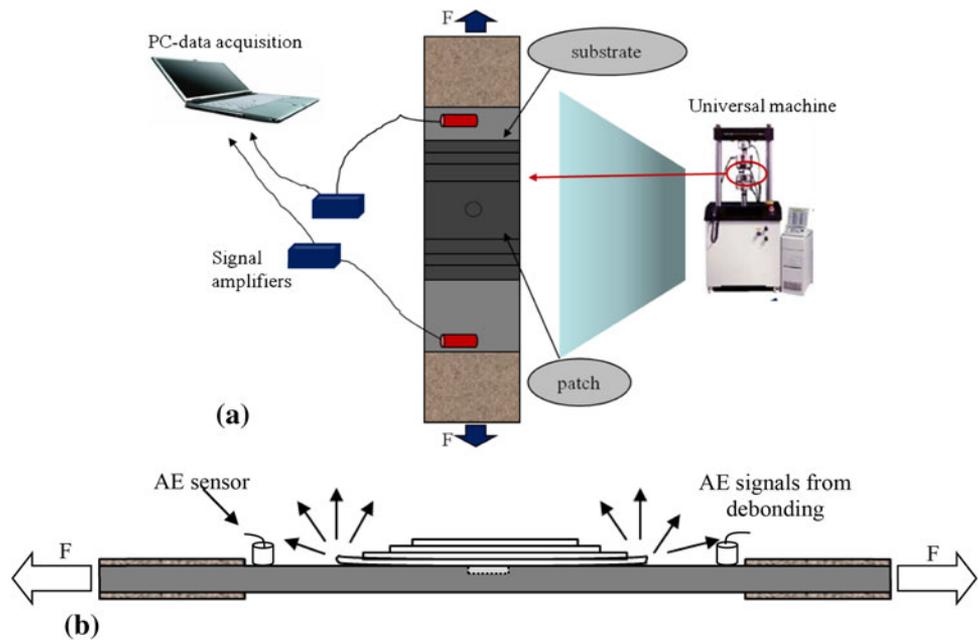
Fig. 3 (a) Schematic representation of AE technique, (b) AE signal measurement principle

For the AE monitoring, two broadband piezoelectric transducers (Pico, Physical Acoustics Corp., PAC) were attached on the specimen as shown in Fig. 3(a) and (b) at a specific distance (80 mm). Ultrasonic gel was applied for the acoustic coupling. The pre-amplifier gain was set to 40 dB. After performing a pilot test, the threshold was also set to 40 dB, in order to avoid electronic/environmental noise. The

As is depicted in Fig. 3(b), the propagation of the patch debonding front causes the generation of AE hits. The simultaneous recording by the two broadband AE sensors allowed for the locating of the events due to debonding, along the length of the specimen. Thus, cumulative AE signals on

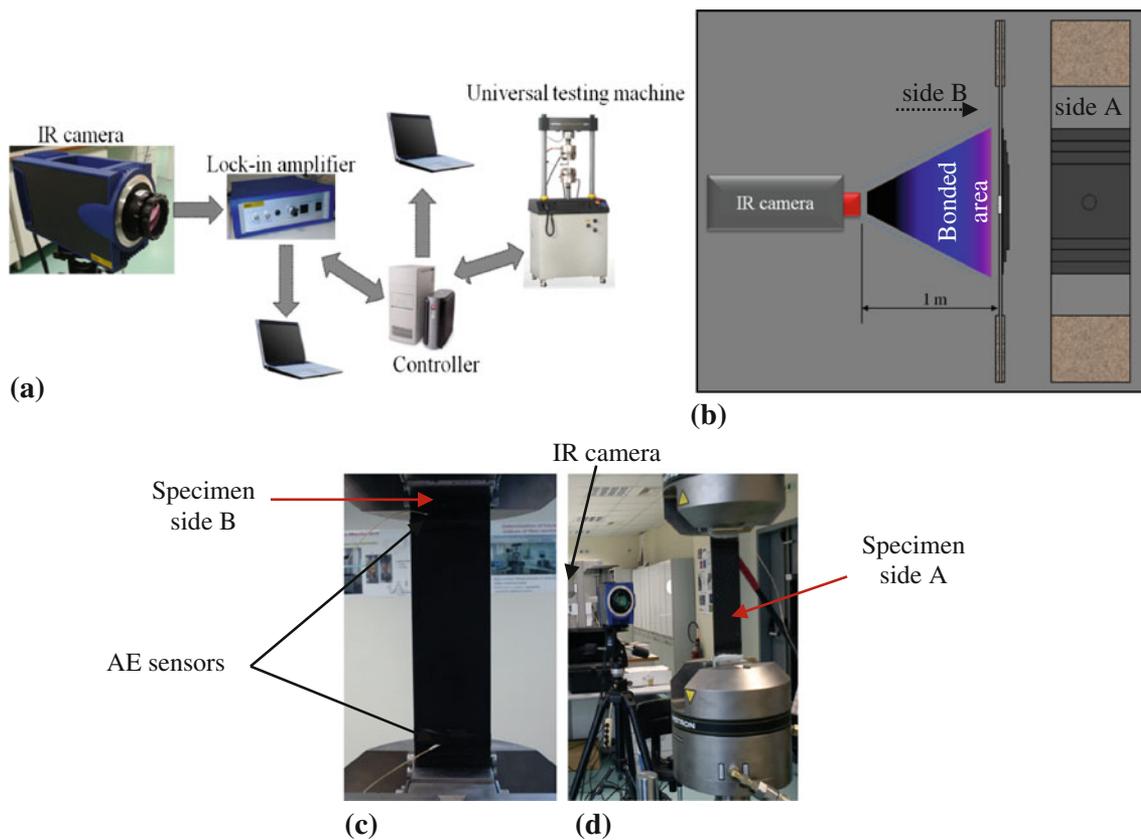
Fig. 4 (a) Schematic of the thermographic experimental setup, (b) recorded FOV of the thermal camera

For the thermographic inspection, the Jade 510-CEDIP-MW infrared camera was used (Fig. 4). The camera employs a cooled indium antimonide (InSb) detector (3-5 μm), with a frame rate from 50-150 Hz and a focal plane array pixel format of 320×240 . The thermal sensitivity of the camera is lower than 25 mK at 25 $^{\circ}\text{C}$ and the resolution 0.001 $^{\circ}\text{C}$. The camera was employed in the lock-in mode at a frame frequency of 50 Hz. The cyclic loading imposed by the loading frame was 5 Hz. For the purposes of this work, the camera was positioned at approximately 1-m distance from the specimen in order to include the whole patched area in the field of view (FOV) of the camera (Fig. 4a, b). At this distance, the corresponding FOV was $208 \times 156 \text{ mm}^2$ with a lateral and perpendicular resolution of 0.65 mm/pixel. Figure 4(c) and (d) shows snapshots of the experimental setup of the second pair, IrT versus AE. In the aforementioned configuration, the cyclic loading is the source of thermal excitation of the material. As has been shown in a previous publication, debonding is manifested in the amplitude domain as a distinct discontinuity in the grayscale area, delineated by a hot zone which indicates the stress concentration at the debonding front.

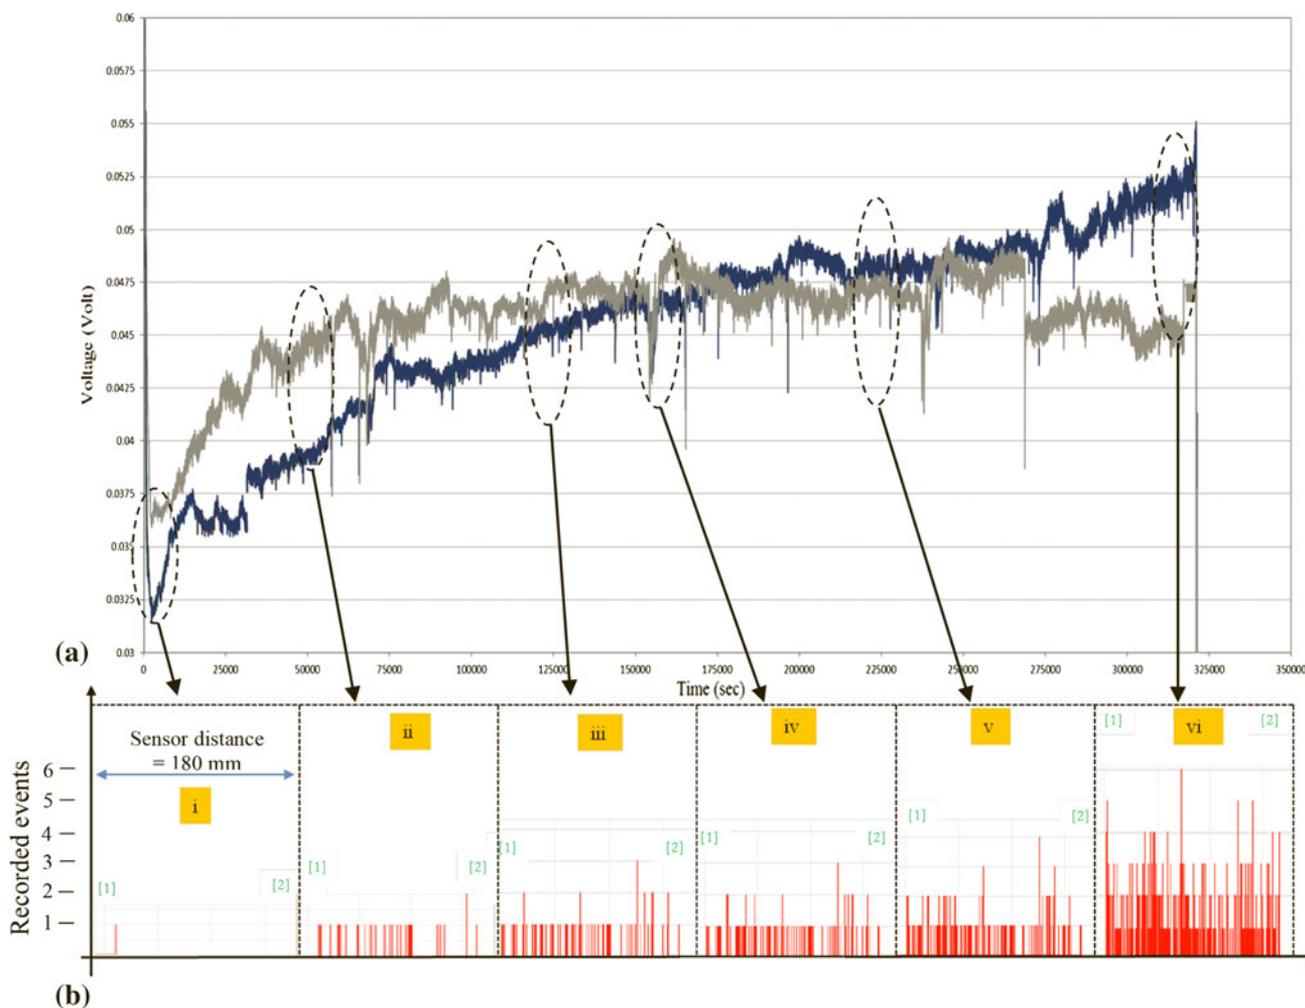
Fig. 5 (a) EPC along with (b) the AE signals during the fatigue mechanical testing

3.3.1 EPCM & AE. Figure 5 depicts the electrical potential changes (EPC) (Fig. 5a) and the acoustic activity (Fig. 5b) recorded during the fatigue mechanical testing of one of the two tested coupons as a function of the loading cycles.

The bottom side indicates the side at which the load was introduced by the loading frame. Both EPCM channels are depicted. The polarity was chosen so that increase in potential values corresponds to increase in the resistance of the monitored closed circuit, which would be the expected result from the propagation of the debonding front. With the selected formality, relative potential increase corresponds to increase in “potential drop” due to electrical resistance increase. AE activity snapshots are overlaid on the EPCM graphs indicating the location of the recorded events at specific instances during the experiment corresponding to the indicated EPCM measurements. The cumulative AE hits for the total duration of the experiment are shown in Fig. 5(b).

Following the aforementioned decrease, the EPC is differentiated from the top to the bottom channel. The top channel (gray line) exhibits a small increase in potential of approximately 10 mV from its minimum value and thereafter the potential values oscillate around a mean (0.045-0.047 V) value, suggesting the existence of the “stick-slip” mechanism which, however has reached a steady state. However, the EPC for the bottom channel exhibits a monotonic increase until the specimen failure. This increase is more than 30 mV from the minimum recorded value. The sudden potential drop at the end of the fatigue life obviously indicates loss of continuity due to specimen failure, which occurred with the critical failure of the bottom part of the patch followed by brittle transverse failure at the vicinity of the notch. Obviously, EPCM was successful in identifying the most probable failure site of the patch coupon, as after the initial stage, progressive critical failure was clearly manifested as monotonic potential increase of the bottom part of the coupon. The relative potential increase values as a function of fatigue life fraction for the bottom part of the coupon are shown in Fig. 6. Summarizing the aforementioned observations, EPCM (i) is capable of identifying the real-time resistance fluctuation within individual fatigue cycles, (ii) indicates the characteristic stick-slip behavior which relates to the progressive debonding of the patch due to fatigue, and most importantly (iii) is capable of clearly identifying the preferential side of failure of the patch.

As far as AE is concerned, the acoustic events as recorded at the same time with the electrical potential values are shown in Fig. 5(b). Snapshots of the cumulative acoustic events are presented as a function of the sensor positions. Events correspond to acoustic activity recorded within the time difference that sound travels within the length of the coupon. The differential arrival time allows for the calculation of the location of the sound source. The acoustic events which reflect the presence and location of damage start to appear from the edges of the repair (critical damage) moving along the center of the specimen indicating the debonding of the repair. As should be noted, the bottom part of the coupon (blue EPCM channel in

Fig. 5a) corresponds to the right side and the top part (gray EPCM channel in Fig. 5a) to the left side of the event location snapshots. The activity corresponding to the bottom channel appears consistently to be higher and this is indicative of the part where failure is most likely to take place. In the final stage of the test and prior to the final failure of the specimen, the recorded acoustic events are concentrated in the center of the specimen. At the same region, the coupon eventually failed due to the presence of the circular notch (subcritical damage). Summarizing, AE (i) is consistent with the observations made by EPCM and (ii) is capable of detecting subcritical failure at the end of the debonding process.

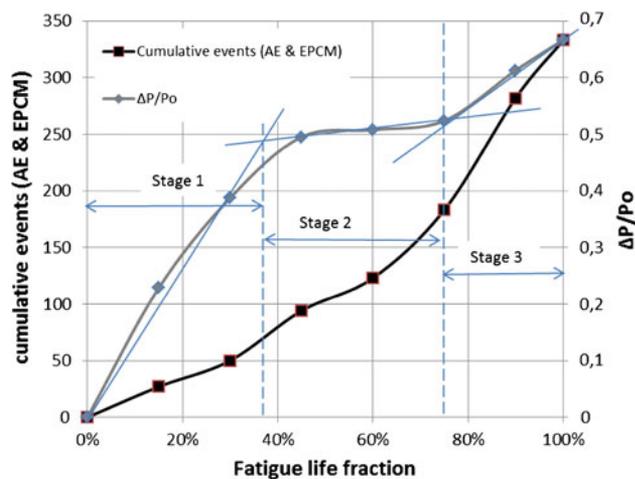
Fig. 6 Cumulative AE events and relative potential change as a function of fatigue life fraction; fatigue life stages that may be defined with EPCM are not obvious with AE

Figure 6 depicts the cumulative events as a function of fatigue life fraction together with the relative potential change recorded by EPCM as a function of fatigue life fraction. As can be easily observed, both techniques exhibit a monotonic increase. It may be postulated that three fatigue life stages may be defined with EPCM as indicated by the successive changes in the slope of the depicted curve, i.e., the onset of damage marked as stage 1, the increase in damage rate marked as stage 2, and finally the rapid deterioration that inevitably leads to failure (stage 3). AE is not as efficient in clearly identifying all stages of the fatigue life. As should be noted, the potential change is typical of a fatigue life diagram as in a typical fatigue case, stage 1 should exhibit a higher damage rate than stage 2. Finally, Fig. 7 depicts the cumulative events versus the relative potential change. This may be regarded as typical benchmarking or calibration graph for EPCM against AE. As can clearly be seen, the benchmarking scheme of both NDE methods is efficient in highlighting the fatigue stages with approximately linear interdependence for each fatigue life stage. Indicative of the potential of the benchmarking approach is that the fatigue life stages are more clearly defined in Fig. 7 than independently for both techniques (Fig. 6).

3.3.3 Cross-Validation of the Applied NDE Techniques. Figures 6 and 9 clearly show that EPCM and IrT are capable of identifying three distinct fatigue stages. These stages are better highlighted when EPCM and IrT are interrelated with AE activity. In this way, the fatigue life stages are clearly defined. Interestingly enough though, the fatigue life stages are almost identical in the fatigue life fraction representation for the two studied configurations, i.e., stage 1 range ends at approximately 35-45% and stage 2 at approximately 60%. In other words, provided that the correlation between the AE activities in the two scenarios is satisfactory, an indirect cross-validation of IrT and EPCM may be performed; Fig. 11(a) depicts the AE activity versus lifetime fraction and Fig. 11(b) depicts the correlation of the cumulative events as recorded for the two distinct configurations. It is interesting to note that the fatigue life stages are clearly defined via the cross-correlation of the results for the two distinct configurations. Moreover, the cross-correlation of the acoustic activity for the two NDE scenarios presents an envelope which is directly relevant to the uncertainty provided by the indirect benchmarking of IrT versus EPCM as concurrent monitoring was not feasible with both techniques. Figure 12 depicts the benchmarking of IrT against EPCM; within the uncertainty of the approach, the indirect benchmarking of the two methodologies can be performed successfully in order to define the fatigue life stages as a function of the fatigue life fraction, providing a universal benchmarking for the two “incompatible” NDE methodologies (Fig. 12).

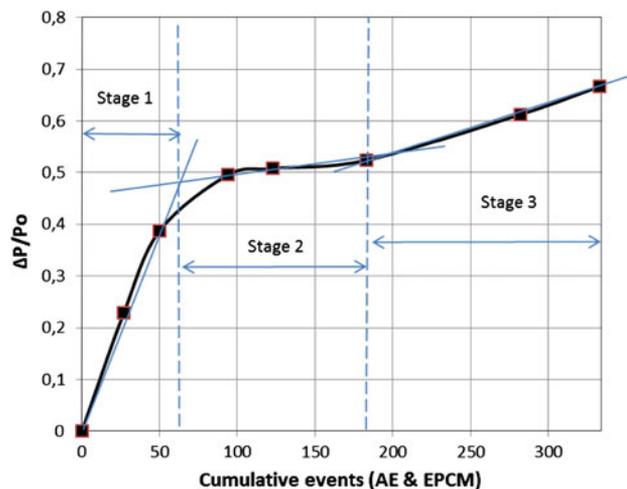
Fig. 7 Cumulative AE events vs. relative potential change

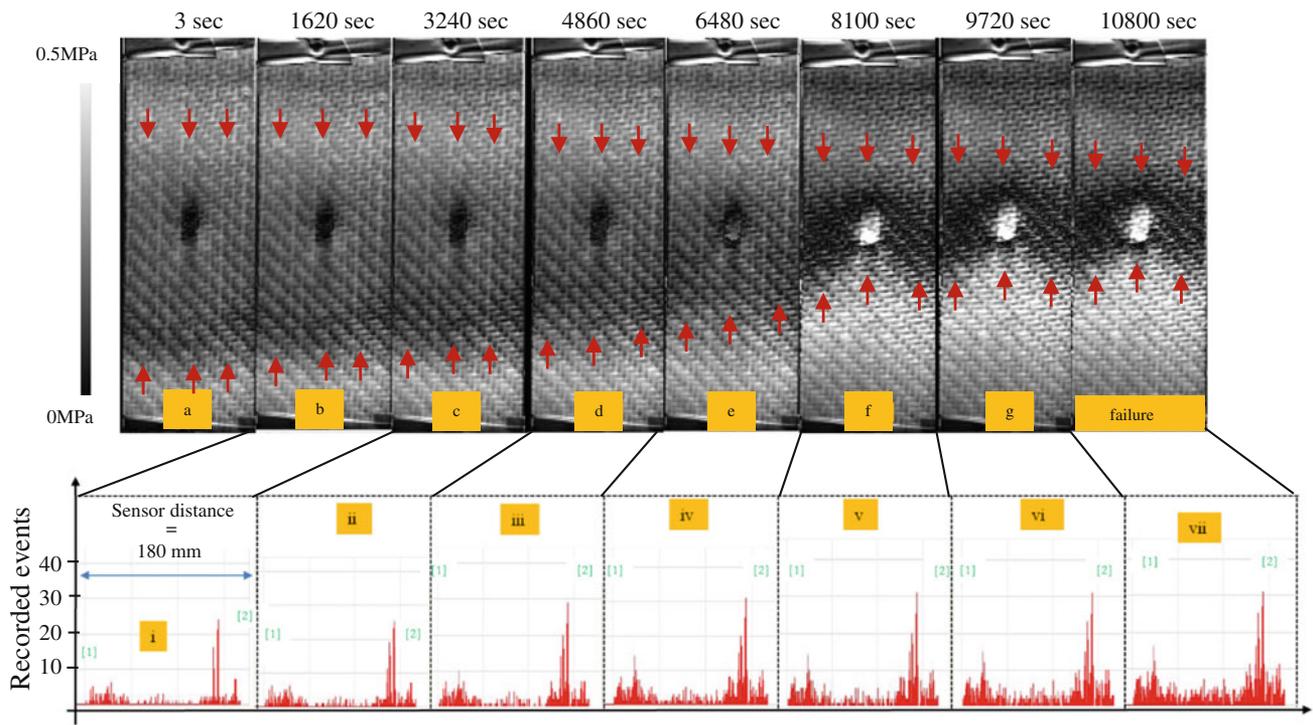
Fig. 8 Thermal images and acoustic events during fatigue mechanical loading at 80% of the σ_{UTS} of the substrate

3.3.2 IrT & AE. In the second testing configuration, IrT was employed together with AE simultaneously to the mechanical testing. Amplitude images at specific load cycles are shown in Fig. 8. As was observed, debonding initiated at the 80% of the σ_{uts} . Hence, only amplitude images at that load level are presented (Fig. 8).

As is depicted in Fig. 8(a) to (h), stress concentration areas are present at the edges of the repair (critical damage) or at the

loci where high stresses are expected to appear and are manifested in the amplitude domain as regions of increased intensity (Ref 26). With fatigue loading, the high amplitude region is constricted from the bottom side toward the center of the specimen, implying that as debonding progresses, the debonded bottom area is practically relieved from stresses which are concentrated toward the middle of the coupon. As can be seen from the amplitude image series, the progress of critical damage of the coupon continued until the complete debonding of the bottom side of the repair from the substrate, which consistently failed in a transverse brittle manner at the

notch edge. As is expected, the exposed “artificial” damage that is the circular notch caused a stress concentration leading to subcritical failure. The arrows on amplitude images show the direction of the patch debonding from the substrate.

Along with the thermal assessment, acoustic events were recorded at the same timing. In Fig. 8(i) to (vii), snapshots of the event location are presented for distinct cycles. As can be seen in Fig. 8(i), there is considerably more acoustic activity on the right-hand side which corresponds to the bottom part in the thermograph (Fig. 8a). As the fatigue progresses, the acoustic pattern is consistent (Fig. 8ii-vii) with considerably higher acoustic activity on the side where debonding is clearly

discerned in the thermographic images (Fig. 8b-h). Additionally, in Fig. 8(i) to (vi), the acoustic events indicate that the debonding process initiated from the edges of the patch and

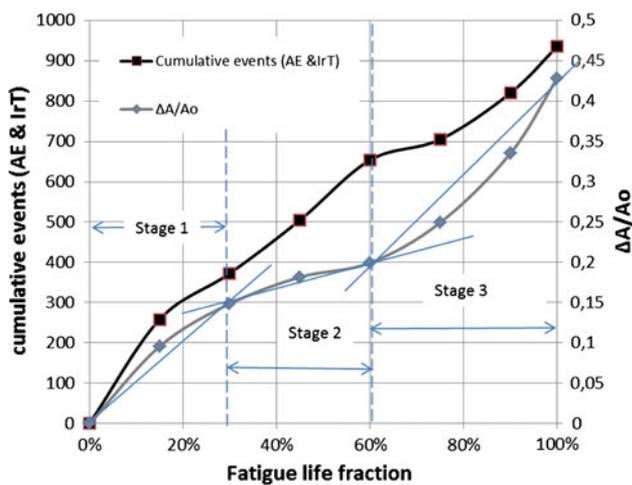
Fig. 9 Cumulative AE events and relative debonded area as a function of fatigue life fraction. Distinct fatigue life stages may be discerned with both methodologies

Figure 9 depicts both the relative debonded area and the recorded cumulative AE events versus the fatigue life fraction. As in the previous configuration, three distinct fatigue life stages are discernible with IrT, whereas this distinction is not obvious in AE. Again, the three fatigue stages as observed via the thermographic monitoring are typical of a fatigue life diagram, i.e., the initial fast damage progression stage (stage 1) is followed by a decreased rate (stage 2) and finally accelerates until failure (stage 3), indicating that the thermographic assessment provides a more reliable representation of damage which may also be readily quantified. This effect is more clearly depicted in Fig. 10, where the cross-correlation of the two methodologies is presented; in this representation, all three stages may be clearly defined, with the acoustic activity being directly proportional to IrT data for each consecutive stage.

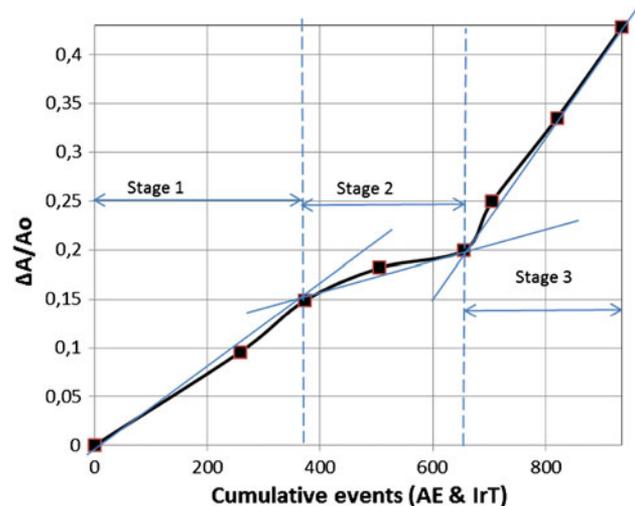
Fig. 10 Cumulative AE events vs. relative area change

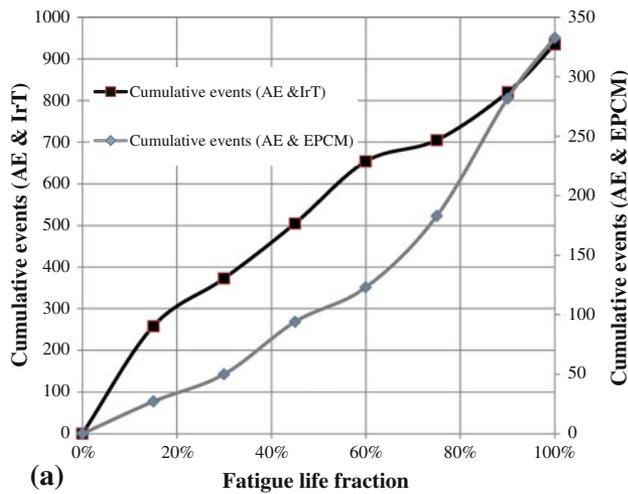
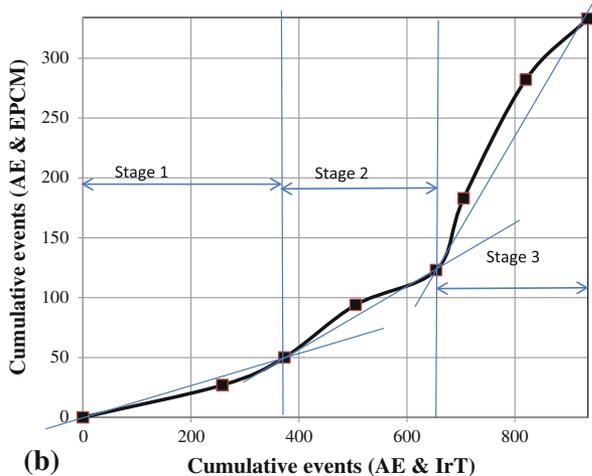
Fig. 11 (a) AE activity vs. lifetime fraction and (b) correlation of the cumulative events as recorded for the two distinct configurations

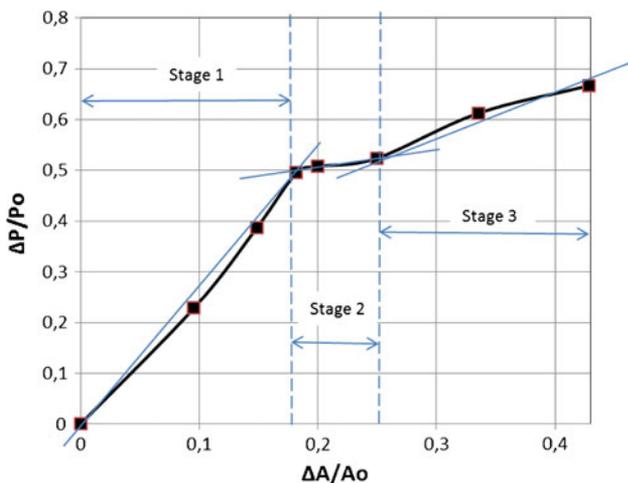
Fig. 12 Relative potential change vs. relative area change

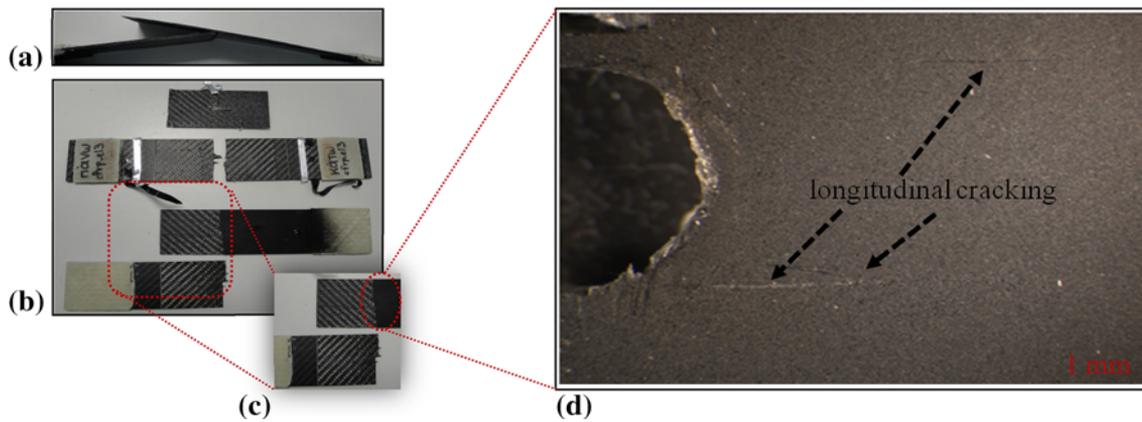
Fig. 13 (a, b, c) Post-failure images, (d) image taken via a stereoscope

Figure 13 depicts post-failure images (Fig. 13a-c) as well as stereoscopic (Fig. 13d) of a representative tested coupon. Longitudinal cracking (horizontal lines) on the surface of the

upper side of the broken specimen is visible in Fig. 13(d). The post-mortem images indicate the consistent type of failure as well as the characteristic behavior of the composite where longitudinal cracks blunt the stress concentration at the edge of the notch.
