Fast, Accurate, and Reliable Detection of Damage in Aircraft Composites by Advanced Synergistic Infrared Thermography and Phased Array Techniques

Abstract: This paper presents an advanced methodology for the detection of damage in aircraft composite materials based on the sensor fusion of two image-based non-destructive evaluation techniques. Both of the techniques, phased-array ultrasonics and infra-red thermography, are benchmarked on an aircraft-grade painted composite material skin panel with stringers. The sensors systems for carrying out the inspections have been developed and miniaturized for being integrated on a vortex-robotic platform inspector, in the framework of a larger research initiative, the Horizon-2020 ‘CompInnova’ project.

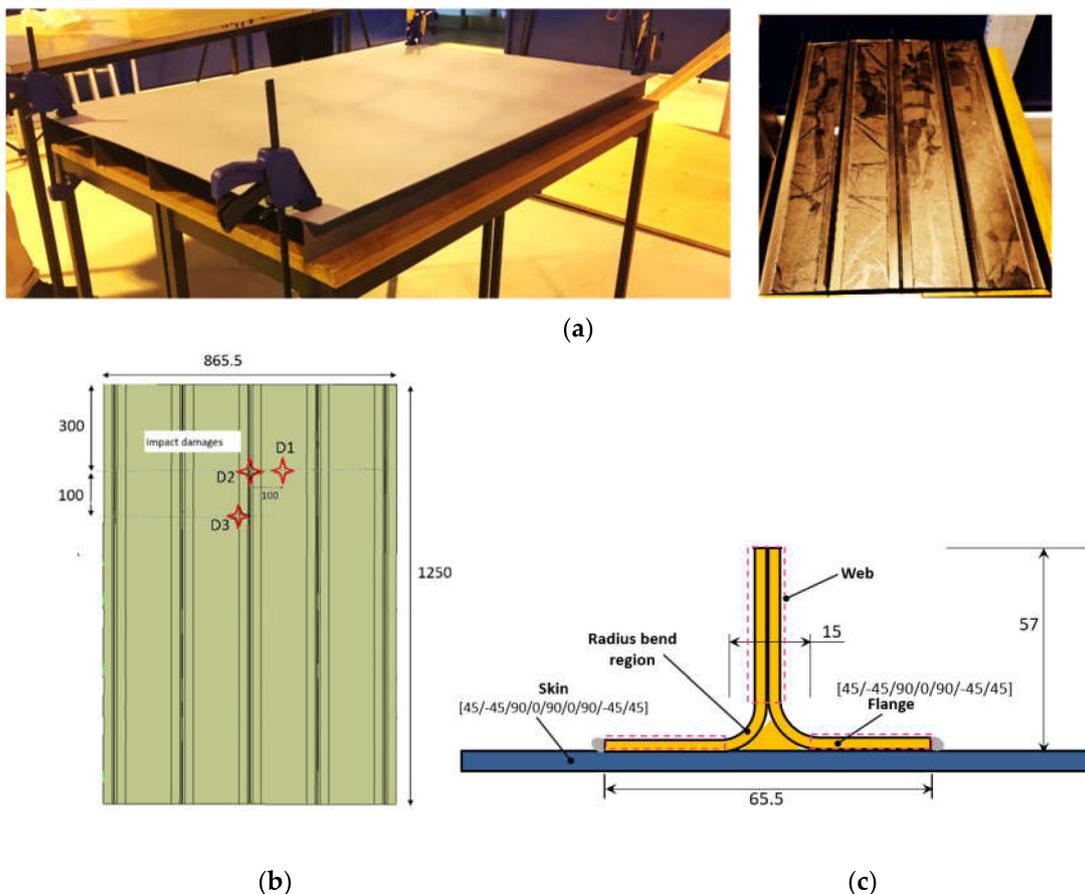
Figure 1. Stiffened composite flat panel (a) finished external surface clamped for infrared thermography/Phased Array (IRT/PA) inspection and panel rear face (b) schematic of barely visible impact damages (BVID) locations on the panel front face (c) T-stringer configuration.

A stringer stiffened composite panel representative of the aircraft structure with dimensions of $1250 \times 865.5 \text{ mm}^2$ was prepared by stacking carbon-fiber prepreg DeltaT-ech T800S-150-DT120-35 with the symmetric $[45/-45/90/0/90/0/90/-45/45]$ sequence; T-shape stringer stacking followed a $[45/-45/90/0/90/-45/45]$ sequence was also manufactured. The schematic of Figure 1 presents the skin with attached stringer geometry, dimensions, and layup sequence. A copper-mesh layer was integrated in the stacking sequence to account for the lightning-strike protection system typical of commercial and military aircraft. The mesh, DEXMET 2Cu6-100FA, an expanded film of copper of a thickness of 0.051 mm and a cavity area of 76%, Long Way Measurement (LWM) of 2.54 mm, was the second ply in the laminate and it resided just below the top GFRP ply, at an approximate depth of 0.18 mm. Autoclave co-curing at 120°C and 6 bars of pressure for 90 min., of the skin with attached stringers pursued, as per prepreg manufacturer specifications. Finally, the external surface of the panel was finished using the same aircraft-grade paint as the coupons. Three barely visible impact damages, termed D1, D2, and D3, were inflicted equally in number locations on the panel while using a gas gun; the schematic of Figure 1b shows their exact positions. D1 was inflicted on the skin region between stringers, D2 on a skin region just above a stringer foot bond area, and D3 on a skin region just above a stringer. Neither damages produced observable surface dents on the skin. Figure 1c shows a view of the panel's rear face with stringers. Thermographic and ultrasonic inspection was performed with the IRT and PA modules that were mounted on prototype VR platforms to perform automated operation on this panel.

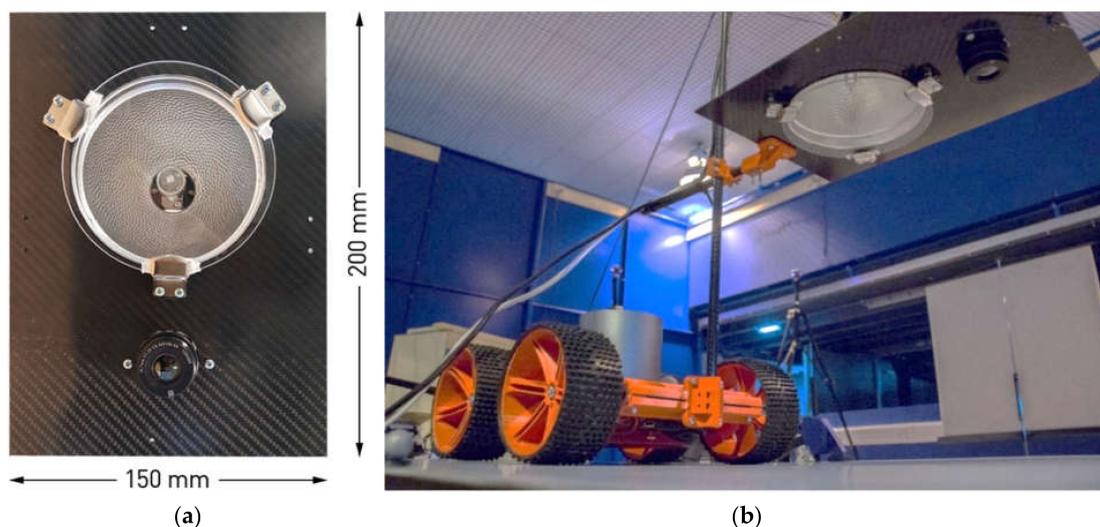
Figure 2. IRT module (a) dimensions and arrangement and (b) mounted on the prototype Vortex Robot Platform developed by Luleå University of Technology [31,32] for automated aircraft skin inspection of BVID by Pulsed Phase-informed Lock-in Thermography (PPI-LT).

The module was assembled by mounting the sensor and source on an autoclave-cured carbon fiber reinforced polymer (CFRP) plate. Figure 2a presents the module face, while Figure 2b demonstrates it mounted on the VR platform. The lens protruded from the plate by 20 mm while the lamp position in the reflector was recessed by 30 mm from the plate. The dimensions of the sensor and the complete module were $30 \times 30 \times 45 \text{ mm}^3$ and $200 \times 150 \times 100 \text{ mm}^3$, respectively. The optimization of the module height (distance of plate from the surface under examination) was performed under the condition of IFOV maximization while maintaining full thermographic information from the surface. The IFOV should be maximum for the corresponding scanned area to be as wide as possible, which minimizes the acquisition timescale requirement for the whole aircraft structure. Based on this, a module height of 400 mm from the surface provided a optimal field of view of $320 \times 240 \text{ mm}^2$. Indicatively, a much smaller field-of-view of $200 \times 150 \text{ mm}^2$ was measured at a module height of 250 mm. Most importantly, the respective weights of sensor and complete module, 70 g and 407 g, are indicative of the compactness and maneuverability offered, which makes them ideal for the targeted field application and mounting method. Prior to the start of IRT inspection, the lens end piece was focused on the surface under examination and a sensor calibration procedure, where the following involved exposure of the sensor to uniformly hot and cold surfaces, in sequence. During the initial phase of PPI-LT, the lock-in frequency was selected after the identification of the thermogram associated with the maximum contrast among those that were collected at various frequencies. In the second step, the surface within the field of view was analyzed in detail by locking thermography at the selected frequency.

The stiffened panel was initially scanned by PPI-LT for rapid wide-area identification of damage location, after which PA inspection was pursued. This primer task was undertaken with the IRT module that was integrated on the VRP, as seen in Figure 2b as a lab-scale demonstration of the envisioned fully automated NDT solution for rapid

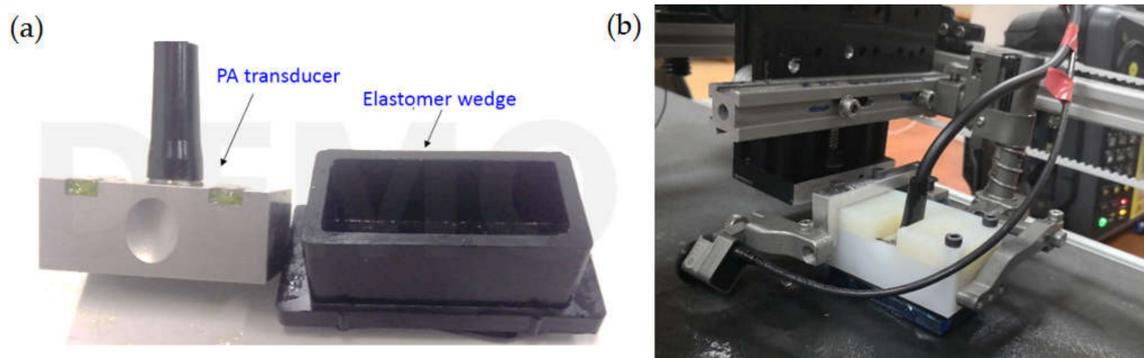
Figure 3. The PA module components (a) PA transducer and bespoke low attenuation elastomer wedge (b) customized spring-loaded positioning-fixture carrying the PA transducer and wedge in light weight Nylon enclosure and screw-clamped encoder.

An ultrasonic inspection typically requires the use of free-flowing water, a film of water, local immersion, or ultrasonic gel as a coupling medium between the transducer and surface under inspection. The restriction of existing methods of couplant usage by VR platform requirements was addressed by developing a new wedge of elastomer material that is similar to a wheel probe roller material [4], which has low attenuation, low acoustic impedance, and lower couplant requirements. The wedge thickness was optimized for a 10 MHz PA transducer that is based on ultrasonic beam characteristics, near-field length, and attenuation in the elastomer material. The elastomer wedge and transducer are enclosed in a light-weight nylon holder for the PA transducer-wedge assembly, as shown in Figure 3. A miniature encoder for capturing positional data is also clamped to the nylon holder.

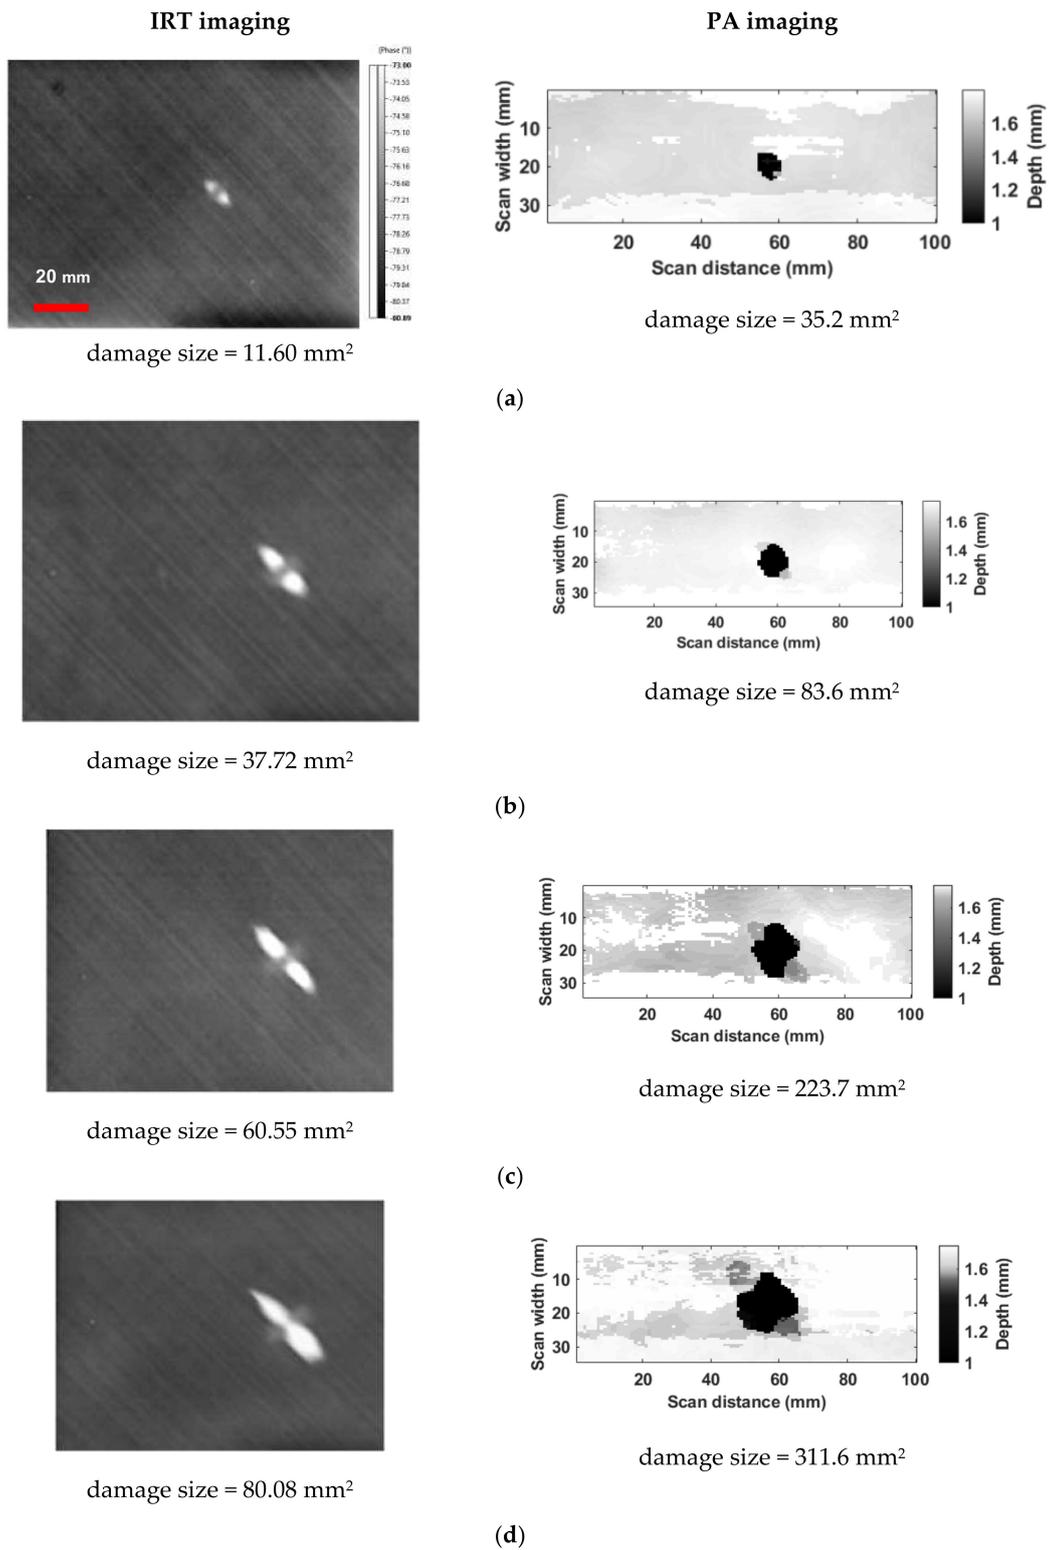
Figure 4. Detection of damage by rapid PPI-LT (thermograms, left column) and subsequent high-resolution characterization by PA imaging (right column) for nine-layer coupons with different impacted energies: (a) 2.5 J, (b) 4 J, (c) 8 J, and (d) 12 J.

By observation of the thermographic results that are presented in Figures 4–6, it is concluded that damage is captured with exceptional precision by the developed PPI-LT approach and sensor in all types of specimens. It is interesting to note that the technique not only assesses the presence of damage, but it can represent its main geometrical features, such as shape and orientation, as documented by the high contrast area corresponding to damage in -45° laminas in the thermograms. In certain cases, such as Figure 5b,c, the barely visible dent produced at the site of impactation is also visible (dark circular mark at the damage center). The increasing extent of damage with increasing impact energy is efficiently assessed by IRT. Hence, it entails that the developed PPI-LT approach and sensor can not only identify damage presence, but can also provide its basic dilatational characteristics.

Observing PA C-scan images of impact damages that are presented in Figures 4–6, the following general observations can be derived: the impact damage size increases with impact energy, and damage tends to propagate along the 45° to fiber direction. In all coupons, the impact damage shows large sub-surface damage, with little or no external indication of the impact. Hence, it is vital to carry out detailed NDT inspections on the composite aircraft’s external surface during heavy maintenance. In all coupons and laminates, IRT imaging shows the good detectability of damage, but the damage area is consistently smaller in size when compared to C-scan. This is because, under the rapid mode requirement of the target application, IRT is used as a fast initial indicator of damage presence; hence, PPI-LT does not offer the resolution that is required for performing full damage analysis. On the other hand, low-speed selective PA on IRT-identified areas only offers the added high-resolution feature that is required for this. In higher thickness coupons, IR thermograms exhibit lower sensitivity on impact damage, even though PA detects large sub-surface damage. These results indicate the importance of impact damage detection and the need for 100% inspection. However, adopting the proposed inspection strategy, 100% detailed inspection of the whole structure using thorough, but also time-consuming, PA can

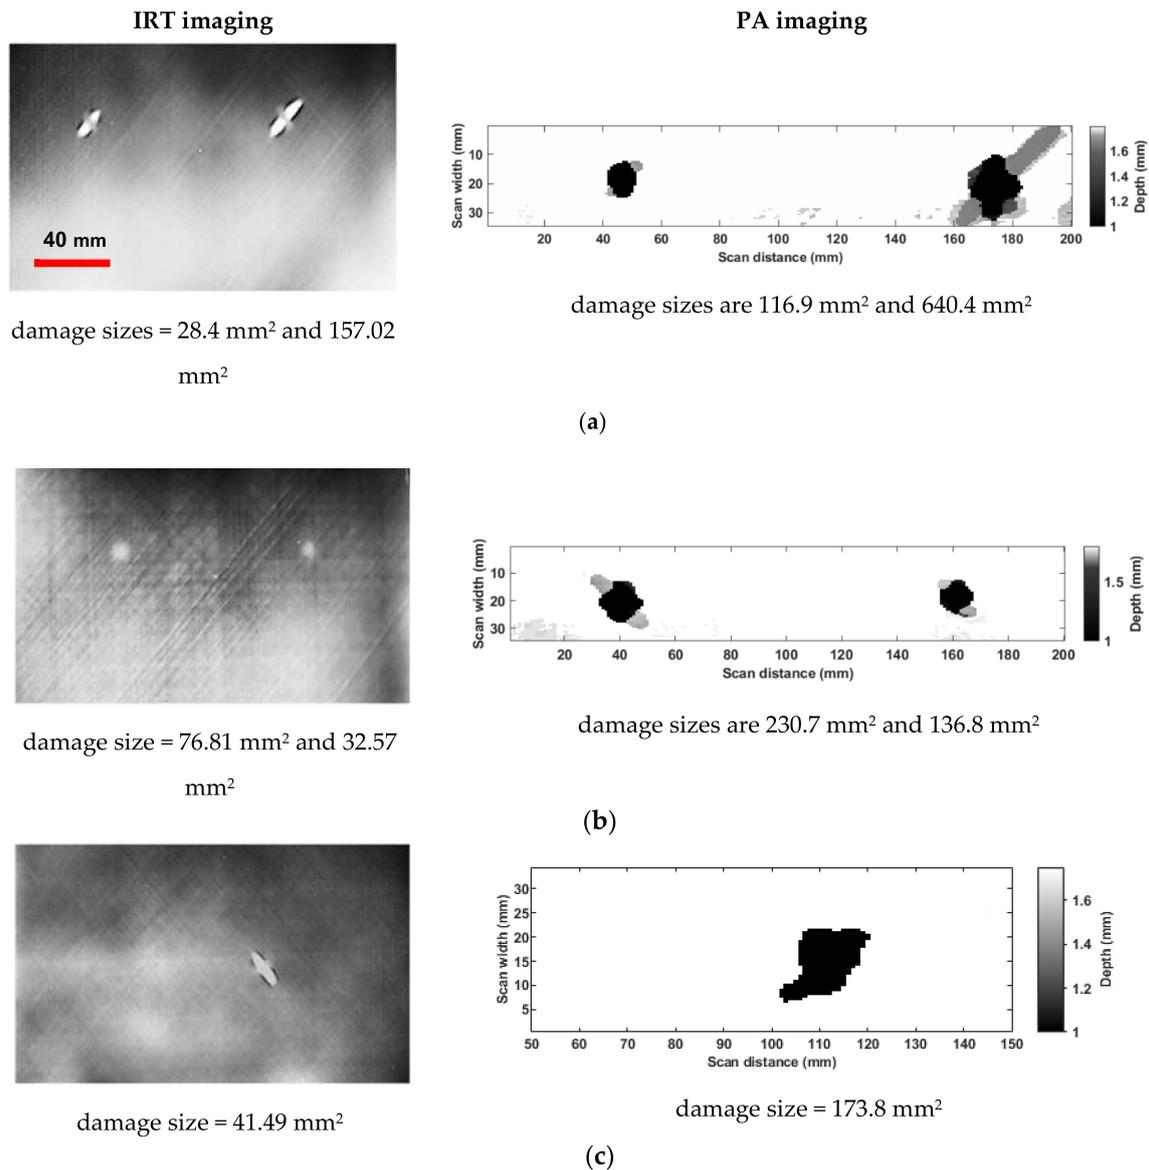
Figure 6. Detection of damage by rapid PPI-LT (thermograms, left column) and subsequent high-resolution characterization by PA imaging (right column) on flat laminates (9 layers) with estimated impact energies (a) 4.5 J (b) 5.5 J and a curved laminate with estimated impact (c) 4.5 J.

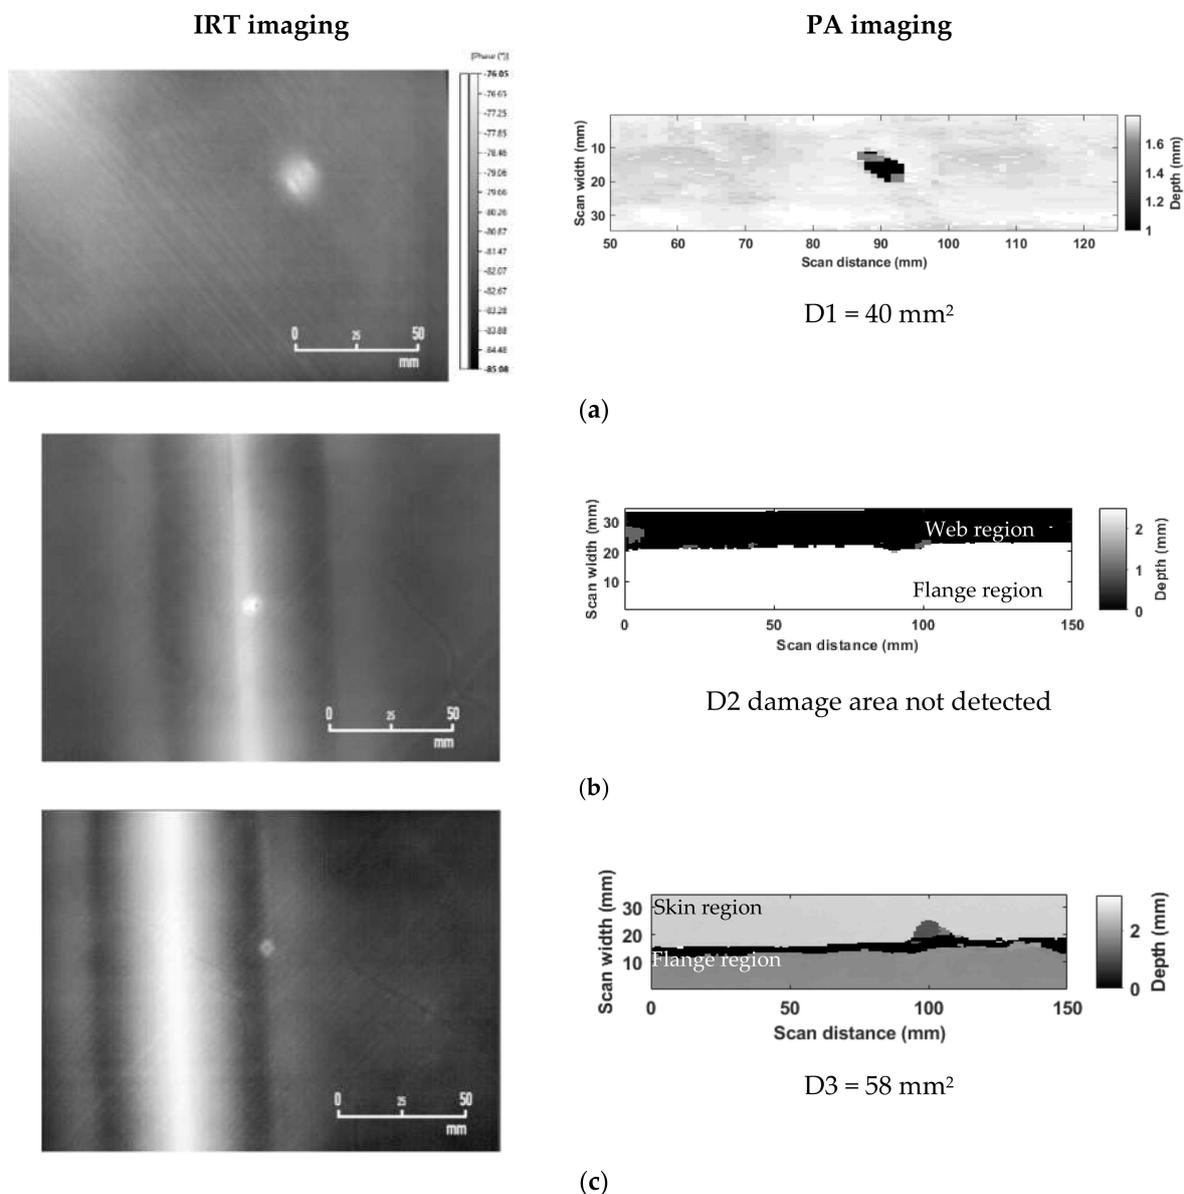
Figure 7. Comparison of IRT and PA imaging for the impact damages (D1, D2, and D3) on the stiffened panel collected using the IRT and PA module on the robot. (a) Skin region (b) web (T junction) region and (c) boundary of the skin-flange region.

and reliable damage inspection in aircraft. The thermographic assessment of damage locations is presented in the left-hand side part of Figure 7. Therein, all three impact damages of the stiffened panel are observed to have been positively identified by the PPI-LT technique. Moreover, the extent of damage appears to be greater in the skin region D1, in the absence of back face stiffening, and smaller in the stiffened area, D3. It is interesting to note that the thermographic signal that was acquired from the stiffened panel did not appear to be deteriorated, when compared to previous findings, as a consequence of the presence, 0.2 mm below the surface, of the copper mesh lighting-protection lamina. Such behavior can be rationalized by the consideration of the small LWM dimension of the mesh with respect to the scanned area, which may lead to a uniformly higher background thermographic signal throughout the specimen, practically masked within the phase scale of thermographs containing high-contrast damage areas. The damaged locations that were identified by IRT were subsequently processed by PA.

Hence, in the next step, the PA module was integrated on to the vortex robot for automated scanning of the stiffened panel. Initially, the PA hardware was pre-loaded with a configuration file with all of the PA inspection parameters, as mentioned earlier; subsequently, PA hardware control was handed over to the robot. The robot interfaces with PA hardware through a custom-developed communication controller to control the PA data acquisition, storage, and water-pump operation for delivering water mist as couplant at the foot of the transducer. The robot then moves to the designated target area on the stiffened panel, around the damages (D1, D2, and D3), and it sequentially performs separate PA line scans. Each line-scans are of fixed 150 mm length and a width of 34.5 mm. The right-hand side graphs of Figure 7 represent the results of the assessment of impact damages on the stiffened panel performed by the PA module mounted on the VRP. The impact damage 'D1' on the skin region is well detected, as shown in Figure 5a. However, damage 'D2' exactly on the web region is not detected, but the damage 'D3' is partially detected. as shown in Figure 7. The thickness of the skin and flange region in the stiffened panel is 1.6 mm and 2.1 mm Figure 5b, c, respectively. At the T-junction region formed by the intersection of both the flanges, there is no backwall reflection of the ultrasonic waves due to the geometric curvature and web width, and, hence, the small damage 'D2' imaging was not successful. Furthermore, it was observed that, on the back-face of the panel, at the transition region between the skin and flange of the stringer, there is an accumulation of excess resin and, hence, at this region there is no reflection of the ultrasonic waves for a short width of 3–5 mm. Because to this reason, the damage 'D3' is partially masked, as shown in Figure 5c.
