# Research Article

# Nondestructive Damage Evaluation in Ceramic Matrix Composites for Aerospace Applications

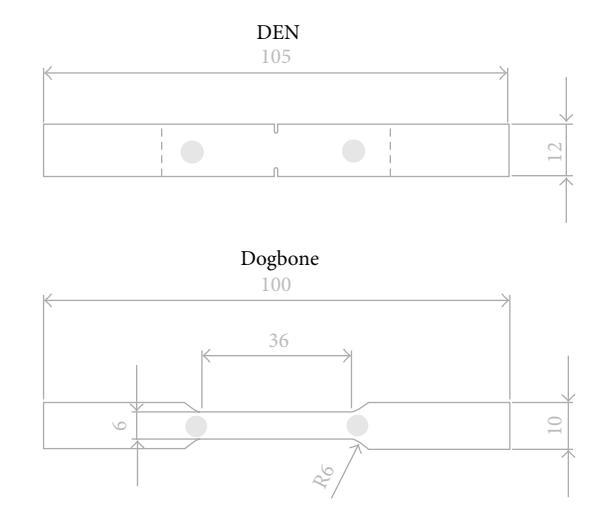
FIGURE 1: Double-edge-notch and dogbone specimen configurations with marked AE monitoring locations (grey circles).

2.1. Materials and Mechanical Testing. SiC/BMAS laminates were provided as 3 mm thick plates. The BMAS glass matrix consisted of 50 wt% SiO<sub>2</sub>, 28 wt% Al<sub>2</sub>O<sub>3</sub>, 7 wt% MgO, and 15 wt% BaO and was reinforced by SiC Tyranno fibers stacked and hot-pressed at 1200°C for 10 min in a symmetric  $(0/90)_{4s}$  orientation. During hot-pressing, a chemical reaction between the fiber and the oxides of the matrix is known to result in the formation of a weak carbon-rich interphase [9] responsible for large-scale bridging and pull-out phenomena during composite fracture [10]. Rectangular specimens of dimensions  $105 \times 12 \times 3 \text{ mm}^3$  were prepared in a vertical CNC with fiber orientation in the external plies set to 0° with respect to the specimen's longitudinal axis. Double-edge notch (DEN) specimens of initial notch-to-width ratios of 0, 0.2, and 0.35 were prepared using a diamond wafering blade intended for cyclic tension testing as shown in Figure 1. Dogbone specimens were prepared for monotonic tensile testing as well as for fatigue loading (Figure 1).

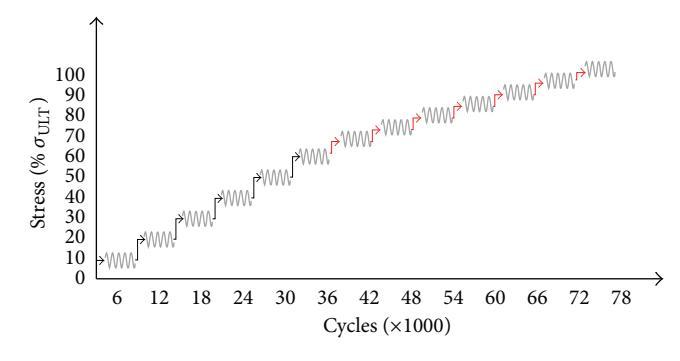
FIGURE 2: Schematic of fatigue loading protocol.

Fatigue step loading until fracture was conducted on dogbone specimens. The first loading step was set to  $10\% \sigma_{ULT}$  and endured for 6000 cycles. The commencing load level was chosen to be low in order to capture the whole mechanical response of the material. The subsequent four loadings, up to  $60\% \sigma_{ULT}$ , occurred with a step of  $10\% \sigma_{ULT}$ . At  $60\% \sigma_{ULT}$  the fatigue loading step was decreased to  $5\% \sigma_{ULT}$  and remained

such until specimen fracture. The frequency of the sinusoidal fatigue load was 10 Hz and R was 0.1. The fatigue loading protocol is represented schematically in Figure 2.

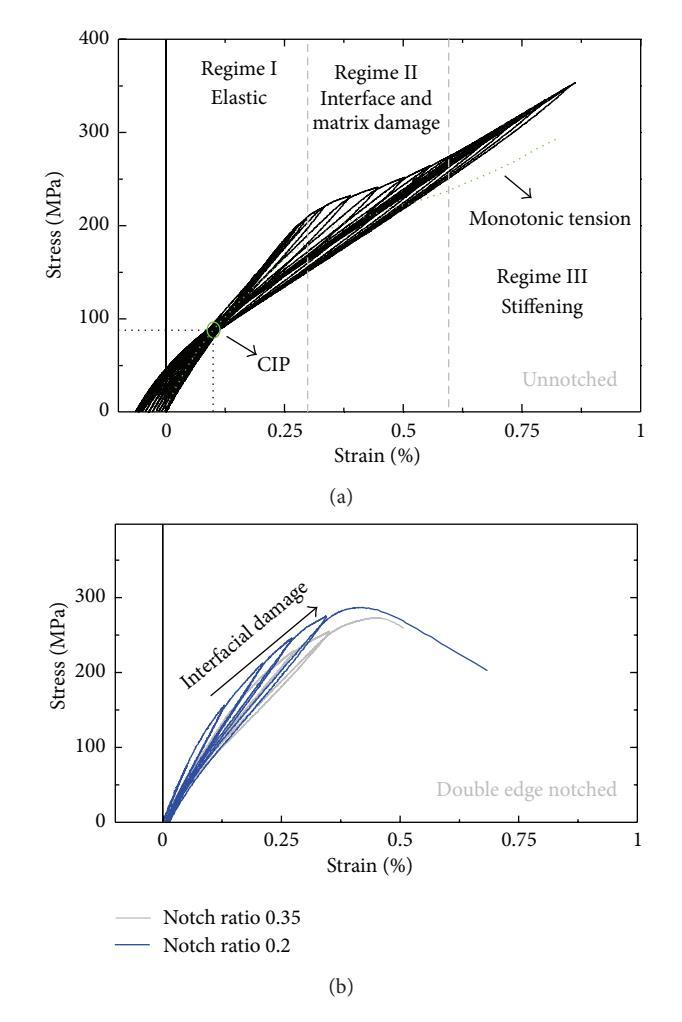
FIGURE 3: Stress-strain response of SiC/BMAS under monotonic loading (dotted line in (a)) and cyclic tension with unloading/reloading loops for (a) un-notched specimens and (b) notched specimens with various notch lengths.

3.1. Mechanical Response under Static Tension. The stressstrain response of notched and dogbone SiC/BMAS specimens under cyclic and monotonic tension, respectively, is presented in Figure 3. Unnotched specimens exhibited a triple regime behavior consisting of a linear initial part followed by a regime of gradually decreasing tangent modulus and a final regime of apparent stiffening. The second regime (regime "II") is associated mainly with interfacial damage, most importantly interfacial debonding but also with progressive matrix cracking evidenced as decreasing material stiffness (average slope of unloading/reloading loops). In the third regime (regime "III") an increase in material stiffness and tangent modulus coupled with an almost linear stressstrain relationship are apparent. In this ultimate regime, the mechanisms of interfacial debonding and matrix cracking have reached a saturated state; hence, material damage is not governed by the interface or matrix anymore; but by a mechanism of superior strength, essentially load bearing by intact fibers [12]. Similar triple regime phenomena with prefailure macroscopic stiffening and linear stress-strain relationships have been encountered before [13]. As observed in the curves of Figure 3(b), Regime III is absent from the mechanical behaviors of notched specimens. This is probably due to premature fiber-hence also composite-stemming from stress concentration in the vicinity of the notch roots.

Comparing the monotonic and cyclic tension curves for the SiC/BMAS composite (Figure 3(a)), it can be concluded that cyclic loading results in an increase by 20% in attainable material stress, calculated at fracture. If this increase is due to higher amounts of energy dissipated at damage mechanisms such as interfacial debonding, matrix cracking, and load bearing by intact fibers [10], it is then suggested that cyclic

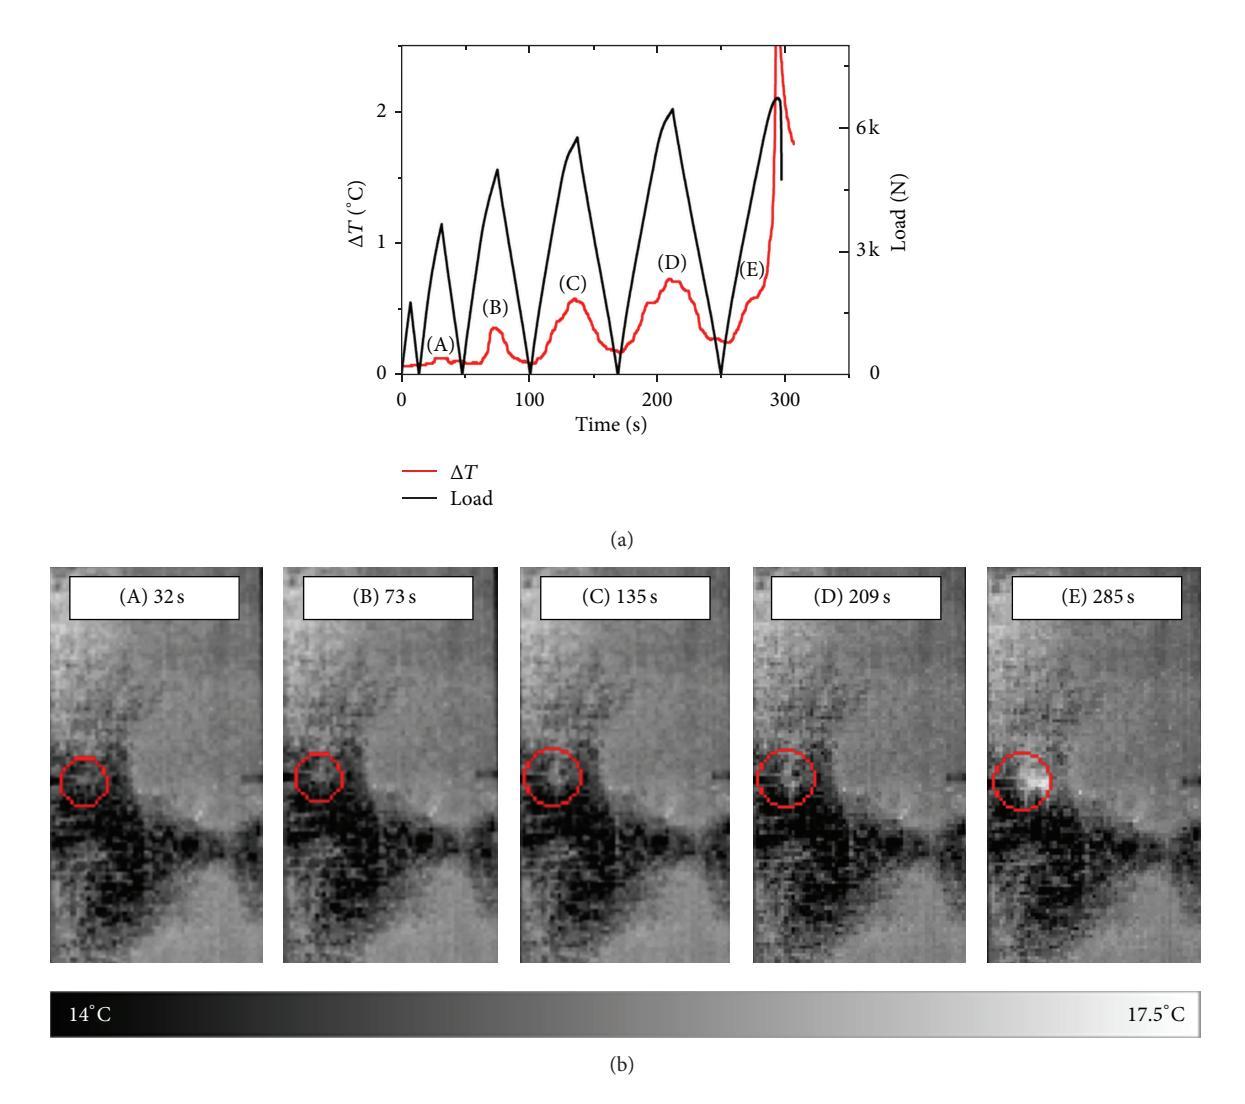
FIGURE 4: (a)  $\Delta T$  and load versus time for a 0.35 notch-to-width ratio specimen loaded in cyclic tension. Sequential alphabet letters indicate instance of thermographs presented in (b).

3.2.1. Static/Cyclic Loading. Temperature variation as measured by IRT,  $\Delta T$ , and load is shown in Figure 4(a) as

a function of time for a DEN specimen with a 0.35 notchto-width ratio. Indices "A" to "E" denote the instances of the thermographs shown in Figure 4(b), collected at the notched ligaments of the composites. It is observed that peak  $\Delta T$ location coincides with the location of maximum load for every cycle, whereas peak  $\Delta T$  magnitude increases with progressing loading, hence also material damage. At the ultimate cycle, the  $\Delta T$  trace appears to follow a completely different pattern than those in previous cycles, wherein temperature appears to drastically increase, indicating that the specimen is heading for catastrophic fracture.

In Figure 4(b), the locations of crack initiation, as identified by IRT, are indicated by a red circle mark. The apparent high-temperature area located outside and to the right of the circle mark is a baseline pattern that exists even before load application and remains constant until catastrophic failure. It is associated with the specimen's surface emissivity, not with material damage. It should not be ignored that IRT is concerned with temperature *variations* as a result of progressive damage, not with *absolute* values. Under this rationale,

no noticeable change in temperature is seen up to 32 sec experimental time (thermograph (A) of Figure 4(b)). 73 sec within testing (thermograph (B) of Figure 4(b)), very small temperature variations can be observed within the marked

(circle) area. Temperature increases become more obvious in thermographs (C) and (D) of Figure 4(b), 135 and 209 into loading, respectively. It is indicated that the damage is extending in area and magnitude. In the last loading cycle, 285 sec

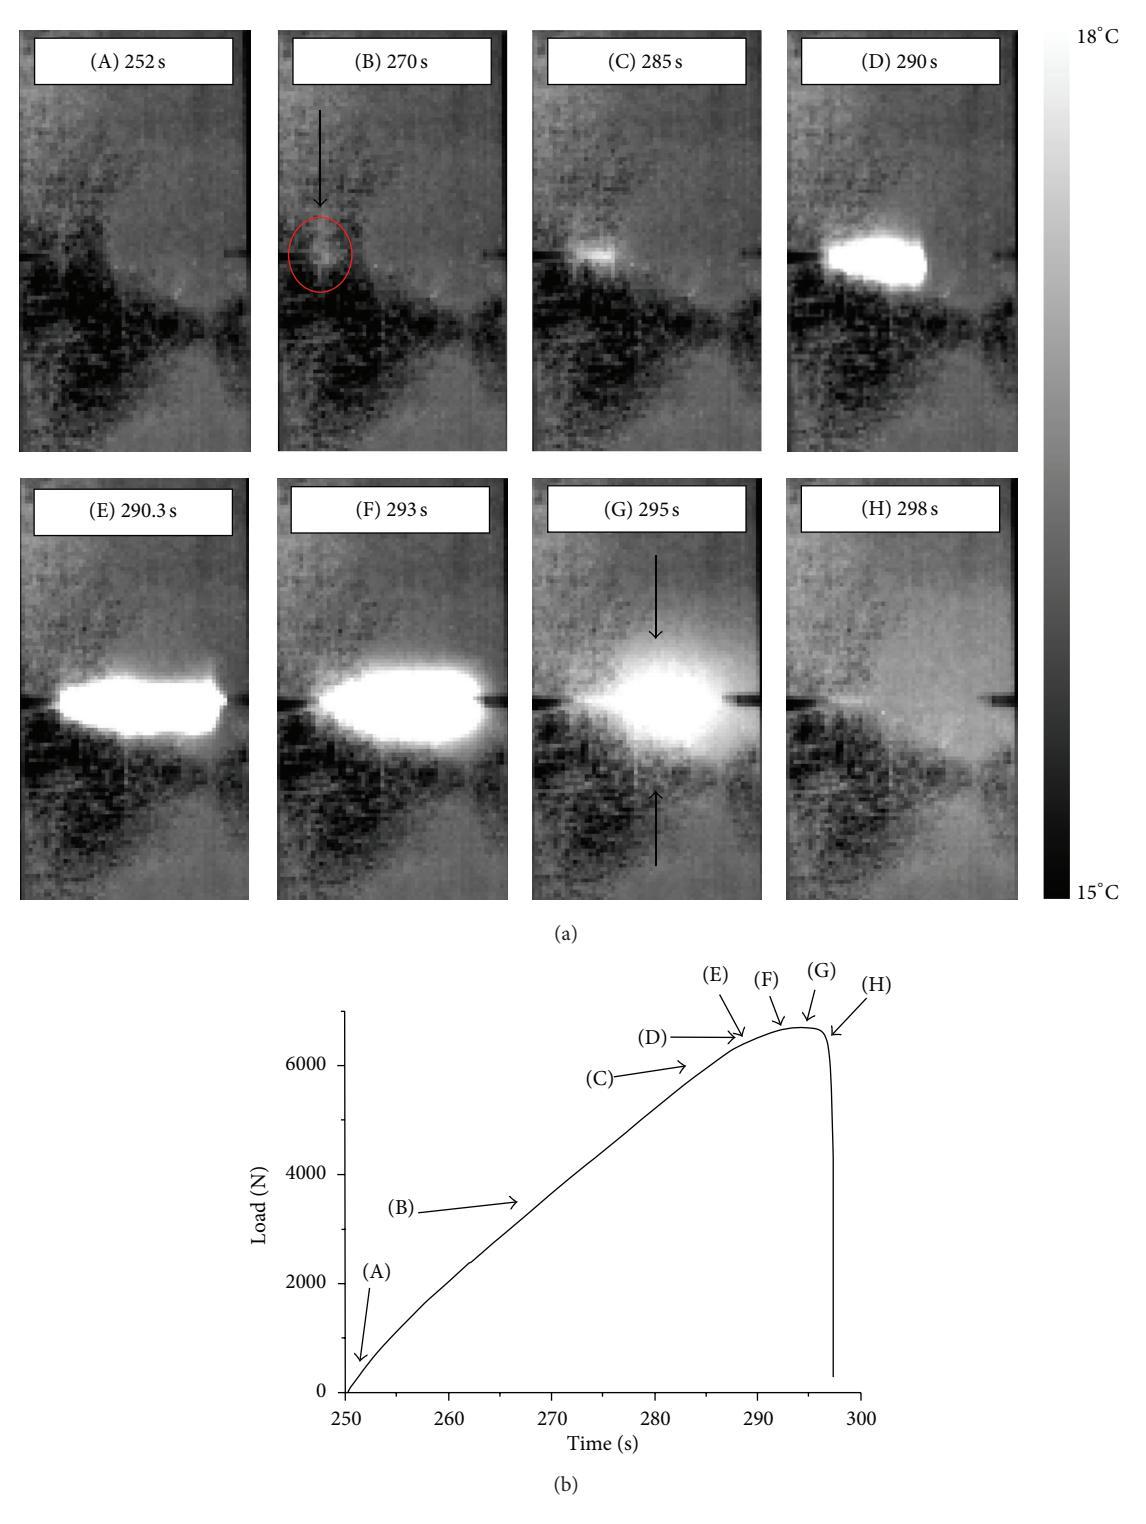
FIGURE 5: Final loading cycle of 0.35 notch-to-width ratio DEN specimen. (a) Thermographs showing crack propagation and (b) load versus time curve.

The thermographic behaviour within the ultimate loading cycle, of the same 0.35 notch-to-width ratio specimen, is demonstrated in Figure 5 and analyzed in the following.

Indices "A" to "H" presented in Figure 5(b) define the instances of the thermographs in Figure 5(a) (note the notch roots). In thermograph (A) of Figure 5(a), no hot appears exist within the notched ligament. In the next instance, thermograph (B) of Figure 5(a), a red arrow indicated what appears to be crack initiation. At 285 sec, thermograph

(C) of Figure 5(a), a significant temperature difference is observed, which coincides with the change in the slope of the mechanical response curve. It is believed that from this instance on, subsurface crack starts propagating from the left notch root with direction to the right. It is important to establish this instance as precisely as possible, as this will facilitate early prediction of the final fracture. It is noted that the associated time (285 sec) corresponds to 73% of the total duration of this ultimate loading cycle. 5 sec later (thermograph (D) of Figure 5(a) at 290 sec) the subsurface crack appears to span half of the notched ligament while only another 300 msec later (thermograph (E) of Figure 5(a)) it propagates abruptly and unstably towards the right notch. The maximum temperature is attained (thermograph (F) of Figure 5(a) at an instance that coincides with the maximum load of the final loading cycle. This temperature is associated with the matrix cracking saturation and the load bearing completely by the reinforcing fibers. Temperature starts decreasing at the left notch in the next thermograph, (G) of Figure 5(a), while it increases above and under the subsurface crack, as indicated by black arrows. This increase is due to the fiber failure under the critical level of applied load. Failed fibers pull out giving rise to the frictional thermal energy evidenced in thermograph (H) of Figure 5(a).

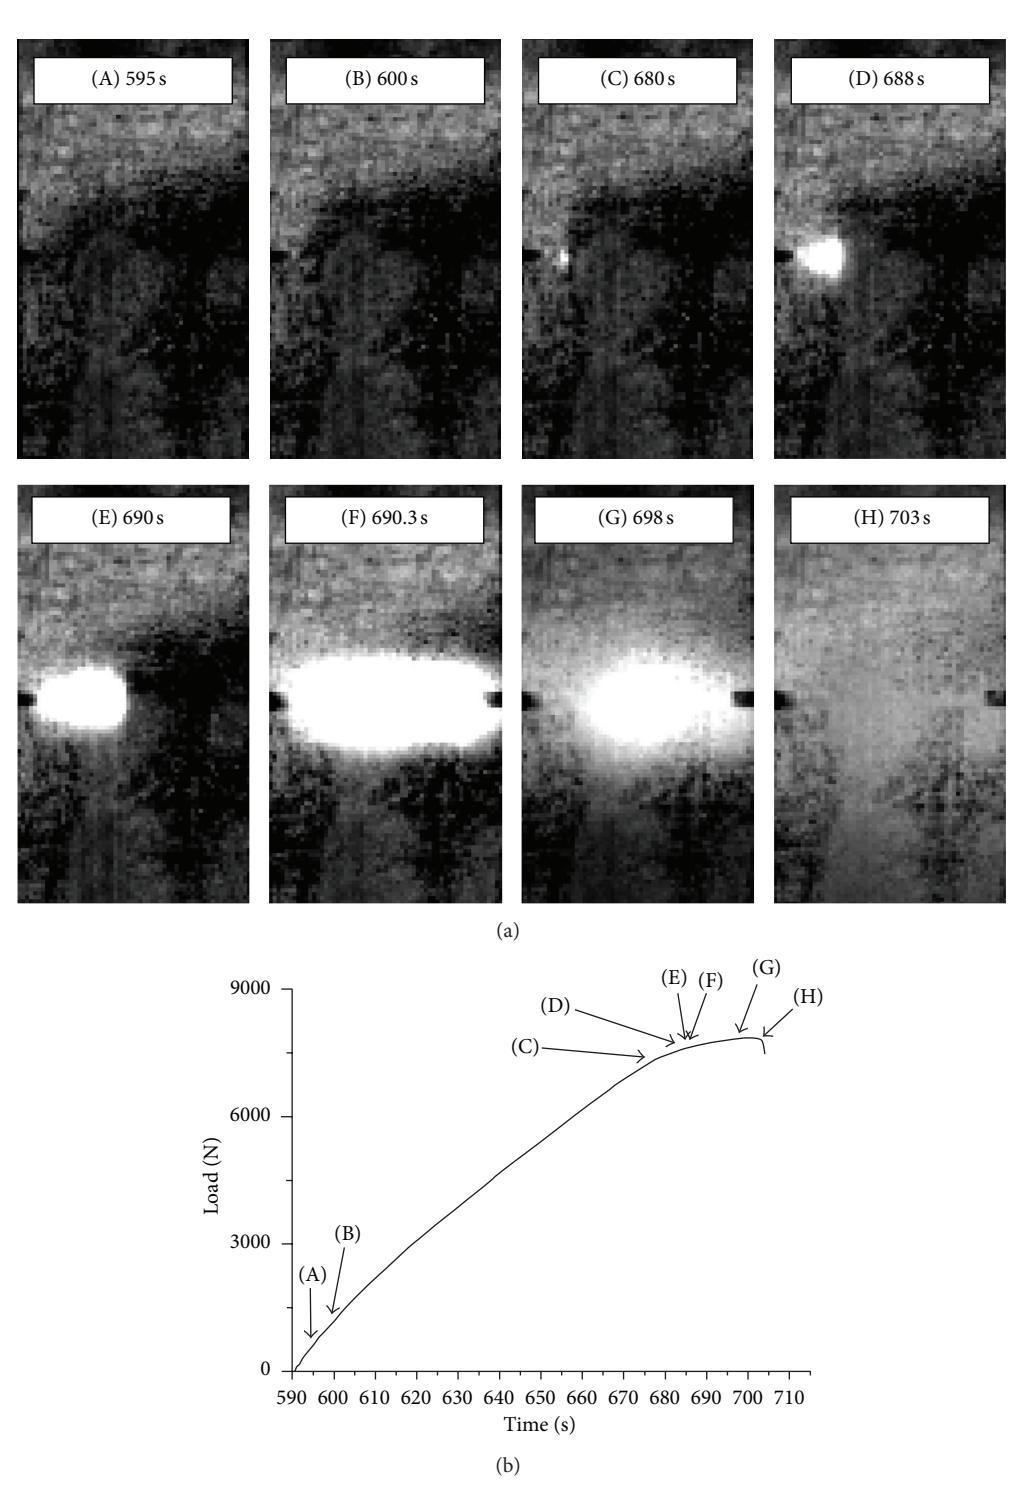
FIGURE 6: ((a), (b)) Thermographs of crack propagation and diagram of load versus time of final loading cycle (0.2 notch-to-width ratio specimen).

Similar trends were observed for DEN composites with smaller notches, as in specimens with 0.2 notch-to-width ratios; the thermographic behaviour within the ultimate loading cycle of such a specimen is demonstrated in Figure 6 and analyzed in the following. Again, indices "A" to "H" presented in Figure 6(b) define the instances of the thermographs in Figure 6(a). After 600 sec of testing time, Figure 6(a)(B), no "warm" damage areas are seen in the thermographs. Crack initiation appears at 680 sec, Figure 6(a)(C), which compares favorably with the instance of slope change in mechanical behavior of the material. It is hence possible to foresee early fracture still at 80% of the final cycle duration. In the subsequent thermographs Figure 6(a)(D) and (E), the subsurface crack propagates from the left notch towards the middle of the notched ligament. The crack then propagates abruptly and unstably towards the right notch. A temperature variation profile compatible with pull out is seen again in the last thermograph, Figure 6(a)(H), where the specimen has failed completely.

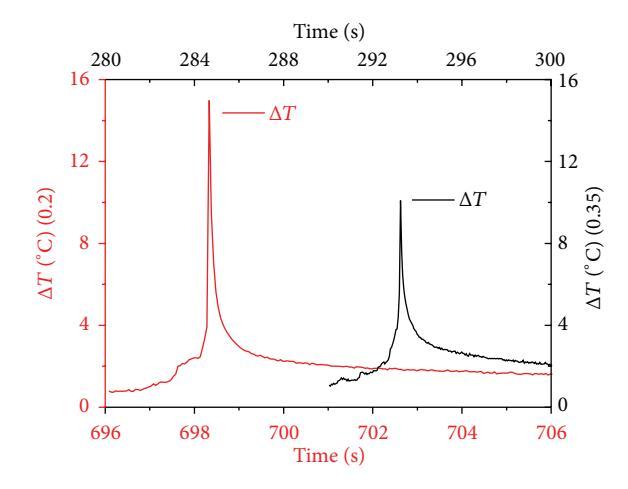
FIGURE 7: Peak  $\Delta T$  for the two notch lengths used in the DEN specimens.

Peak  $\Delta T$  is shown in Figure 7 for the two notch lengths used in the current study. It is observed that specimens with shorter notches exhibit  $\Delta T$  of 15°C at fracture while the ones with longer notches exhibit  $\Delta T$  values around 10°C. It is believed that in specimens with larger notched ligaments (smaller notches), damage evolves over a wider material region throughout testing; hence peak temperature at the critical load is not high. On the other hand, damage is accumulated and relieved not so drastically in a specimen with less material available within the notched region.

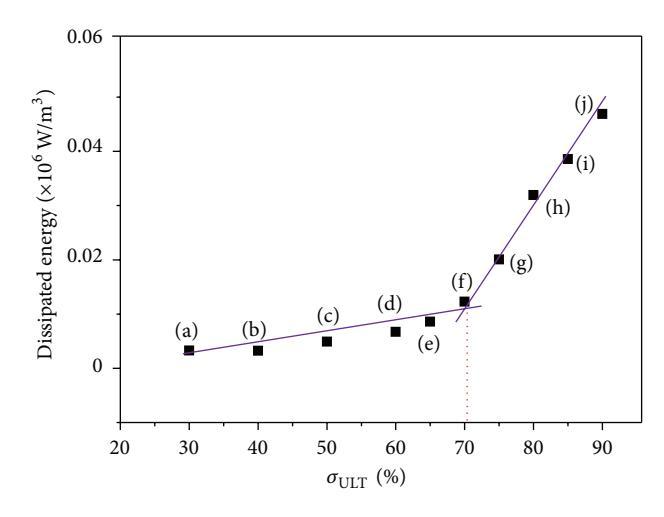
FIGURE 8: Dissipated energy versus %  $\sigma_{\rm ULT}$  for fatigue-loaded SiC/BMAS.

*3.2.2. Fatigue.* Lock-in thermography was applied during fatigue loading of SiC/BMAS dogbone specimen. The intrinsically dissipated energy as monitored by the IR camera for 10 different stress levels ranging from 30% to 90%  $\sigma_{\rm ULT}$  is plotted as a function of %  $\sigma_{\rm ULT}$  in Figure 8.

The curve exhibits two distinct slopes, visualized by the two linear regressions seen in Figure 8. At low stress levels, 30% to 60%  $\sigma_{\text{ULT}}$ , the dissipated energy increases with a low rate, while from 70%  $\sigma_{\text{ULT}}$  and upwards it rises considerably more rapidly. The intersection point of the two lines defines the fatigue limit of the material. The value of fatigue limit calculated for the cross-ply SiC/BMAS through the thermographic approach of this study is 70%  $\sigma_{\text{ULT}}$  or 205 MPa.

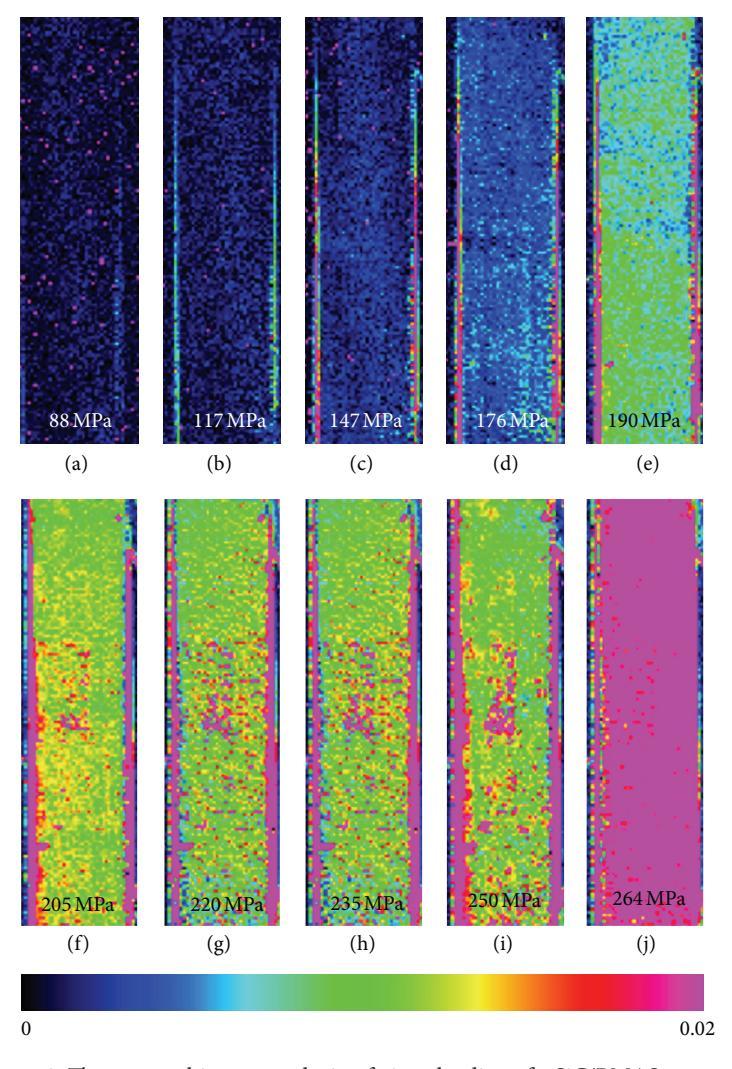
FIGURE 9: Thermographic pattern during fatigue loading of a SiC/BMAS composite.

An examination of the thermographic pattern of crossply SiC/BMAS at different stress levels is of particular interest in view of the established fatigue limit value. This information is presented in Figures 9(a)–9(j), wherein the 70%  $\sigma_{\rm ULT}$ fatigue level which corresponds to thermograph Figure 9(f). Two distinct cases are made obvious by examination of this figure: (i) thermographs Figures 9(a)–9(d) depict low energies in cold (blue) color coding in the initial loading stages associated with minimal material damage and (ii) thermographs Figures 9(e)–9(j) capture progressive damage accumulation which is captured by increasingly warmer colors (high energy). In the first four thermographs, up to

176 MPa applied stress, there is practically no appreciable change in the dissipated energy. In the fourth thermograph, Figure 9(e), a slight change in color can be attributed to the saturation of elastic energy accumulation on the onset of appearance of fatigue. A totally dissimilar energy distribution pattern appears in thermograph Figure 9(f) due to the unfolding of internal energy dissipation phenomena such as interfacial damage, delamination, and fiber sliding across the debonded interface [18]. At thermographs Figures 9(g)–9(j) (75%–90% of  $\sigma_{\rm ULT}$ ), a raise in energy can be noticed indicated by the increment of the magenta spots until fracture. At the particular loading level, this energy can be attributed to fiber bridging, fiber failure, and pull out.

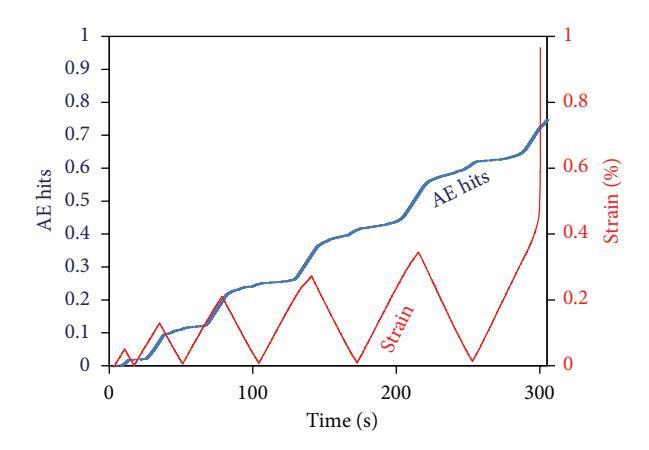
FIGURE 10: Strain and AE cumulative history for specimen B.

3.3.1. Static/Cyclic Loading. Cumulative AE signal history collected during cyclic loading of a DEN specimen with 0.35 notch-to-width ratio is shown in Figure 10 alongside with strain. The rate of AE acquisition exhibits fluctuations according to the cyclic loading protocol. Specifically, AE rate increases as the load increases to the maximum within

each cycle. After these maxima points, the AE rate decreases without however being completely eliminated, at the cycle's minimum load. The total activity was of the order of 4000 signals.

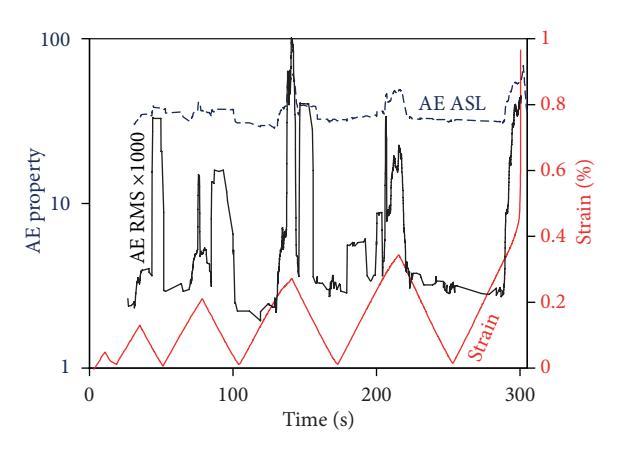
FIGURE 11: Strain history and AE amplitude parameters for a doubleedge notched specimen with notch-to-width ratio of 0.35.

Therefore, both of them are indicative of the AE signal emitted by the fracture. Figure 11 shows the sliding average (window of 20 points) for both AE parameters. Focusing on the ASL first, local peaks are indicated at the moments of local maxima of strain, especially for the last three cycles. This means that at those periods of high strain, stronger fracture incidents take place which are recorded as waveforms with different intensity characteristics. The same holds for the RMS which again gives a measure of the elastic energy recorded by the sensor being proportional of the pressure wave that impinged on the sensor's surface. The values of RMS were multiplied by a thousand for visibility reasons in the graph. These parameters show that monitoring of AE and specific qualitative AE features allows the recording of the high stressing moments and the whole loading history until the material is brought to failure.

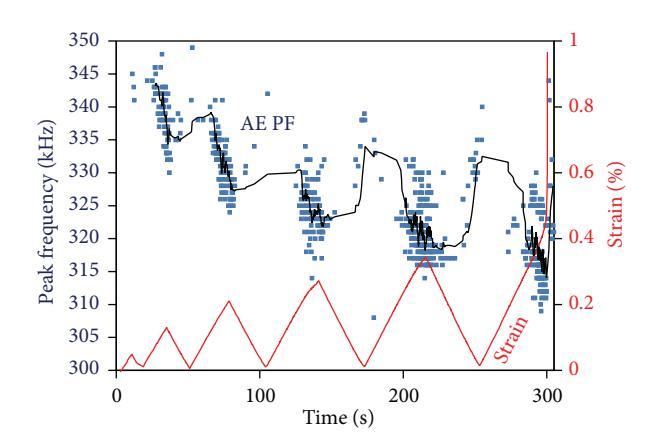
FIGURE 12: Strain history and AE peak frequency for a double-edge notched specimen with notch-to-width ratio of 0.35. The solid line is the sliding average of recent 20 points.

damage accumulation and is linked with the shift between fracture modes (e.g., initial tensile matrix cracking to ultimate shearing) [20, 21]. The index that is displayed here is peak frequency (PF) and is the frequency of the highest peak of the FFT of the AE waveforms. Using the specific AE sensors typical peak frequencies average around 450 kHz which is the maximum sensitivity of the sensors, while different bands from 100 kHz up to approximately 800 kHz can also be recorded. Figure 12 focuses on a specific family of emissions which initially exhibit frequencies between 330 and 350 kHz. It can be easily seen that this group of emissions are registered near the maxima of the strain cycles. However, one certain trend is that the main frequency of this family steadily drops in frequency after each cycle. This drops is of the order of 5 to 10 kHz in each cycle resulting in an average of 315 kHz at the last cycle just before failure. This drop of frequency is a result of the shifting between fracture mechanisms within the material since the monitoring conditions (sensors, separation distance) were constant throughout the experiment duration.

The observed behavior can be due to the increasing number of interfacial F that is expected to happen at the higher strain levels of the cycles. This allegation is supported by visual evidence of fiber bundle sliding and existence of off-axis layers seen in the postmortem side view of a specimen's notched ligament, microphotograph in Figure 13. It is observed that crack opening is approximately 500  $\mu$ m. It is also observed that fibers are bridging the crack sides being pulled out of the matrix. While rupture of a large number of individual fibers is evident, fiber bundles have not failed completely since the specimen was removed in one piece after the test.

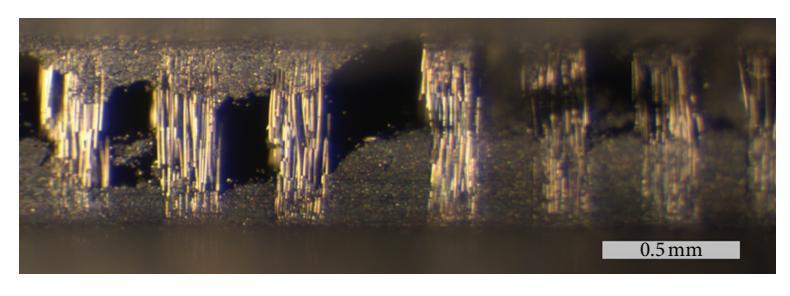
FIGURE 13: Stereoscope image of the side of a fractured specimen.

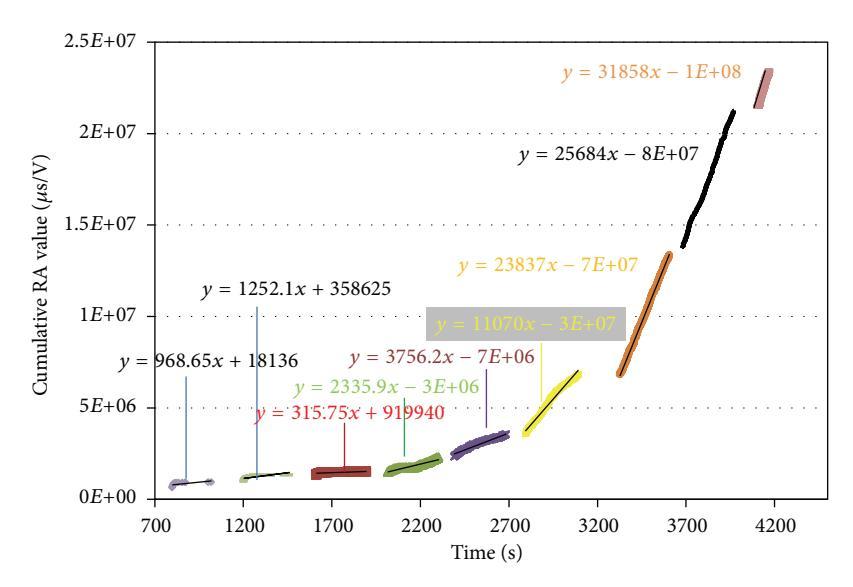
FIGURE 14: Cumulative RA value for the different fatigue loading stages.

where RT is the rise time of the waveform (or delay between the onset and the highest peak in  $\mu$ s) and *A* is the amplitude of the highest peak in V. In general this feature increases as damage develops along with the shift of the failure mechanisms from matrix cracking to shearing phenomena like interfacial sliding and debonding [18, 19]. Therefore, RA values are progressively increasing until the final failure of the specimen. Figure 14 shows the cumulative RA value for the different stages of fatigue loading. As mentioned above, at the early stages, RA values accumulation is low. At the block of loading starting at approximately 2000 s (70% of UTS) the RA values seem to accumulate at a higher rate, which is increasing for each successive step.

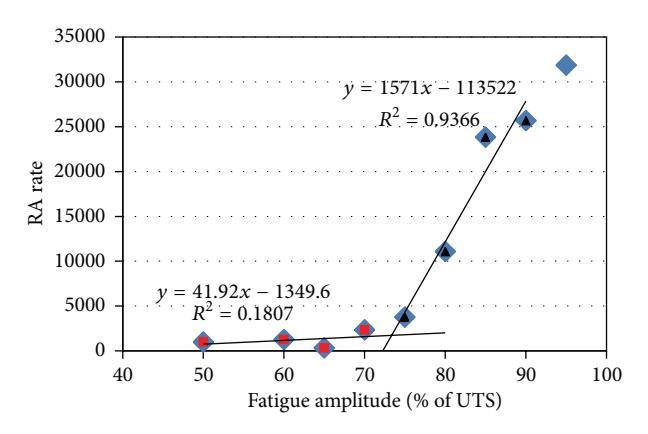
FIGURE 15: RA increasing rate for different fatigue loading amplitudes.

The rate of RA accumulation is shown in Figure 15. This allows a more clear visualization of the trends between the AE and RA at different stages. It is concluded that the curve can be fitted by two straight lines. The change of slope between the two lines occurs below 75% load which is a certain indication that significant changes take place after that load level. At lower loads, the events emit notably lower RA values showing

less intensity compared to levels higher than 75%. The intersection of the two lines is between 70% and 75% and coincides well with the change of slope in the corresponding thermal dissipation curve presented earlier. This shows that both techniques can register small but delicate changes of the failure processes, depending on the fatigue loading. It seems that although incidents that, emit acoustic emission and heat are induced by low loading, these exhibit distinct values from corresponding events at loads higher than the fatigue limit which eventually will lead to the failure of the specimen.
