Tunnelling and Underground Space Technology 23 (2008) 629–637

Evaluation of grouting in tunnel lining using impact-echo

D.G. Aggelis^a, T. Shiotani^{b,*}, K. Kasai^c

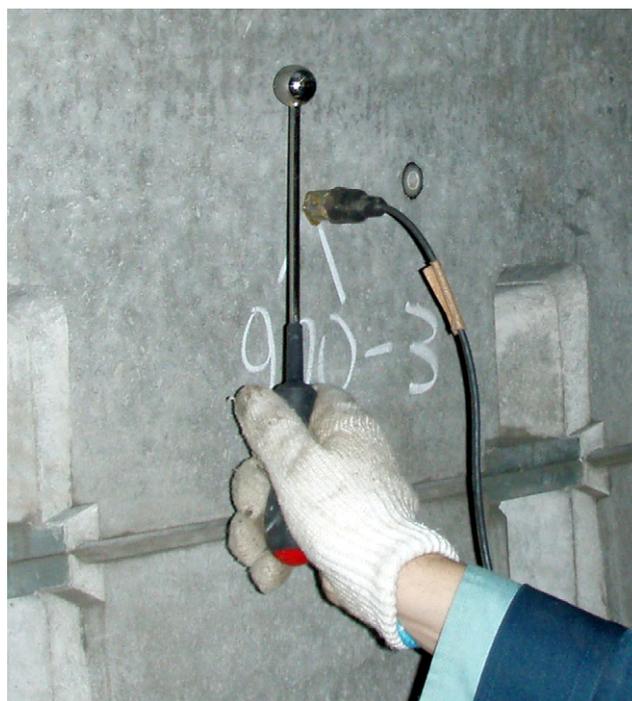
Fig. 1. Excitation using an impact hammer of 25 mm near the accelerometer.

As to the main measurements at the tunnel site for the evaluation of grouting, the excitation was conducted by an impact hammer, as seen in Fig. 1. The impact hammer diameter was 25 mm although smaller diameters were tested, down to 3 mm. This diameter was selected since it resulted in high energy and clearer signal. Theoretically, the maximum frequency excited by a steel ball of diameter 25 mm, is 11.5 kHz (Sansalone and Streett, 1997). Hammering was repeatedly conducted for 10 s resulting in acquisition of 20 individual signals. However, the signal was strong enough and stacking did not reveal difference in spectral content from the individual waveforms. The used accelerometers were Fujicermics SAF51 with flat response up to 30 kHz and the signal was acquired by a TEAC GX-1 system. The sampling rate was set to the maximum available value of 200 kHz.

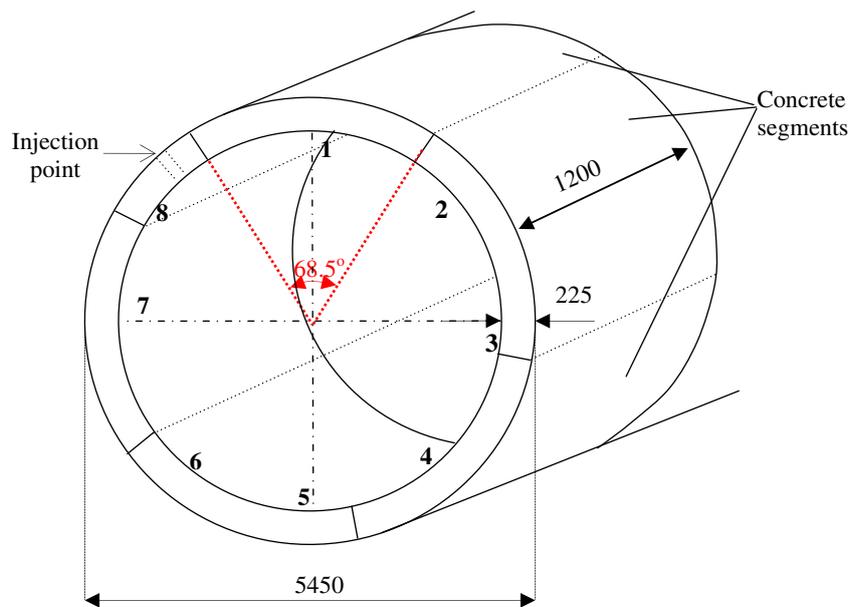
Fig. 2. Cross-section of the concrete ring, consisting of six segments. (the dimensions are in mm).

Fig. 2 shows the cross-section of the tunnel. The reinforced concrete segments, used to support the mudstone, had a thickness of 225 mm. They can be considered arches of 68.5° of a circle with external diameter of 5450 mm (see Fig. 2). Five full scale segments and a smaller one were used to seal the cross-section, consisting a “ring”. To seal the whole length of the tunnel, several thousands of consecutive rings were placed, while the width of the segment (and the ring) was 1200 mm.

The grouting was performed at each one out of two consecutive rings from a hole in the center of a top segment. Using the excavation diameter (5.6 m) as well as the estimated empty volume between the concrete segment and mudstone, the sufficient quantity of grouting material was calculated. Due to uncertainties related to this estimation the actually injected grout volume exceeded this value by 30%, while the existence of grouting material was visually observed from the next holes. The maximum injection pressure was 35 MPa. However, although the pressure of

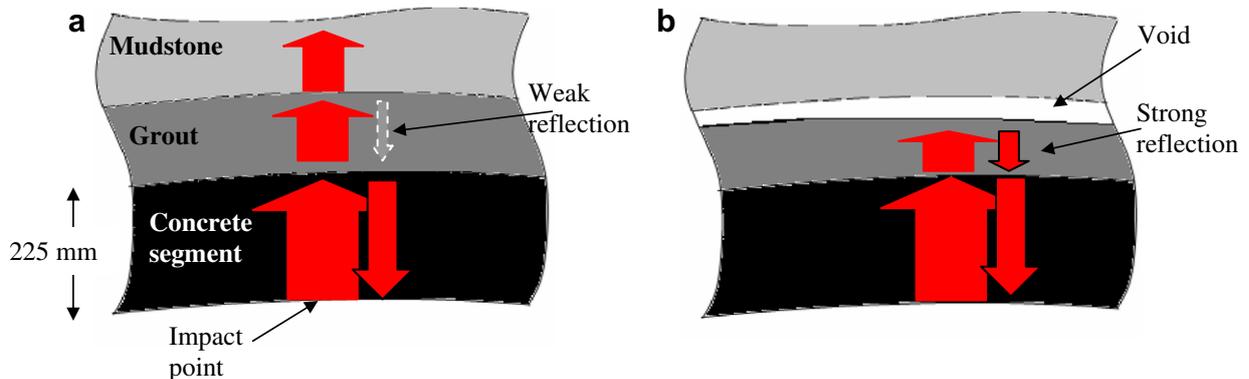
Fig. 3. Reflections according to the internal geometry (a) fully-filled case, (b) partially filled case.

Since the material properties were derived, more specific calculations can be conducted, concerning the expected frequencies of the test. After excitation at an impact point, the wave propagates through the thickness of the segment, until it reaches the opposite surface (see Fig. 3a). At the

interface between the concrete segment and bentonite a part of wave energy is reflected back. This is because the acoustic impedance of stiff concrete is much higher than the one of bentonite (12.5 MRayl and 1.97 MRayl, respectively) as seen in Table 1. The reflection coefficient is given by (Sansalone and Carino, 1991):

tact with the mudstone (see Fig. 3a). As mentioned earlier, the impedances of these two materials are very close and therefore, the reflection coefficient will be very low ($R = 0.09$). In order a reflection to be clear, a coefficient of more than 0.24 is necessary (Sansalone and Streett, 1997). Therefore, almost all the energy will propagate into the mudstone away from the receiver. This means that only one major frequency peak at approximately 11 kHz is expected for the fully grouted case.

If the grouting is not complete, a void will be present between bentonite and mudstone, as depicted in Fig. 3b. Since air has negligible impedance, the reflection will be strong ($R = -1$). The resulting frequency in the spectrum will depend on the propagation time through the bentonite (grouting) layer and therefore, its thickness. For example, for bentonite layer thickness of 70 mm, the propagation time would be approximately 85 μ s (considering its pulse velocity of 1650 m/s). In addition to the 90 μ s through concrete, this leads to an expected frequency peak at 5.5 kHz. Therefore, a second lower frequency peak should arise in the spectrum, indicating the void between the grout and the surrounding mudstone.

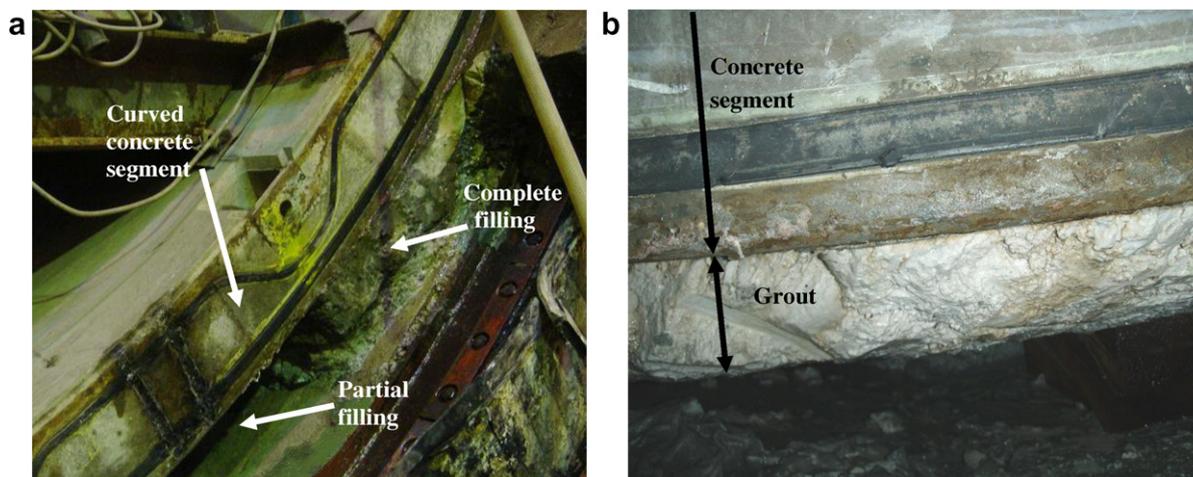
Fig. 4. (a) Different filling cases simulated at the entrance of the tunnel, (b) detail of partial filling case.

Before applying the method to rings throughout the actual structure, measurements were conducted under controlled conditions on several positions near the entrance of the tunnel. There are different cases simulated namely complete and partial grouting, as can be seen in Fig. 4a. Fig. 4b shows the detail of the partial case with the grout layer of about 70 mm.

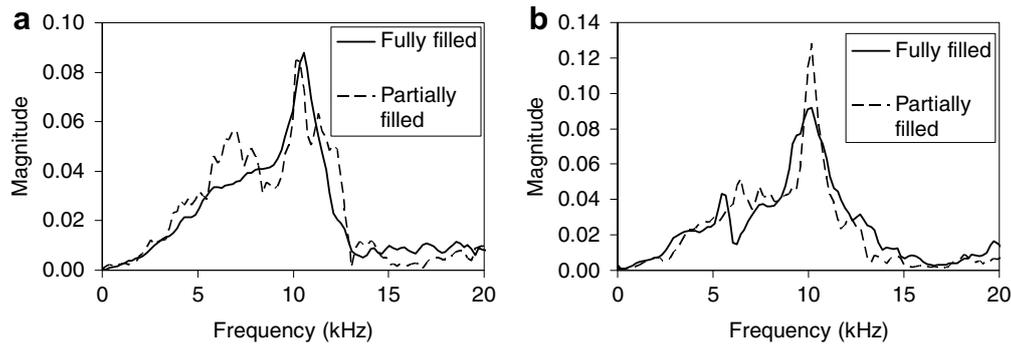
Fig. 5. FFT of different filling cases. (a) Distinguishable cases, (b) not distinguishable cases.

Fig. 5a shows typical fast Fourier transforms (FFT) of totally filled and partially filled cases. The FFT of fully filled, exhibits a single peak just above 10 kHz, corresponding to the thickness of the segment, as explained earlier. In

the case of partial filling, except the high frequency, another clear peak is seen at around 6 kHz. However, not all cases could be distinguished easily. In Fig. 5b two other indicative cases are presented. Concerning the fully-filled position, a small frequency peak at 5 kHz can be observed. This peak could cast doubt if the filling was not visually confirmed. On the other hand, the case of partial filling in Fig. 5b exhibits again a similar small peak at low frequencies. Therefore, the existence of this peak should not be the unique criterion for characterization, since it can be observed in both fully and partially grouted conditions. It could be the result of the reflection due to a void or the reflection between grout and mudstone in the fully-filled case (even though theoretically it is expected to be weak according to the acoustic impedance values, as mentioned above).

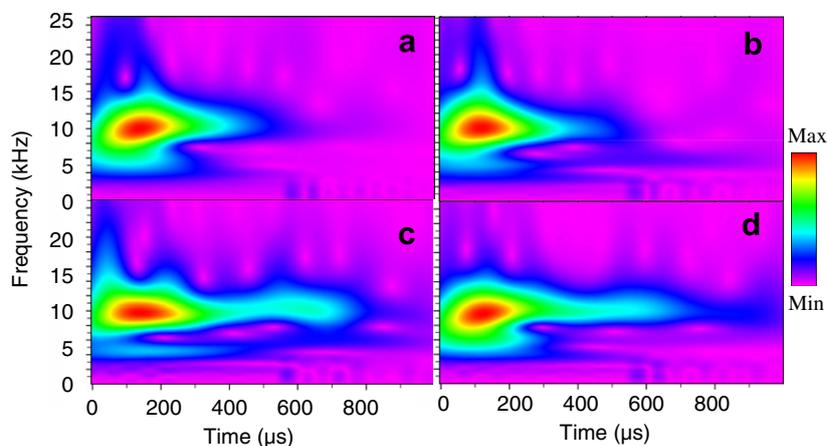
Fig. 6. Wavelet transforms of responses from: (a) and (b) fully filled, (c) and (d) partially filled position.

A powerful way to visualize the response is the use of wavelets, which can offer valuable information. Wavelet transformation is a means of conducting frequency analysis in a localized part of a signal. Therefore, it is possible to identify the time within a waveform when each frequency component is active (as opposed to the Fourier transform that gives information about the frequency content of the whole signal as an entity). The wavelet transform (WT) works by breaking the signal into shifted and scaled ver-

sions of the original wavelet (fast decaying mathematical function) (Misiti et al., 1996). To handle suitably any signal, different original (“mother”) wavelet functions can be used. In the specific case, the software used by the authors (AGU-Vallen Wavelet) employs the “Gabor” Wavelet, which has proven very useful for analysis of ultrasonic and acoustic emission signals (Hamstad, 2005). The results show that it is adequate for the analysis, since it helps the identification of different cases, while possibly a number of other mother wavelets would produce similar results. In Fig. 6a and b one can see the wavelet transform of waveforms corresponding to fully filled condition. The major part of energy is concentrated before 200 μ s and almost no energy is depicted after 500 μ s. For the case of partial grouting though (see Fig. 6c and d), the energy is noticeable until about 800 μ s. Additionally, a distinct energy component at 5 kHz is more evident, surviving up to approximately 400 μ s (especially in Fig. 6c), corresponding to the lower peak of the FFT discussed earlier. Visual observation can serve the purpose of rough characterization; however, there is not a decisive difference between the filled and not filled cases, since the low frequency component can be seen in both healthy and partial conditions (see Fig. 6b and d). The visual inspection of wavelet transformation can distinguish between some extreme cases, but

it is not adequate for reliable quantification purposes. Therefore, other features were studied to lead to a more robust characterization scheme. These features come from the time domain and, although they are not commonly examined in impact-echo testing, they led to more powerful characterization than frequency features in this case.

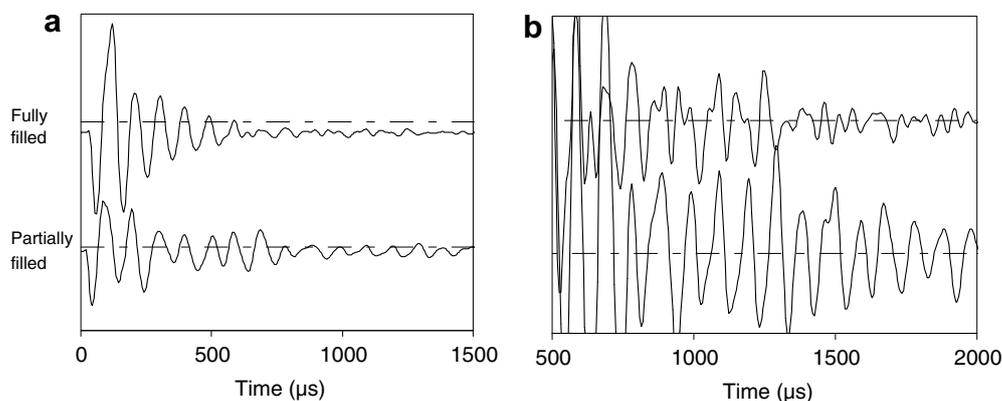
Fig. 7. (a) Waveforms from different filling cases with threshold 10% of the maximum, (b) the waveforms magnified after 500 μs , with threshold 0.1%.

Fig. 7a shows typical waveforms obtained for fully and partially filled positions. For the case of full grouting, the waveform consists of one single burst that decays smoothly. Almost all the energy arrives before the 500 μs , while no threshold crossings (see horizontal dash-dot line) are observed afterwards (except a number of small high-frequency cycles which are better depicted in Fig. 7b and will be discussed later). This is reasonable since the reflection from concrete–grout interface is the only strong one, and the energy propagating through the grout will never be reflected back, due to the similarity of grout and mudstone, as explained earlier. For the case of partial filling though (see again Fig. 7a), the decay is not smooth, presumably due to the arrival of the late reflection expected at around 170 μs . Additionally, even after 500 μs , some low frequency oscillations are observed.

ber of 6 counts that is common for filled and unfilled positions. The results are improved if one considers the counts of the later part of the waveform. As seen in Fig. 7a, the filled case exhibits significant energy up to about 500 μs , while for the partial case, the energy expands up to 800 μs . Therefore, in Fig. 8c one can see the counts after 500 μs . In this case characterization is much easier, since there is no overlap; the fully-filled cases exhibit 0 or 1 count, while the partial exhibit at least 3 or more.

As stated earlier, and seen in Fig. 7b, the waveforms of fully grouted positions exhibit numerous low-voltage, high-frequency oscillations after the initial burst. These can be examined by a suitably low threshold of 0.1%. This seems to be another also powerful descriptor, since the full cases exhibit numerous low, high-frequency counts compared to the partial (see Fig. 8d).

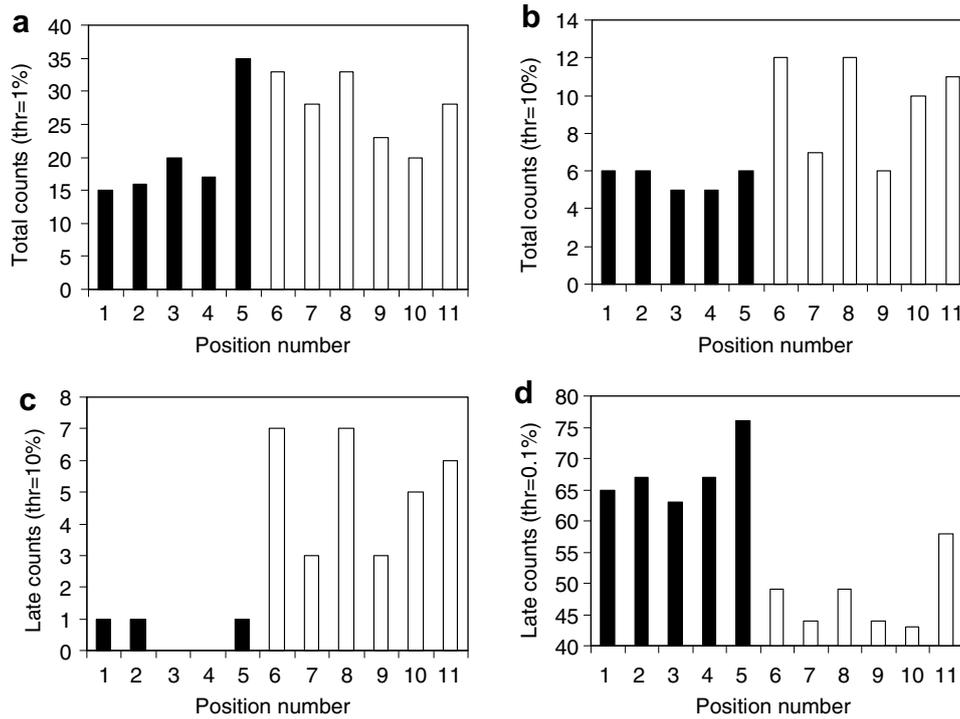
Fig. 8. Number of (a) counts for threshold 1% of maximum voltage, (b) counts for threshold 10% of maximum voltage, (c) counts after 500 μ s for threshold 10%, (d) counts after 500 μ s for threshold 0.1% (positions 1–5 correspond to full filling and 6–11 to partial filling).

To quantify this trend, the number of threshold crossings or simply “counts” in acoustic emission terminology (Shiotani et al., 2003) is examined. It is reasonable that the threshold voltage is of paramount importance for such a descriptor. In Fig. 8a, one can see the number of counts for threshold equal to 1% of the maximum voltage for each waveform. The positions 1–5 correspond to full grouting, while 6–11 to partial, as simulated in the entrance of the tunnel (see Fig. 4a). It is seen that most of the fully grouted positions exhibit lower counts than partial; however, this does not hold for all the cases since position 5, although considered fully grouted, exhibits the highest number of crossings. If the threshold is set to 10%, only larger oscillations are counted and the results are depicted in Fig. 8b. It is obvious that this threshold provides better discrimination, although there is some overlap concerning the num-

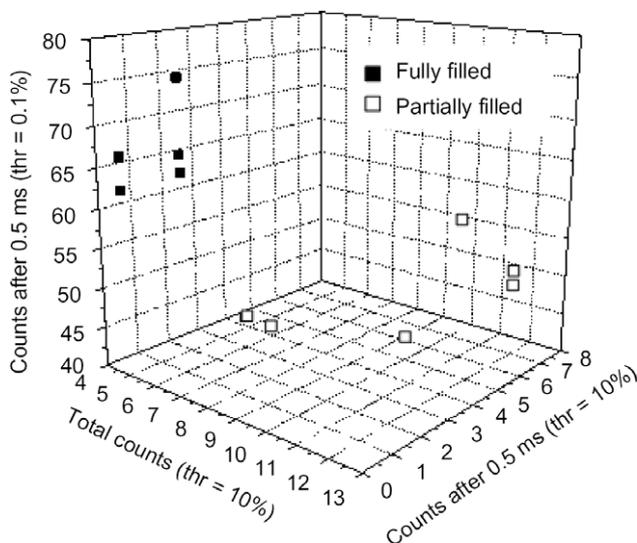
Fig. 9. Three dimensional representation of different clusters.

In Fig. 9, the 11 reference cases are depicted in a three dimensional graph with axes: total counts with threshold 10% of the maximum, counts after 500 μs with the same threshold and counts after 500 μs with the low threshold of 0.1%. It is obvious that the results form two clearly separated clusters. This could be the first step of a pattern recognition approach if the problem of characterization is difficult and one single descriptor is not powerful enough.

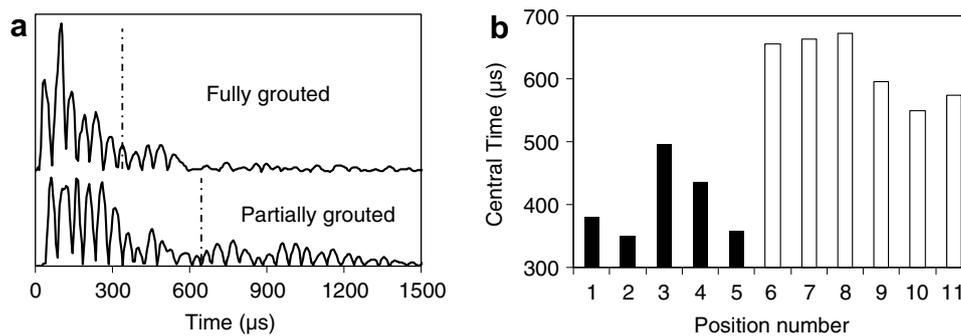
Fig. 10. (a) Rectified waveforms for different grouting cases, (b) central waveform time for different testing points (positions 1–5 correspond to full filling and 6–11 to partial filling).

Another descriptor that seems characteristic is the waveform central time (or the centroid of the rectified waveform), which has been studied in other cases (Aggelis and Philippidis, 2004). As can be seen in the examples of Fig. 10a, the filled positions exhibit a single burst followed by small cycles. For the partial cases though, the burst lasts longer, while more, strong oscillations follow, translating the centroid of the signal to later times. For any of the

intact positions, the central time is below 500 μ s, while for all the partially filled cases it is higher than 550 μ s, as can be seen in Fig. 10b.

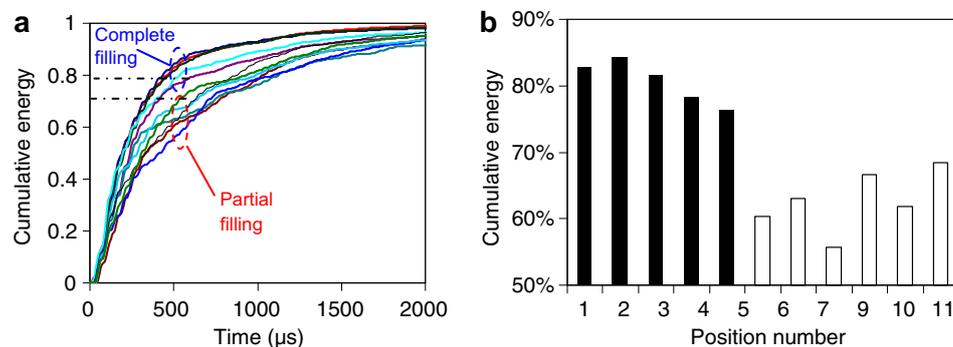
Fig. 11. (a) Normalized cumulative energy for different testing points, (b) normalized cumulative energy at the time of 500 μs (positions 1–5 correspond to full filling and 6–11 to partial filling).

An additional feature that could be used to quantify the later arrivals is the accumulated amplitude of the waveform points. This is calculated by addition of the absolute amplitude of each waveform point to the previous (Kruger, 2005; Shiotani and Aggelis, 2007). In Fig. 11a one can see the accumulated amplitude curve of the waveforms for the different reference positions. For all the curves of fully-filled positions, more than 75% of the total energy is received before 500 μ s. On the contrary, for the cases of partial filling, at the time of 500 μ s, the energy is less than 70% of the total (see Fig. 11a), since, as stated earlier, some energy components arrive later. This parameter is depicted in Fig. 11b for different positions and can also be used to characterize the filling since no overlap between the full and partial cases is observed.
